# Microstructural analysis of mechanically tested reduced-activation ferritic/martensitic steels

## Abstract

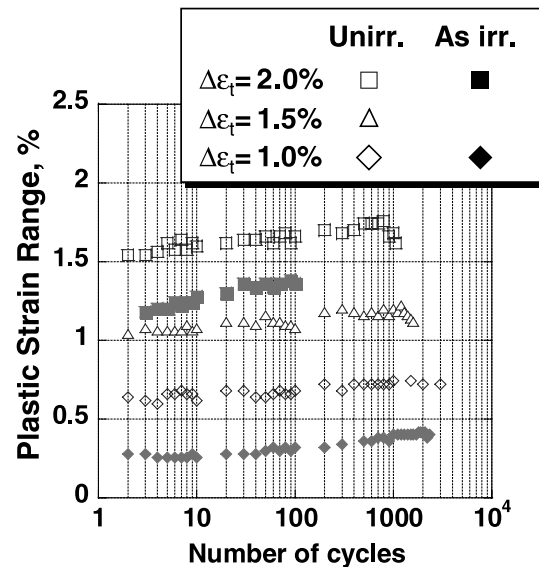
Fig. 1. Change in plastic strain range during fatigue tests.

Fig. 1 shows plastic strain range changes during fatigue tests on unirradiated and neutron-irradiated F82H. In all conditions, comparing those results obtained from the same diametral strain range tests, it is clear that plastic strain ranges in irradiated specimens are smaller than those of unirradiated specimens. This corresponds to hardening caused by low-temperature irradiation. Fig. 2 shows the fatigue lifetimes ( $N_f$ ) of as-prepared and irradiated F82H. In general, the  $N_f$  of an irradiated specimen was shorter than that of the unirradiated one. In the case of  $\Delta\epsilon_t = 2\%$ , the  $N_f$  was reduced to less than 10% of the unirradiated one. On the irradiated specimen tested at  $\Delta\epsilon_t = 1\%$ ,  $N_f$  is about  $1.9 \times 10^3$ , and this value itself is about the same as that of the unirradiated specimen tested at  $\Delta\epsilon_t = 1.5\%$ , for

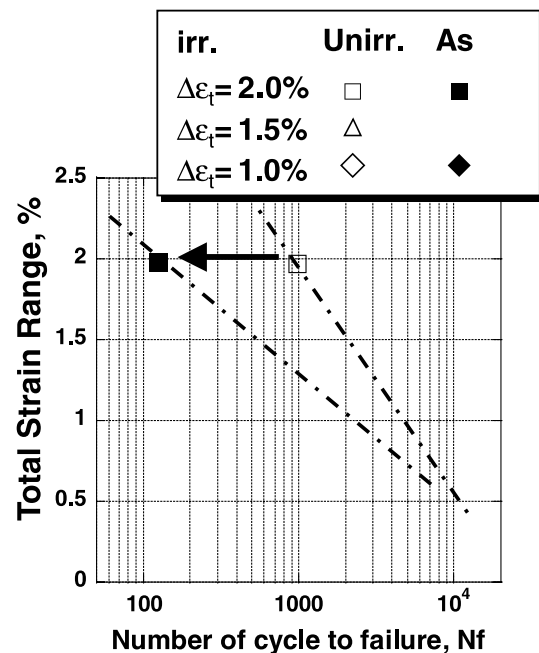
Fig. 2. Fatigue life in each condition.

which  $N_f$  is about  $2.3 \times 10^3$ . In the following sections, the fatigue fracture mechanisms corresponding to these two results will be discussed on a microstructural basis. The detailed discussion on a mechanical data basis is presented in an other paper [9].
