Mechanical properties and microstructure of AlMg_3 irradiated in SINQ Target-3

Y. Dai *, D. Hamaguchi

Spallation Neutron Source Division, Paul Scherrer Institut, 5232 Villigen PSI, Switzerland

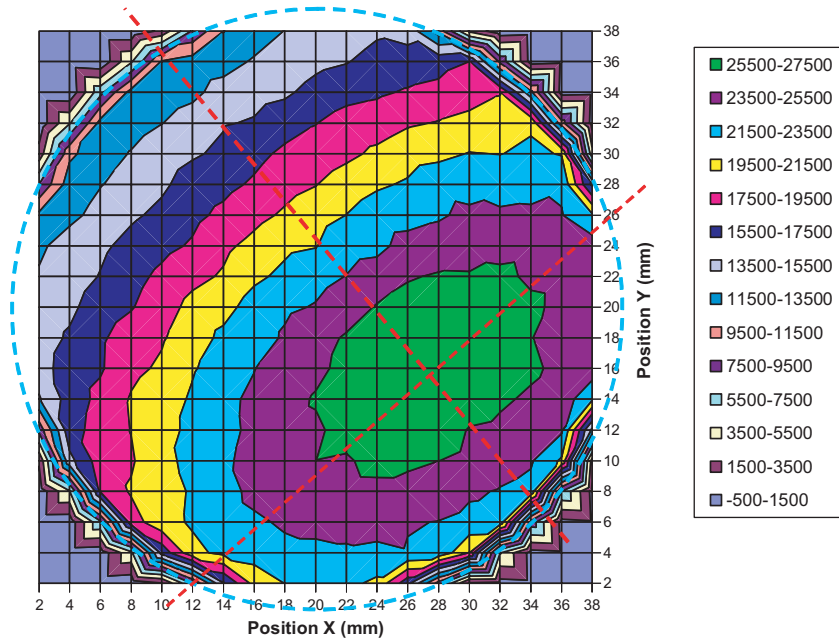
Fig. 3. γ -Mapping of Disc 1B from the center area (the middle hole shown in Fig. 2) of the beam window of the AlMg₃ safety-hull. The numbers are the counts of Na-22 measured in 20 min.

In order to determine the profile of the proton beam, γ -mapping was performed on the discs. Fig. 3 shows an example of the results of the disc from the centre area of the window. It can be seen that the proton beam has an elliptical profile. However, it is impossible to deduce the complete profile of the proton beam from the γ -mapping results because the size of the discs is too small. Hence, the proton fluence was still calculated from the known proton beam geometry [4].
