# Rupture pressure of wear degraded alloy 600 steam generator tubings

Seong Sik Hwang <sup>\*</sup>, Chan Namgung, Man Kyo Jung, Hong Pyo Kim, Joung Soo Kim

*Nuclear Material Development Technology Division, Korea Atomic Energy Research Institute, 150 Deokjin-Dong Yuseong-Gu, Daejeon 305-353, Republic of Korea*

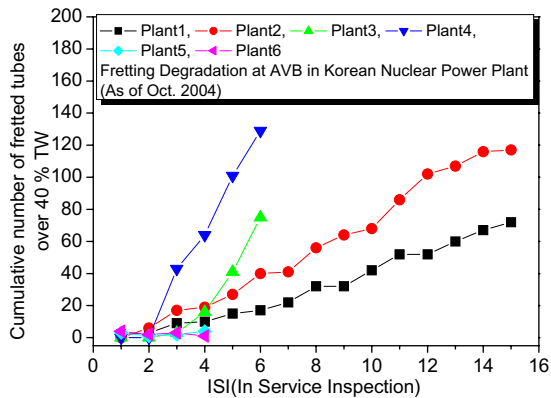
Fig. 1. Degradation trend of a fretting/wear at the AVB in Korean Plants.

SG tubes of a PWR have suffered from various types of corrosion, such as pitting, wastage and stress corrosion cracking (SCC) on both the primary and secondary side of the SG tubes [1,2]. Ligament rupture pressure of axial notch defect machined by an electrodischarge machining (EDM) has been evaluated [3–5]. Wastage was another concern with new steam generator, and it was usually found in the region of a low coolant flow and a high heat flux until the late 1970s [6]. After change of the secondary side water chemistry from a phosphate to an all volatile water treatment (AVT) in the early 1980s, the wastage substantially decreased. Then denting caused by corrosion of carbon steel support and SCC became the main degradation problems of a SG in PWRs. Recently, fretting/wear degradation at the tube support region has been reported in some Korean nuclear power plants as shown in Fig. 1. It is important to establish the repair criteria to assure reac-

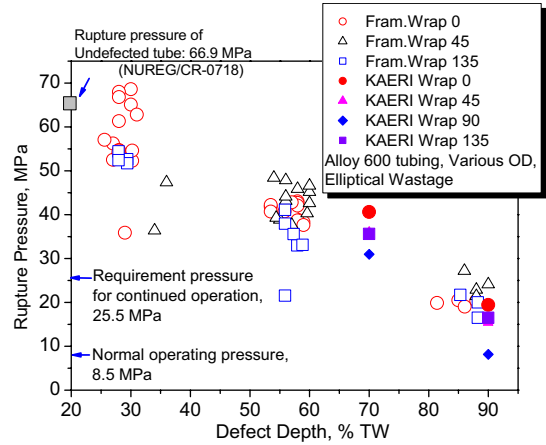
Fig. 5. Effect of the defect depth on the burst pressures of elliptical wastage specimens.

men. In the case of a large remaining thickness and low water pressure, the tube did not display a significant bulging. When the water pressure reached a yielding value, the tube showed an abrupt rupture, then the flow rate out of the ruptured tube was recorded. The tube of which the defect depth was 70% of the TW showed a ligament rupture at 37 MPa. This pressure is much lower than that of the unflawed tube; 66.9 MPa [6]. Ligament rupture pressures of the tubes with different defect depths and different wrap angles are shown in Fig. 5. Pressures of 30–40 MPa were obtained for the tubes with 70% TW defects. For the tubes with 90% TW defects, ligament rupture pressures of 15–20 MPa were recorded, which are higher than that of a pressure difference for the normal operating pressure difference between the primary and the secondary side of the SG tubes. The ligament rupture pressures showed a wrap angle dependency as indicated in Fig. 6; as the angle increased from 0° to 90°, the pressure decreased and showed the minimum value at 90°. As the wrap angle was greater than 90°, the pressure increased and it showed a similar value at 135° to that at 45°.

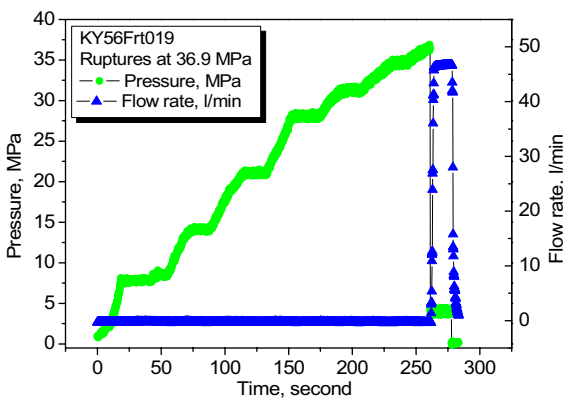
Fig. 4. Burst pressure and leak rate of a wastage tube (KY56frt019).

Fig. 4 shows the behavior of the pressure and the leak rate during water pressurization for a fretted tube speci-

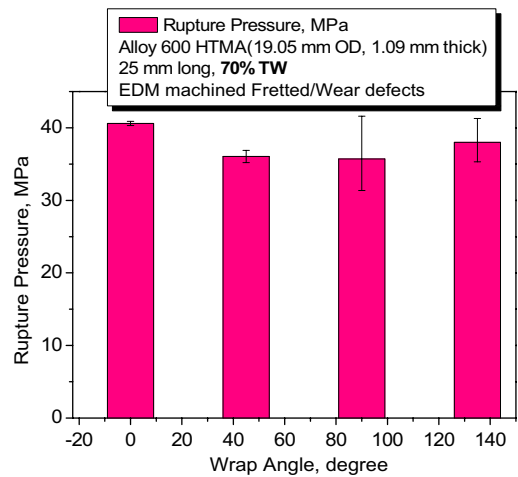
Fig. 6. Effect of the wrap angle on the burst pressure of the wastage specimens.

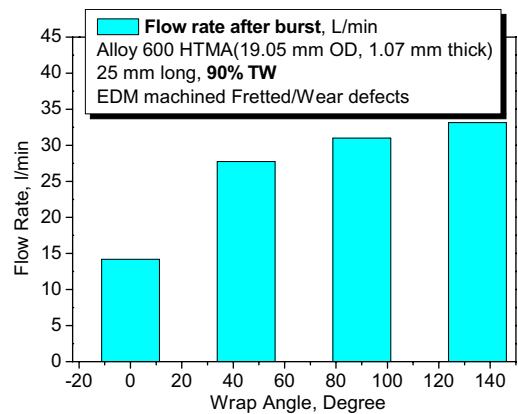
Fig. 7. Effect of the wrap angle on the flow rate of the wastage specimens.

Flow rates from the burst tubes are illustrated as a function of the wrap angle in Fig. 7. The flow rate increased with the wrap angle. It implies that a thin wall of the larger wrap angled specimens was torn easier, and it showed a larger defect opening than that of the small wrap angled specimens. The pressures were similar from the aspect of the wrap angle, but they decreased a lot when the defect depth changed from 70% to 90% TW. So the main controlling factor for the rupture pressure seems to be the defect depth.

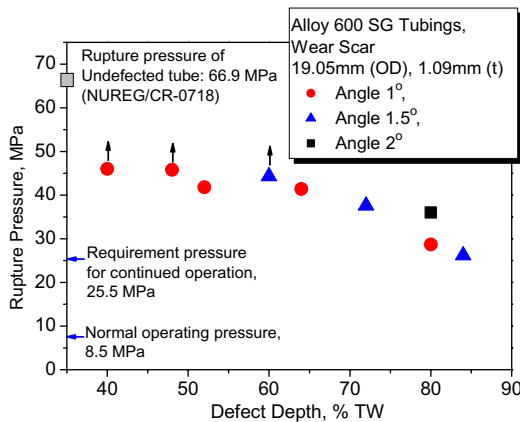
Fig. 9. Effect of the defect depth on the ligament rupture pressure of the wear scar tubes (alloy 600 HTMA).

In a general trend, as the defect depth increases, the rupture pressure decreases as shown in Fig. 9. The tubes of 40% and 47% TW with an angle of 1° did not undergo a ligament rupture at the maximum system pressure limit of 46 MPa. Those of a 60% TW with an angle of 1.5° also did not show a ligament rupture at the pressure limit of the testing system.

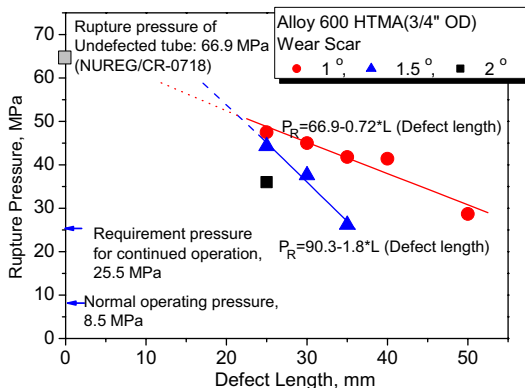
Fig. 10. Effect of the defect length on the ligament rupture pressure of the wear scar tubes (alloy 600 HTMA).

Fig. 10 shows the relationship between the rupture pressure and the defect length. The slope for a 1.5° specimen is much larger than the case of 1°; the slope is 1.8 for 1.5° specimen, and 0.72 for 1° specimen, respectively. And the constants of the linear relationship were calculated. Since

the defect depth is proportional to the length, it can be also said that the rupture pressure depends on the defect depth and length. Tubes of over 80% TW did not satisfy the three times normal operation pressure difference criterion required for a continued operation, which is similar to the elliptical wastage specimens.
