## Influence of radiation damage on plasma facing material erosion

### A B S T R A C T

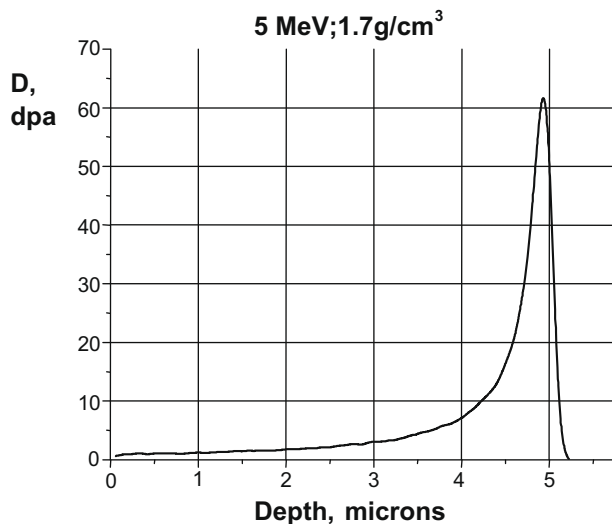
Fig. 2. Calculated profile of primary radiation defects produced in carbon material ( $\rho = 1.7 \text{ g/cm}^3$ ) irradiated by 5 MeV carbon ions up to  $10^{18}$  ion/cm $^2$  dose.

and ion energy. Fig. 2 shows the result of numerical calculation for the profile of the primary radiation defects  $D$  (dpa) as a function of depth for a carbon material with density  $\rho = 1.7 \text{ g/cm}^3$  (MPG-8) after irradiation with 5 MeV carbon ions to the dose  $10^{18}$  ion/cm $^2$ . The average value of this distribution is  $\langle D \rangle = 9.7$  dpa. The maximal value  $D_{\text{max}} = 65$  dpa lies at a depth of  $\sim 5 \mu\text{m}$ .
