# Cleaning surface treatments for the fabrication of ITER First Wall panels by HIP

This paper presents our investigations to find an industrial route to clean copper alloy and stainless steel in order to manufacture high-strength joints for ITER Primary First Wall panels. Products investigated are chemical liquids, and a more advanced technique that uses a plasma process is also investigated. HIP joints have been tested by performing impact toughness and tensile tests. Surface cleanliness has been assessed thanks to XPS measurements.

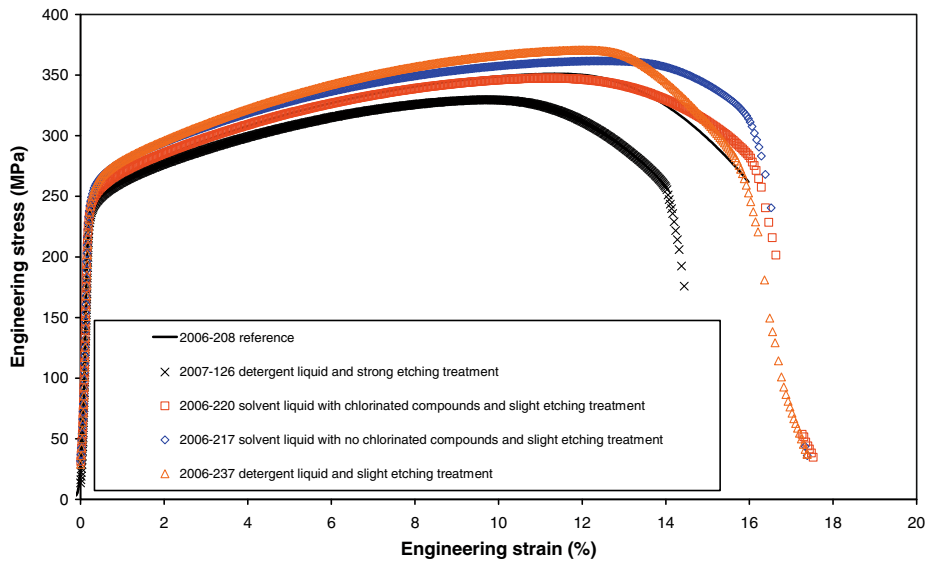
**Fig. 2.** Tensile behaviour of CuCrZr joints (room temperature).

Micrographs of CuCrZr joints presented in Fig. 1 show that no recrystallisation occurs through the interface whatever the cleaning treatment. Tensile tests present similar results (Fig. 2), with similar values of yield strength, ultimate tensile strength and elongation whatever the cleaning treatment. Furthermore, rupture occurred always in CuCrZr and not at the joint (Fig. 3), which indicates that tensile testing is not relevant to characterize the effect of the investigated cleaning treatments. Fig. 4 shows that higher impact toughness values are obtained with plasma cleaning. The worst results are obtained when CuCrZr alloys are cleaned with solvent liquid constituted with chlorinated compounds and are etched by a slight acid liquid. Furthermore, results are highly scattered. The lowest impact values are associated to a bad diffusion welding: machining marks are visible on the broken surfaces (Fig. 5(a)). In the other cases, the crack propagates both through CuCrZr and at the joint (Fig. 5(b)–(c)).

Tensile tests performed on CuCrZr/316LN joints gave results that were similar to those obtained in the case of CuCrZr/CuCrZr joints (Fig. 2). Moreover, the ultimate tensile strength of the CuCrZr/316LN joints is similar to that found in [3], where CuCrZr is aged for 4 h at 480 °C. Fig. 6 shows the impact toughness results of CuCrZr/316LN joints. All the joints present about the same impact toughness whatever the cleaning treatment. Slightly lower values were obtained with 316LN material ultimately passivated. This treatment favours the development of a protective chromium oxide layer which probably hinders the diffusion process and reduces the joint impact toughness. Since in all the cases the rupture occurred in CuCrZr, it is difficult to choose a cleaning route based on these results alone.

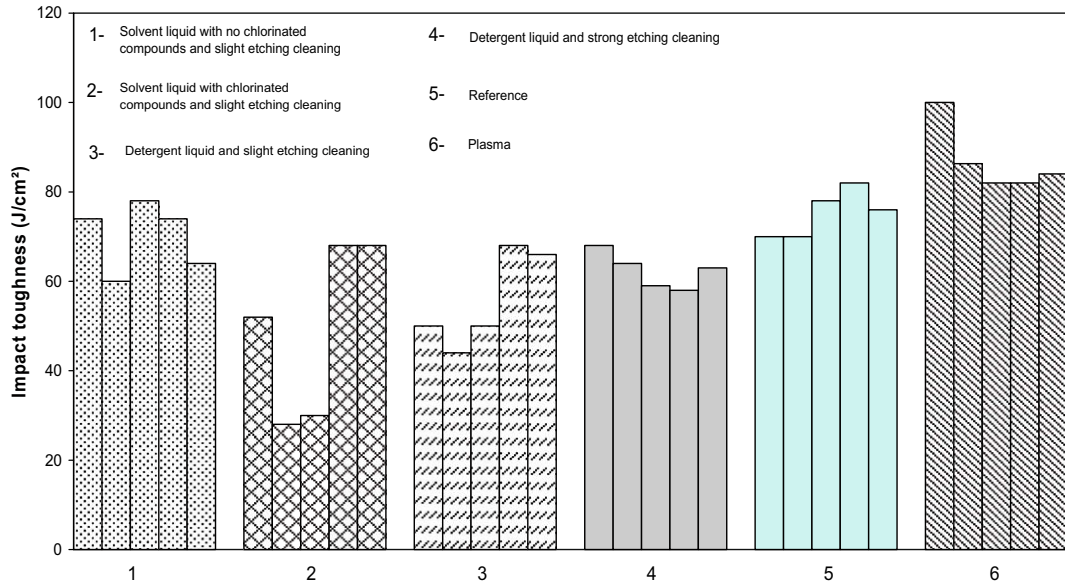
Fig. 4. Impact fracture toughness of CuCrZr joints.

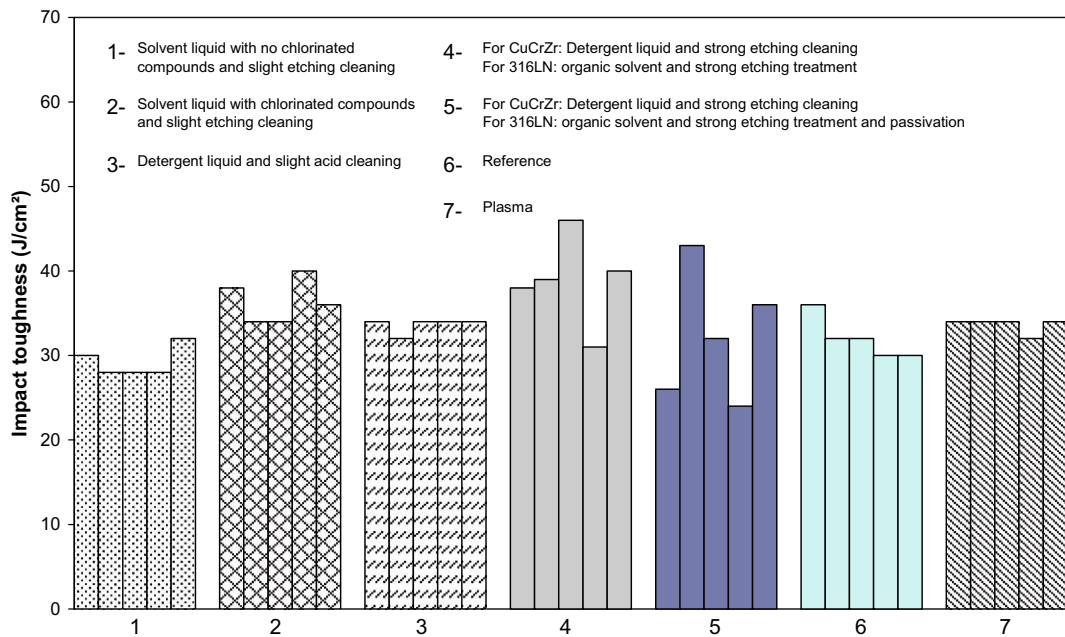
Fig. 6. Impact toughness of CuCrZr/316LN joints.

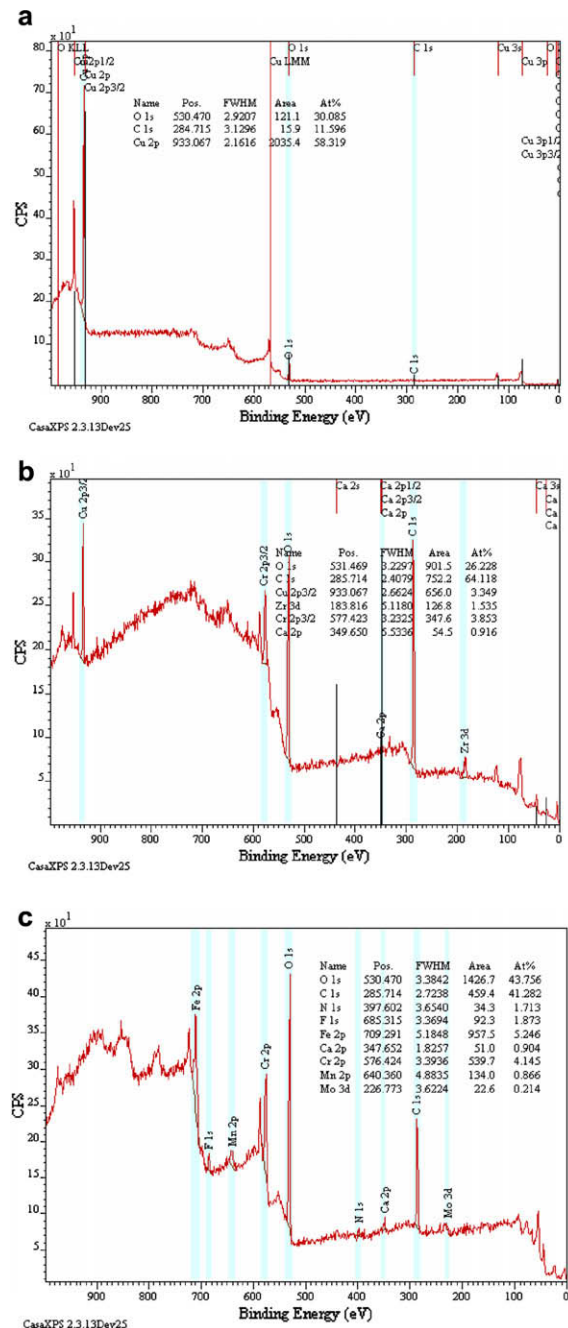
Fig. 7. XPS spectra after a brief etching (120 s) of the metallic surface with 2 keV argon ions. (a) CuCrZr after a plasma cleaning treatment, (b) CuCrZr degreased with detergent liquid and etched with a strong acid liquid, (c) 316LN sample degreased with an organic solvent and deoxidized with a strong acid liquid.

are very low (Fig. 7(a)), 10 at.% and 20 at.%, respectively. Residual pollution associated to chemical liquid processes is higher as shown in Fig. 7(b). Correlatively, impact results are lower. However, cleaning with detergent liquids coupled with a strong etching treatment allows to achieve CuCrZr/316LN joints with mechanical properties as good as those achieved with our own reference route. This is why these products seem to be a good industrial alternative to our reference route. Moreover, XPS measurements show that the surface of austenitic stainless steel cleaned with organic solvent and strong acid liquid presents approximately the same residual pollution as the sample cleaned with plasma (Fig. 7(c)). In this case,

the observation of the Fe2p peak associated to the substrate indicates that the residual pollution layer is less than 10 nm thick.
