Micro/nano scale modification of plasma facing components in LHD and its impact on the metal dust generations

M. Tokitani^{a,*}, Y. Ohtawa^b, N. Yoshida^b, K. Tokunaga^b, T. Fujiwara^b, N. Ashikawa^a, S. Masuzaki^a, H. Yamada^a, A. Sagara^a, N. Noda^a, A. Komori^a, LHD experimental group^a

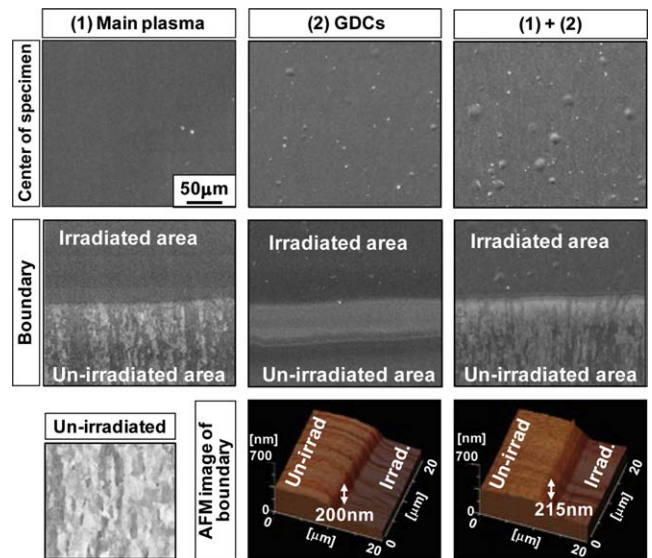
Fig. 2. Upper series; SEM images of exposed specimen. Middle series; SEM images of boundary between exposed and un-exposed area. Lower series; AFM images of boundary area.

Fig. 2 shows SEM and AFM images of Mo after exposed to the case of (1), (2) and (1) + (2). The upper series of micrograph shows that in the case of (2) and (1) + (2), large blisters with size of over 20 μm in diameter and the dusts with size of few micrometer were formed on the surface. The number of them is more remarkable at

the case of (1) + (2). The middle series shows boundary between exposed and un-exposed area. In all cases, the surface condition after irradiation has changed. And also, the lower series shows AFM images of boundary area. It was clear that exposed area of (2) and (1) + (2) suffered strong sputtering erosion over 200 nm. In contrast, exposed area of (1), some erosion was observed, but intensive deformation such as blisters and dusts were not identified. The results indicate that GDCs has a major role for surface modification and sputtering erosion than that of main plasma discharges.

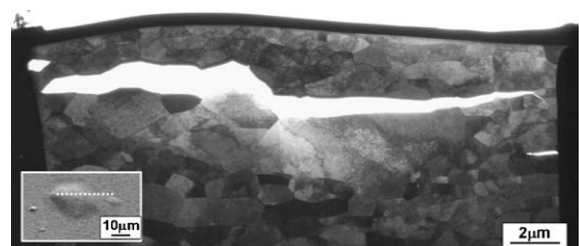
Fig. 3. Cross-sectional TEM image of large blister at the case of (1) + (2) fabricated by FIB technique.

Fig. 3 shows a cross-sectional TEM image of large blister at the case of (1) + (2) fabricated by FIB technique. Strong black layer of top surface with $\sim 0.5 \mu\text{m}$ thick is protection layer for FIB fabrication. Grains with different orientation are shown by different contrast. It should be noted that thickness of the blister's lid was estimated at about 2 μm , and fracture and upheaval of it has been occurring from grain boundaries. It is considered that injected hydrogen atoms during main plasma discharges and GDCs were diffused up to 2 μm , and were accumulated in grain boundary which may act as effective trapping site of hydrogen atoms. Newly, injected hydrogen atoms were continuously trapped along the grain boundary one after another, and formed the highly pressurized and expanding fields on grain boundaries. Finally, they caused intergranular fractures. In the case of helium ion irradiation in metals up to the dose of $\sim 10^{23}$ He/m² with low energy (< 1 keV), such a large size blisters will not be formed [8,9]. Because helium once injected in metals with low energies (< 1 keV) is immediately trapped by lattice defects which exist in the project range of it (10–

20 nm). Therefore, they cannot diffuse up to the depth of 2 μm . Details are discussed in Section 3.2.

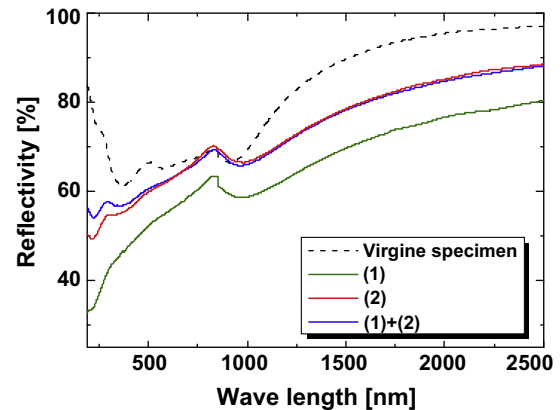
Fig. 6. Optical reflectivity of Mo after exposed to three exposure cases in Table 1.

Fig. 6 shows the optical reflectivity of Mo specimen after exposed to three exposure cases by using spectrophotometer. Reflectivity of virgin specimen was also plotted together. It is clear that reduction of reflectivity has occurred in all cases, and it near 200 nm or less and also infrared region was remarkable. The spectrum of (1) which was exposed to only main plasma discharges is significantly large reduction. Although we cannot explain this phenomenon well now, it seems to be due to the energetic neutral-helium bombardment with the energy of ~ 1 keV which was created by charge-exchange collisions. It was reported that effects of helium bombardment are three orders of magnitude higher than that of hydrogen bombardment for optical reflectivity [7]. In that case, it is considered that reduction of optical reflectivity is due to the multiple scattering of light by the helium bubbles in the sub-surface region. It should be noted that specimens were placed to bottom of the outer-port, where relatively far from the first wall position (see Fig. 1). In future fusion devices, mirrors for plasma diagnosis will be designed at same manners. In that case, reduction of reflectivity due to the plasma bombardment is serious problem.

Optical reflectivity of Mo after exposed to three exposure cases was measured by spectrophotometer. Reduction of reflectivity has occurred in all cases, and it near 400 nm or less was especially remarkable. It should be noted that these specimens were placed to relatively far from the first wall position. In future fusion de-
