Evidence of radiation damage impact on material erosion in plasma environment

ABSTRACT

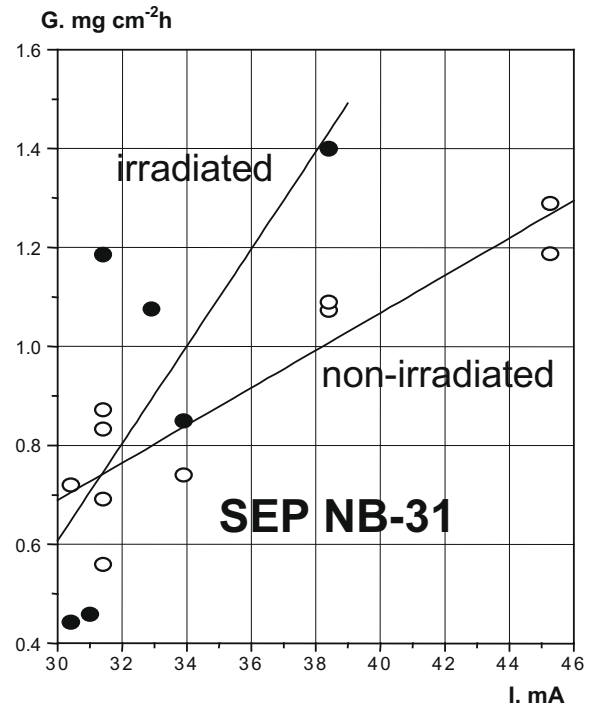
Fig. 6. Erosion rate of SEP NB-31 composite vs. plasma ion flux.

Erosion rate was evaluated by weight loss measurements. Fig. 5 shows the pyrographite erosion rate as a function of the impinging ion current from the plasma. The same measurement on the SEP NB-31 is shown in Fig. 6. The slope of the curves presented on the picture gives the erosion yield Y . The yields ratios of the irradiated materials to those having no damage deduced from these data were the following: $Y_{SEP-irrad}/Y_{SEP} = 2.6 \pm 0.6$ at/ion, $Y_{pyro\ irrad}/Y_{pyro} = 4.8 \pm 0.4$ at/ion. The result shows the increase of the erosion yield for the radiation-damaged material as compared with the non-irradiated material.
