Radiation effects on epoxy/carbon-fiber composite

Carbon fiber-reinforced bisphenol-A epoxy matrix composite was evaluated for gamma radiation resistance. The composite was exposed to total gamma doses of 0.5, 1.0, and 2.0 MGy. Irradiated and baseline samples were tested for tensile strength, hardness and evaluated using Fourier transform infra-red spectroscopy and differential scanning calorimetry for structural changes. Scanning electron microscopy was used to evaluate microstructural behavior. Mechanical testing of the composite bars revealed no apparent change in modulus, strain to failure, or fracture strength after exposures. However, testing of only the epoxy matrix revealed changes in hardness, thermal properties, and spectroscopy results with increasing gamma irradiation. The results quantify the changes in the epoxy within the composite as a result of exposure to gamma radiation at doses relevant to service.

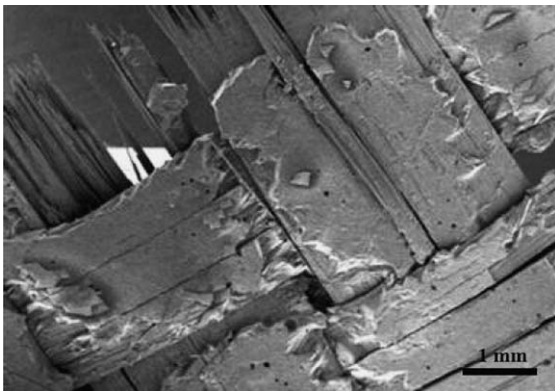
Fig. 10. Epoxy surface on tensile bar subjected to 2.0 MGy gamma radiation.

As further evidence of increased degradation after a 2.0 MGy gamma irradiation, several bulges covered in cracks have formed on the irradiated sample. These are possibly due to the release of gases from the epoxy upon radiation decomposition or a post-cure phenomenon. Off-gassing of polymers during radiation exposure is expected. Additional images of radiation damage are shown in Fig. 10, depicting the macroscopic disconnect between sections of epoxy on the carbon fiber weave. Macrocracks form at the interface of carbon fiber bundles as well as along the length of the carbon fiber bundles. The crack formation suggests the epoxy has lost significant reinforcing properties.
