Advanced TEM characterization of stress corrosion cracking of Alloy 600 in pressurized water reactor primary water environment

Advanced transmission electron microscopy techniques were carried out in order to investigate stress corrosion cracking in Alloy 600 U-bend samples exposed in simulated PWR primary water at 330 °C. Using high-resolution imaging and fine-probe chemical analysis methods, ultrafine size oxides present inside cracks and intergranular attacks were nanoscale characterized. Results revealed predominance of Cr₂O₃ oxide and Ni-rich metal zones at the majority of encountered crack tip areas and at leading edge of intergranular attacks. However, NiO-structure oxide was predominant far from crack tip zones and within cracks propagating along twin boundaries and inside grains. These observations permit to suggest a mechanism for intergranular stress corrosion cracking of Alloy 600 in PWR primary water. Indeed, the results suggest that stress corrosion cracking is depending on chromium oxide growth in the grain boundary. Oxide growth seems to be dependent on oxygen diffusion in porous oxide and chromium diffusion in strained alloy and in grain boundary beyond crack tip.

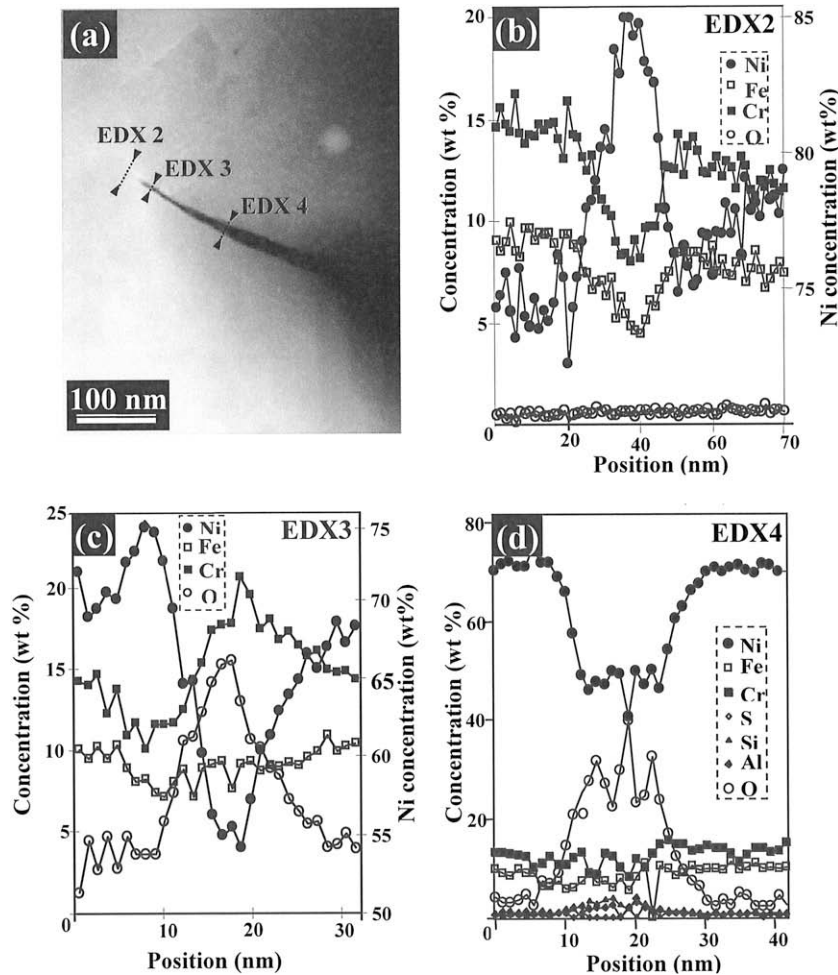
Fig. 6. (a) STEM-HAADF image of crack 1 with indication of EDX analysis locations; Compositional profiles obtained using fine-probe EDX analysis performed ahead of the crack tip (b); at tip zone (c) and at mid-zone area (d).

To determine nature of oxides formed inside *principal* cracks, EDX analysis using nanometric probe and high-resolution imaging were combined. Fig. 6a shows a STEM-HAADF image of crack 1. The chemical contrast allows to clearly distinguish between oxidized zones and intact boundary ahead of the crack tip. Line-scan EDX analyses were then performed through and ahead of the oxidized zones as indicated on the figure. The corresponding compositional profiles are presented in Fig. 6b, c and d, respectively. Thus, Ni enrichment (Cr and Fe depletion) of the boundary over approximately 100 nm just ahead of the crack tip was detected (Fig. 6b).

At the tip area, compositional profiles clearly showed the presence of both Cr-rich oxide and nearly pure Ni metal regions distributed side by side (Fig. 6c). Far from the tip area, NiO-structure oxide with metal-atom ratio similar to the alloy seems to be predominant (Fig. 6d). Traces of S, Si and Al were also detected but were attributed to polishing compounds used in the sample preparation. Concerning the particles formed along the crack flanks, EDX analysis revealed element concentrations in agreement with $\text{Ni}(\text{Fe,Cr})_2\text{O}_4$ oxides.

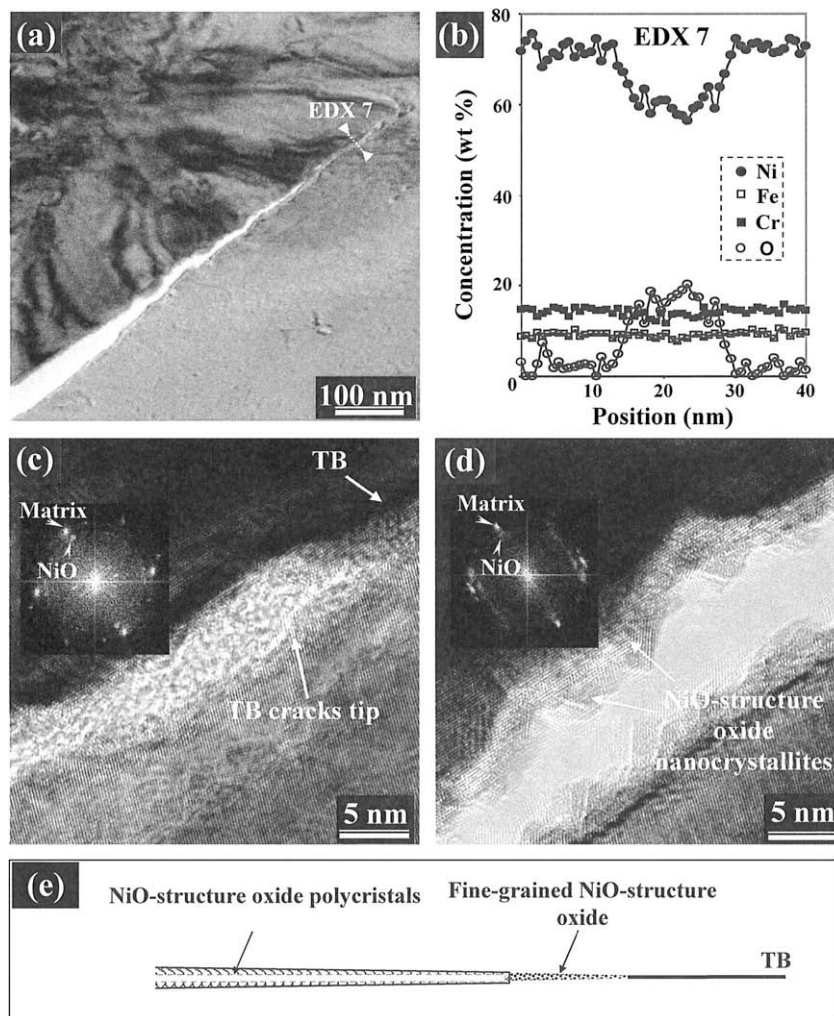
Fig. 9. (a) TEM micrograph of a twin boundary crack; (b) compositional profiles obtained using fine-probe EDX analysis performed through the tip area revealing predominant NiO-structure oxide; (c) lattice image of the tip area showing a very fine-grained structure identified as NiO-structure oxide (inset FFT diffractogram). (d) Lattice image showing nanocrystals formed along the crack flanks identified as NiO-structure oxides (inset FFT diffractogram); and (e) schematic representation of the oxides nature and repartition in twin boundary cracks.

Twin boundary (TB) cracks exhibited a different shape and different oxides structure compared to *principal* cracks propagating along general boundaries. Indeed, TB cracks were unfilled and the tip area consisted on a porous fine-grained zone extending over approximately 150 nm before terminating on intact boundary (Fig. 9a and c). Fine-probe EDX analysis performed through the tip zone (EDX7) showed exclusive oxygen enrichment as illustrated by the compositional profiles presented in Fig. 9b. Thus, the exploitation of FFT diffractograms corresponding to local areas in this zone revealed that is about a NiO-structure oxide (see inset FFT diffractogram in Fig. 9c).

On the other hand, lattice images obtained along the open crack showed the presence of nanocrystalline particles forming a continuous layer on both crack flanks. These nanocrystals were equally identified as NiO-structure oxides (Fig. 9d). Other particularity of TB cracks was the absence of the Fe-rich oxide particles frequently observed on *principal* crack flanks and inside *secondary* cracks. Fig. 9e presents a schematic representation which sums up *twin boundary* cracks features.

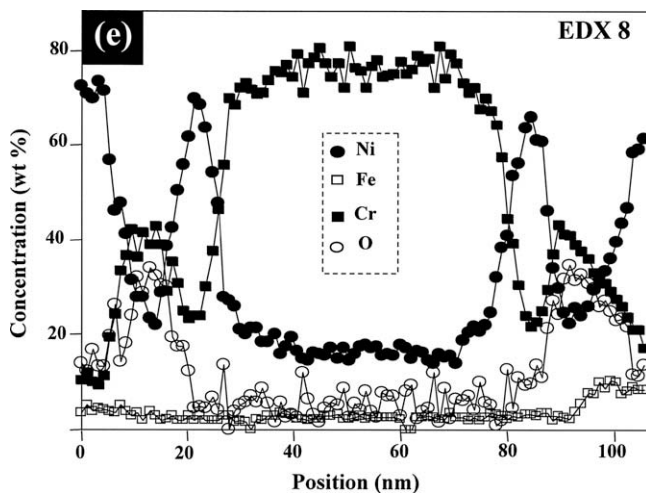
Fig. 11. Compositional profiles obtained using fine-probe EDX analysis performed through the carbide revealing that the oxidized zone is Cr-rich while the bright-contrast intermediate zone is Ni-rich.

Fine-probe EDX analysis was performed through the oxidized carbide (EDX8) and the obtained compositional profiles are reported in Fig. 11. Carbon is not presented because of contamination and absorption effects making unreliable its quantification. Analysis of element concentration profiles revealed that the oxide layer was enriched in chromium (~ 43 wt%) while the Ni content is probably originated from the alloy matrix regions crossed by the transmitted electron beam. EDX analysis also confirmed the Ni-enrichment of the bright-contrast band separating the carbide from the oxide layer observed on STEM-HAADF image of Fig. 10d.
