## Creep damage mechanisms in polyethylene gas pipes

This study deals with the creep damaging processes of two polyethylene (PE) resins. One is a ductile material while the other is a brittle one. Scanning electron microscopic (SEM) observations as well as chemical analysis are used to identify elementary process involved in the crack initiation and propagation. Of the two considered resins, only the second exhibits a lifetime controlled by slow crack growth (SCG). It is shown that catalytic residues act as initiating agents for the damage. Nevertheless, the presence of such particles in an extruded resin does not lead to a creep damage in every case.

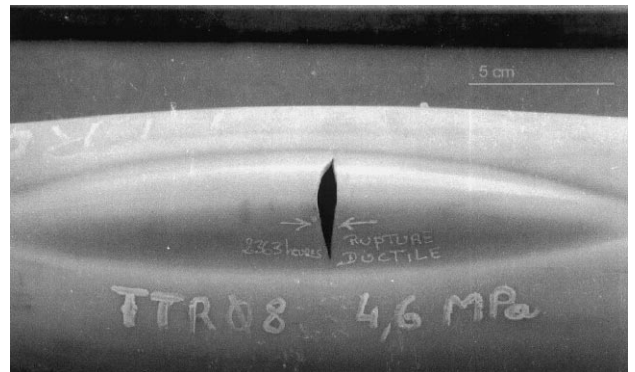
Fig. 12. Ductile failure under hydrostatic pressure (9.6 bar) at 80°C (resin A).

Resin A breaks in a ductile manner after a localized deformation (Fig. 12).

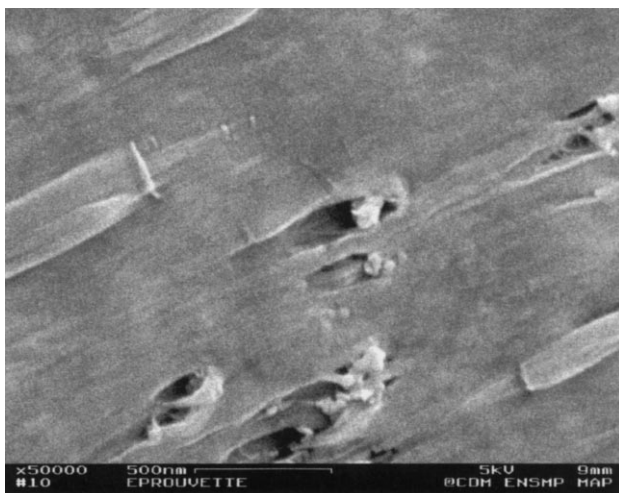
Fig. 20. Particles of catalytic residues in resins A and B.

Other analyses using X microprobe (wavelength dispersive spectrometry WDS) on microtomed samples (Fig. 20) show that the resin contains many particles of the same type (see Fig. 21).
