## **Assignment of acoustic emission to the failure sequence and damage zone growth in glass fiber strand mat-reinforced structural nylon RIM composites**

**J. Karger-Kocsis<sup>1,\*</sup>, Q. Yuan<sup>1</sup>, and T. Czigány<sup>2</sup>**

<sup>1</sup>Institut für Verbundwerkstoffe GmbH, Universität Kaiserslautern, Postfach 3049, W-6750 Kaiserslautern, Federal Republic of Germany

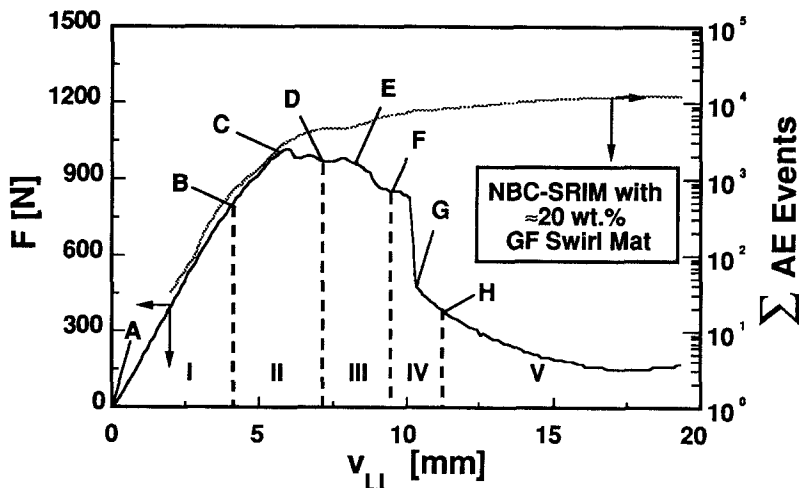
**Figure 2**  $F-v_{LL}$  curve and the cumulative run of the AE events taken in localization mode for a modified CT-specimen. Note: this figure displays both the taking positions of the microphotographs in Figure 3 and the "fragmentation" of the curve for AE signal analysis.

Figure 2 displays the force - load line displacement ( $F-v_{LL}$ ) curve of the CT-specimen together with the course of the cumulative AE events. The  $F-v_{LL}$  curve was "fragmented" (cf. I to V in Figure 2) in order to assure a confident assignment of the AE signals to the failure manner observed (cf. Figure 3). The series of the related bright field photographs taken during the loading of the CT-specimen are envisaged in Figure 3.
