### Improvement of the Durability of Zinc-Coated Steel/Epoxy Bonded Joints

M. Bremont<sup>a</sup>; W. Brockmann<sup>a</sup>; M. F. Guimon<sup>b</sup>; G. Pfister-guillouzo<sup>b</sup>

**To cite this Article** Bremont, M. , Brockmann, W. , Guimon, M. F. and Pfister-guillouzo, G.(1993) 'Improvement of the Durability of Zinc-Coated Steel/Epoxy Bonded Joints', *The Journal of Adhesion*, 41: 1, 147 – 168

The durability properties of bonded lap shear joints made from an epoxy/dicyandiamide adhesive and hot-dipped galvanized (G2F) or electroplated-phosphated (EZ2) steel have been investigated. The degradation mechanisms have been studied after three accelerated ageing tests: the "cataplasme humide" ("C.H.T."), immersion ("I.T."), and salt spray ("S.S.T.") tests. X-ray photoelectron spectroscopy (XPS) analysis of fracture surfaces after ageing have shown that anodic dissolution of the zinc-coating is responsible for debonding in all cases and that intergranular corrosion phenomena account for poorer performances of the hot-dipped galvanized substrate during "C.H.T." and "I.T." Silane coupling agents were successfully used as primers on both substrates to increase the hydrolytic stabilit

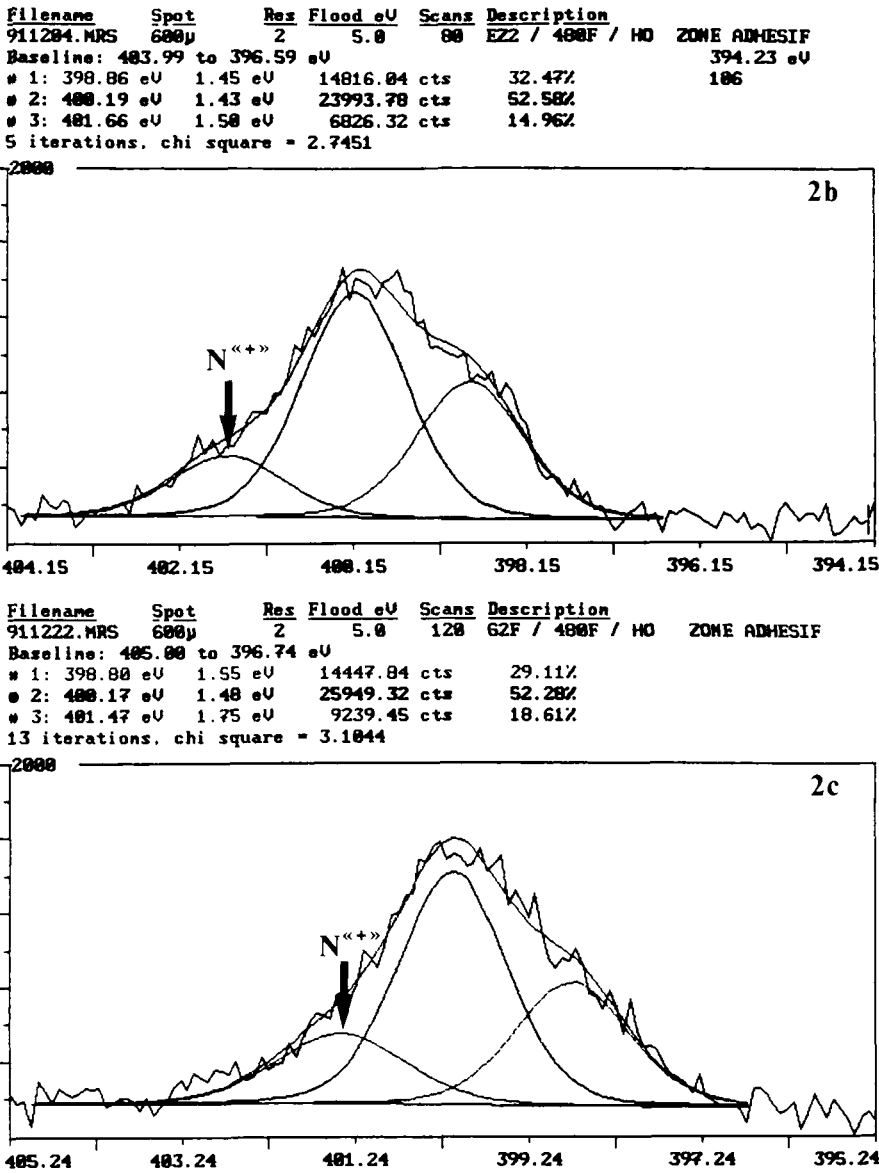
*Presence of a "protonated amino species" at the adhesive/metal interface* Hong *et al.* reported the formation of a "protonated amino species" on the interfacial metal side of oil-contaminated, cold-rolled steel/epoxy bonded joints cured with an amidoamine curing agent having a low amine number.<sup>11</sup> Later, they could also pinpoint a "protonated amino species" in the interfacial region formed between an epoxy/polyamide adhesive and cold-rolled steel or 2024 aluminium.<sup>10</sup> Surprisingly, no protonation was detected when using an electrogalvanized steel substrate. Figure 2 compares the N(1s) high resolution spectra of EZ2 and G2F/1K-A interfacial

FIGURE 2 N(1s) spectra obtained from a cross-section of the bulk adhesive (2a) and EZ2 (2b) or G2F/IK-A (2c) interfacial adhesive side.

adhesive side with the N(1s) high resolution spectra of a cross-section of the bulk adhesive. Both interfacial regions display, in addition to the characteristic bands associated with  $N\equiv C$ ,  $N=C$  (at ca. 399 eV) and  $N-C$ ,  $N-H$  (at ca. 400 eV), an extra peak shifted 1.5 eV at higher binding energies. This may indicate that an acid/base reaction between dicyandiamide and the hydroxylated surfaces took place for both galvanized substrates. The N(1s) high resolution spectra of specimens

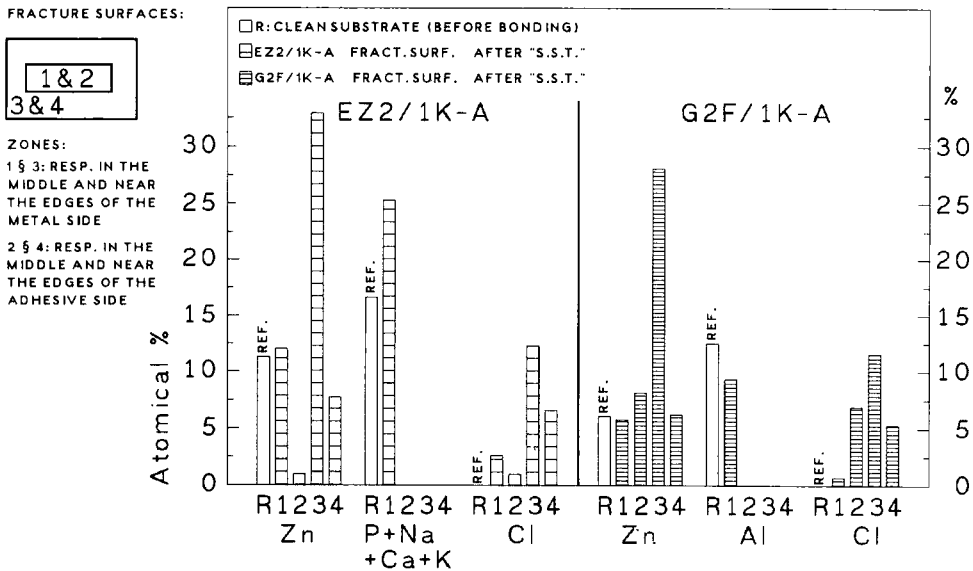
The main features of the XPS analyses of EZ2 and G2F/1K-A fracture surfaces after “S.S.T.” are presented in Figure 7. The concentration of Cl increases from

FIGURE 7 XPS analysis of the 4 zones of EZ2 and G2F/1K-A fracture surfaces after salt spray test.

2.6% to 12.3% on the interfacial metal side as we move from the middle (Zone 1) to the edges of EZ2/1K-A bonded joints (Zone 3). The phosphate coating does not display any sign of dissolution in Zone 1. Therefore, contrary to what was observed after "I.T.," the extent of degradation effects merely due to diffusion of water is limited to a small area preceding the corrosion front. The higher concentrations of alkali metal salts and phosphorus observed on the interfacial metal side, 25.3% against 16.6% for the "clean" metal surface, are likely to be due to partial displacement of the contamination layer (8.6% of C at 284.8 eV against 23.1% for the reference substrate). Figure 8 illustrates the clear transition between Zone 1 and Zone 3. The atomic % of the three corrosion products present in Zone 1, ZnO, Zn(OH)<sub>2</sub>, and ZnCl<sub>2</sub> are, respectively, 5.2%, 15.0%, and 12.7% (overall concentration of Zn: 32.9%).

The same effects are observed on G2F/1K-A fracture surfaces, providing evidence of a degradation mechanism less dominated by diffusion of water. Concentrations of Al and Zn close to the ones found on the clean substrate are measured in Zone 1 (9.3% and 5.3% respectively, against 12.5% and 6.1%). Only C, O, Zn, and Cl are detectable in Zone 3. The same species plus N are detectable in Zone 4. Therefore, the failure, which is cohesive inside a layer of adhesive for unaged specimens, is located in a layer of zinc corrosion products consisting of ZnO, Zn(OH)<sub>2</sub>, and ZnCl<sub>2</sub> after "S.S.T." (respectively, 9%, 14.6% and 4.5% for an overall concentration of 28.1 atomic % Zn in Zone 3). Apart from the characteristic

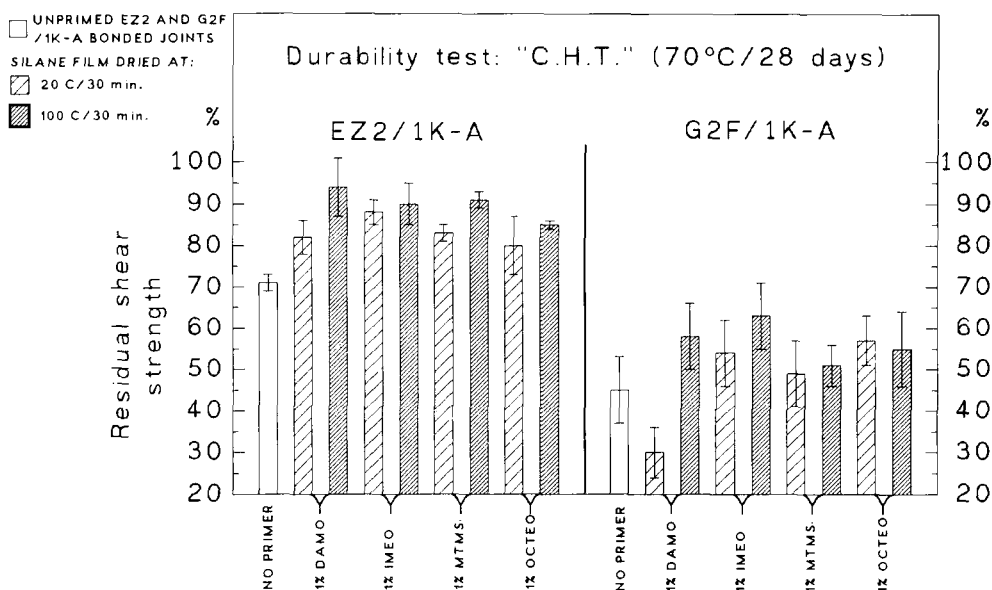
*Influence of the drying conditions of the silane film* EZ2 and G2F/1K-A bonded joints made from metal coupons primed with DAMO, IMEO, MTMS, or OCTEO at room temperature or 100°C were aged following the "C.H.T." procedure. Although the durability properties of all silane-treated specimens were much better than those of the control specimens, Figure 14 demonstrates that it is often profitable to cure the primer prior to bonding. The average improvement was ca. 10% of the residual lap shear strength after "C.H.T." This effect was most pronounced for G2F specimens primed with a 1% solution of DAMO. Badly polymerized DAMO is likely to weaken the silane film and, because of the large excess of unreacted amino groups, increase the hydrophilicity of the metal/adhesive interface. The high natural PH of the solution (ca. 11) can also contribute to the dissolution of the "aluminium islands" on the surface of G2F.

FIGURE 14 Influence of the drying temperature of the silane film on the durability of the bonded joints.

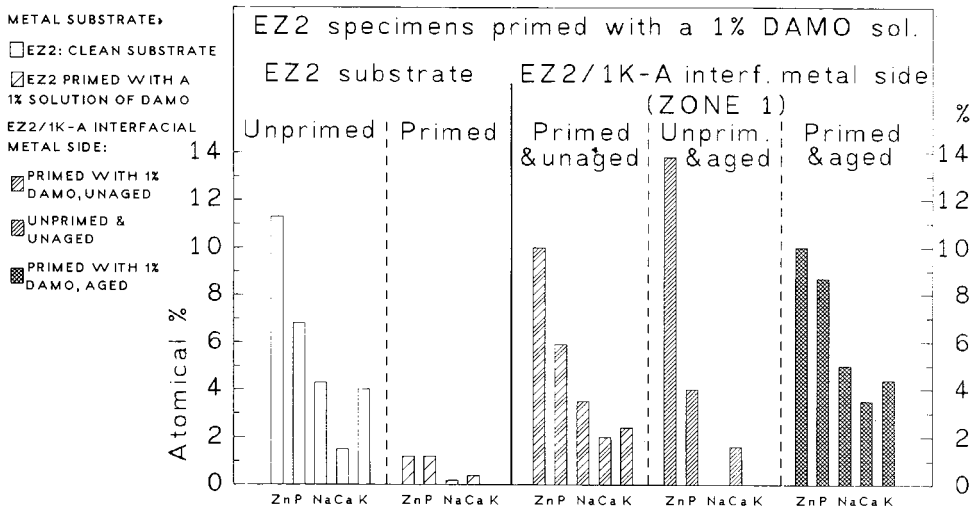
*XPS analysis of specimens primed with DAMO* Figure 15 illustrates the chemical composition of the surface of EZ2 specimens primed with DAMO in isopropanol (main components of the phosphate layer). The concentrations of Zn and P on samples primed with a 1% DAMO solution in isopropanol were both equal to 1.2%, against 11.3% and 6.8% for the clean metal substrate. Weight measurements gave an average surface coverage of 180 mg/m<sup>2</sup> corresponding to a silane film thickness of ca. 180 Å. The overall composition of the interfacial metal side of primed specimens is very close to the composition of the clean metal substrate. It is interesting to see that Si, present at a 5.8 atomic % on the surface of the primed substrate, was not detectable on the unaged interfacial metal side. Furthermore, the Si concentration on the adhesive side increased from 3.5% to 7.8%. This demonstrates that the silane film fully remained on the adhesive side after shear testing and that the failure took place at the silane film/metal interface. Five and 10 atomic % of nitrogen were found, respectively, on the interfacial adhesive side and the primed non-bonded EZ2 substrate, giving additional evidence that the primer was displaced while curing the adhesive.

After ageing tests, the phosphate coating of untreated specimens was nearly entirely dissolved away from the interfacial metal side, whereas its chemical composition remained unmodified for DAMO-treated specimens. This clearly shows that DAMO, and most likely all other tested coupling agents, stabilize the metal/adhesive interface against hydration.

FIGURE 15 Atomic % of Zn, P, Na, Ca, and K on EZ2 surface and EZ2/1K-A interfacial metal side (for primed and unprimed specimens) before and after "cataplasme humide" test (70°C/28 days).
