Interphase Formation and the Characterisation of Polymer/Ceramic Adhesion

Interphase Formation and the Characterisation of Polymer/Ceramic Adhesion*

The adhesion of photocured resins to ceramic substrates has been investigated using a variety of surface analytical techniques. Work has been aimed at establishing the physical and chemical interactions between resin and substrate in the interphase region and the effect of environmental exposure on these. Analysis was aided by use of specially-designed, *in-situ* fracture facilities attached by an X-ray photoelectron spectrometer. Specific attention was focused on identification of localised regions of varying chemical composition in adhesive and adherend by imaging spectroscopies (imaging XPS and ToF SIMS imaging) and the study of the significance of such heterogeneities on adhesion and subsequent failure mechanisms.

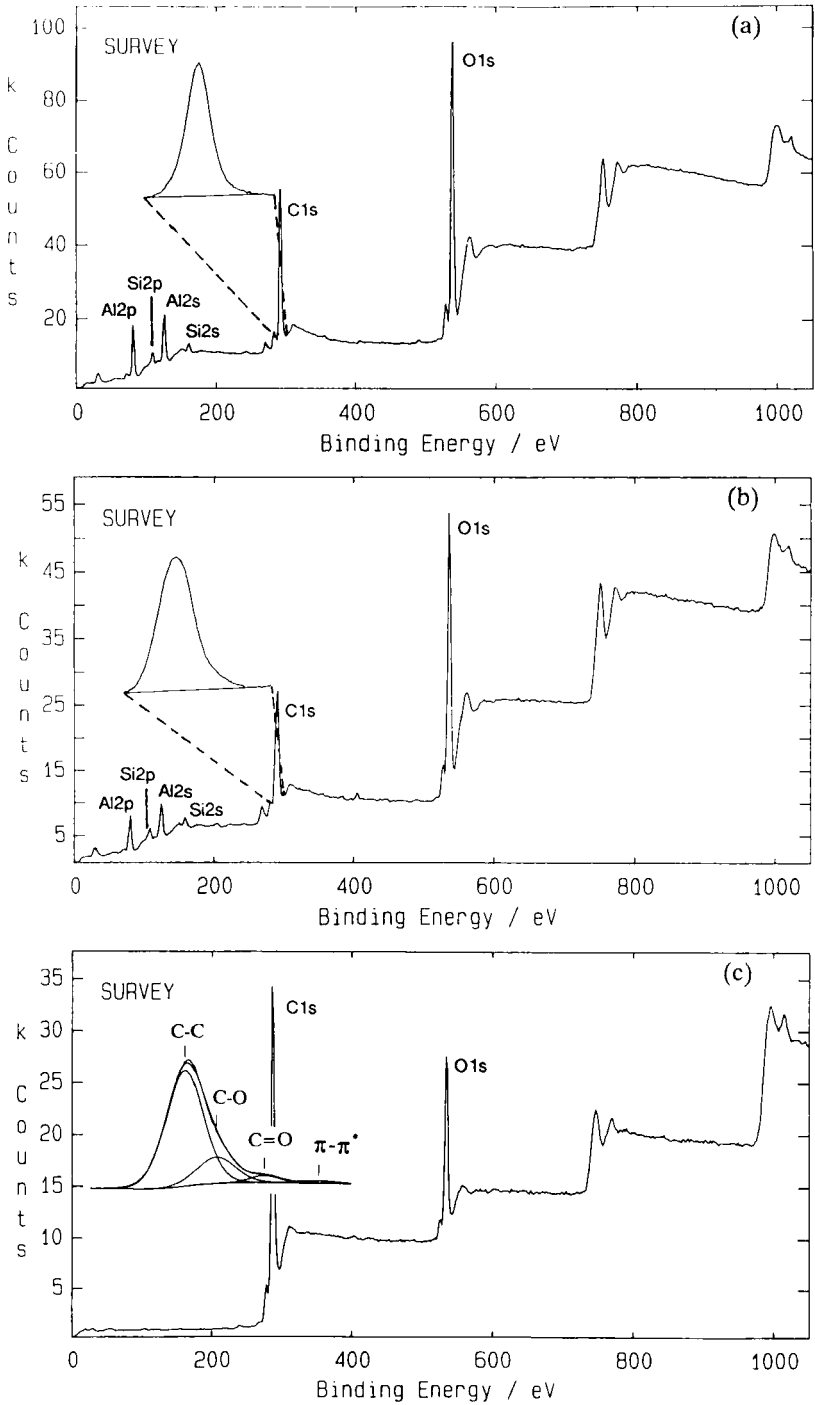
FIGURE 6 Comparison of both survey and C1s spectra for (a) as-received Coors AD96 alumina, (b) alumina side of an interfacial failure and (c) Luxtrak™ side of the interfacial failure.

These data are consistent with failure occurring at the junction of, or just within, an adventitious layer which exists on the alumina substrate prior to bonding and is slightly rearranged during the cure of the polymer. The latter is most likely and is suggested by curve-fitting the C1s spectrum. This indicated a relative increase in the C—H contaminant, most likely arising from a thin layer of adventitious material which became transferred to the polymer side of the interfacial failure.

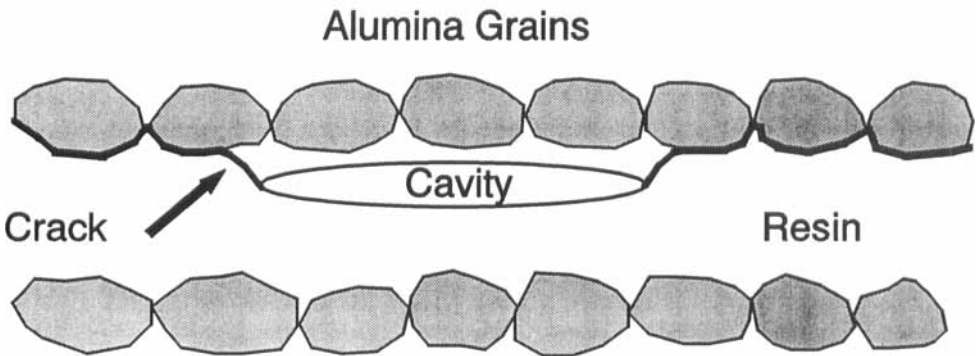
FIGURE 11 Fracture initiation by a defect (bubble or cavity).

In this particular case, it is suggested that a physical defect, most likely a gas bubble, or polymer cavity, is responsible for crack initiation. Other potential sites include areas of lower polymer cross link density or regions of chemical heterogeneity. Failure within the mirror zone was confirmed as interfacial by both SEM and imaging XPS. A more detailed study of the mechanical properties of this system,¹⁴ involving the use of double cantilever beam tests (pure Mode I failure), also resulted in interfacial failures. XPS carried out on the underside of the polymer, which had previously been adhered to the alumina, did not reveal the presence of inorganic material. This makes it unlikely that the instability of the interface is due to the presence of a weak boundary layer resulting from the presence of surface-segregated processing aids.

- (i) A crack is initiated at a defect, in this case a bubble.
- (ii) The crack runs interfacially for a certain distance. At this stage, the crack is forced to change direction continually as it follows the natural contours of the alumina grains.
- (iii) Eventually, the crack becomes unstable and follows an energetically more favourable pathway within the polymer itself.
