The Locus of Environmental Crack Growth in Bonded Aluminium Alloy Joints

The locus of crack growth in epoxy/aluminium-alloy joints exposed to water at 60°C has been investigated using X-ray photoelectron spectroscopy and electron microprobe analysis. The surface pretreatment to which the aluminium alloy is subjected prior to bonding is shown to influence both the subsequent joint durability and the locus of crack growth.

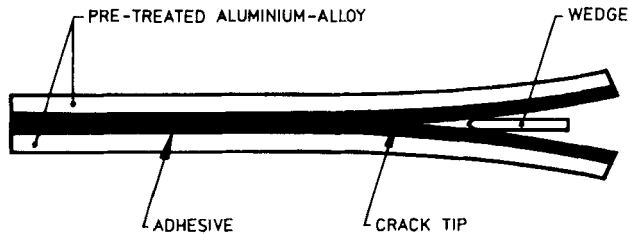
FIGURE 1 Wedge-test crack-growth specimen.

Two pretreated strips were bonded together and, to crosslink the adhesive, the resultant joint was subjected to a cure schedule of 24 hours at 23°C followed by 24 hours at 60°C. A wedge was then driven carefully into the joint for a fixed distance and the position of the crack tip noted. The test method is shown schematically in Figure 1. The joint was then immersed in distilled water at 60°C from which it was removed periodically for the measurement of crack tip advance. After about seven hours immersion the joint was taken out and the strips pulled completely apart. Areas of the strips where environmental crack growth had occurred were then cut out for subsequent examination.

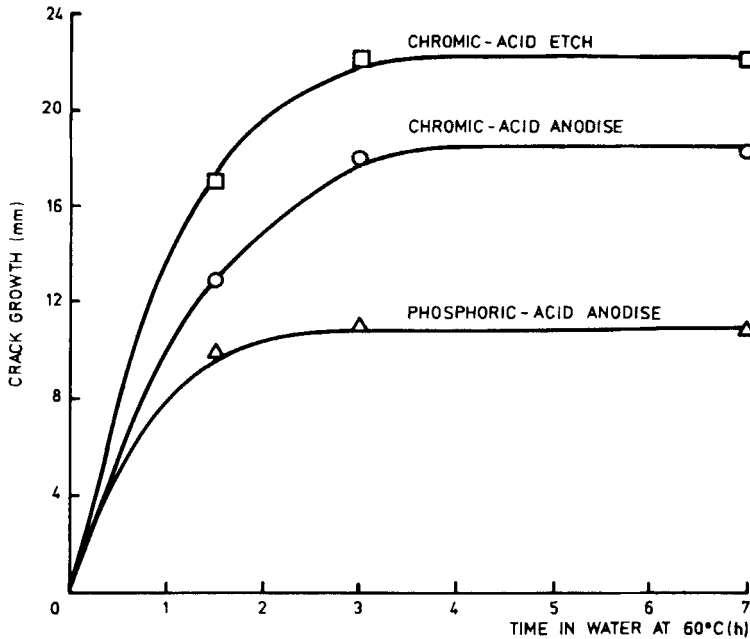
FIGURE 2 Crack growth versus time in environment of water at 60°C for the wedge joints. Three different surface pretreatments employed.

60°C is shown as a function of time in Figure 2 for the three different surface pretreatments. All the joints exhibited environmental crack growth but the extent depended on the particular pretreatment employed. The ranking order for environmental resistance is in agreement with previous work^{1,6} and is: phosphoric-acid anodised > chromic-acid anodised > chromic-acid etched.

iii) *Phosphoric-acid anodised joints:* In the case of the phosphoric-acid anodised joints, the “metal” side of the joints had a relatively high carbon concentration, even after argon-ion profiling to a depth of about 120 Å, confirming the presence of adhesive. The aluminium (oxide) concentration on the adhesive side was comparatively low. Thus, the extent of failure within the oxide appeared to have decreased while the degree of cohesive fracture of adhesive, albeit close to the interface, had increased, compared to the effects of the chromic-acid etched and anodised pretreatments. These observations are in agreement with the superior durability exhibited by joints prepared using the phosphoric acid anodising pretreatment shown in Figure 2.

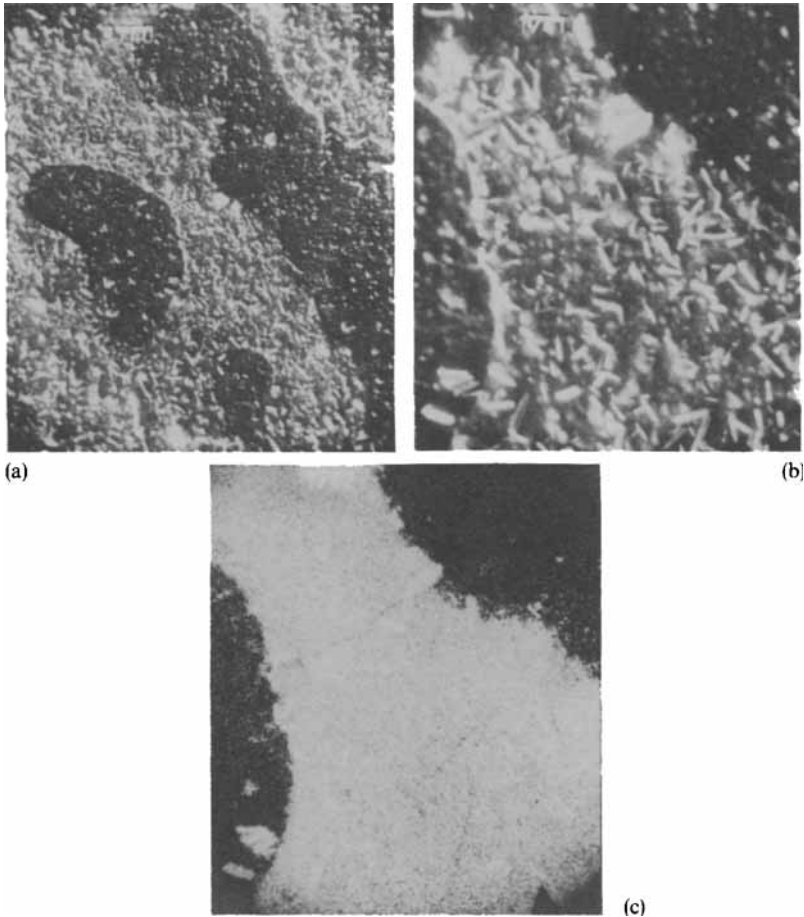
FIGURE 3 “Adhesive” side of an environmental fracture of bonded chromic-acid etched aluminium alloy. a. Scanning electron micrograph ($\times 200$) b. Scanning electron micrograph ($\times 600$) c. Distribution of aluminium in 3(b), using electron microprobe analysis.

i) *Chromic-acid etched:* The surface of the “adhesive” side showed two types of structure which can be seen in Figure 3a, taken from an area where both types co-existed. A higher magnification micrograph is shown in Figure 3b, with the corresponding Al X-ray image in Figure 3c. The layer giving bright contrast is clearly aluminium, resulting from environmental crack growth through the oxide. The magnitude of the aluminium signal indicated that the covering of aluminium oxide was about 2000 Å thick, assuming that it had the density of alumina¹⁰. A small Al signal consistent with perhaps 20 Å of oxide was measured from the darker area (but 20 Å had already been removed from the specimen by ion bombardment). An oxide thickness of 40 Å is not inconsistent with the results from the XPS analysis on the “adhesive” side.

Thus, as discussed above, the aluminium oxide has become hydrated whilst immersed in water at 60°C and its thickness increased³ from a few hundred Å to a few thousand Å. Environmental crack growth occurred largely in this hydrated oxide layer. However, the crack wandered from near the oxide/metal interface to near the adhesive/oxide interface, leaving an oxide layer on the “adhesive” side of 40 Å to 2000 Å thickness.

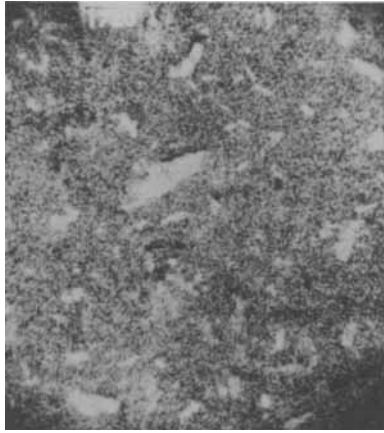
FIGURE 4 “Adhesive” side of an environmental fracture of bonded chromic-acid anodised aluminium-alloy showing the distribution of aluminium using electron microprobe analysis ($\times 800$).

ii) *Chromic-acid anodised:* The fracture surfaces of the “adhesive” sides of the joints prepared using chromic-acid anodising were far more uniform than those described above, both topographically and in the distribution of aluminium, which is shown in Figure 4. The oxide layer on the “adhesive” side is estimated to have been of thickness between 400 to 900 Å.

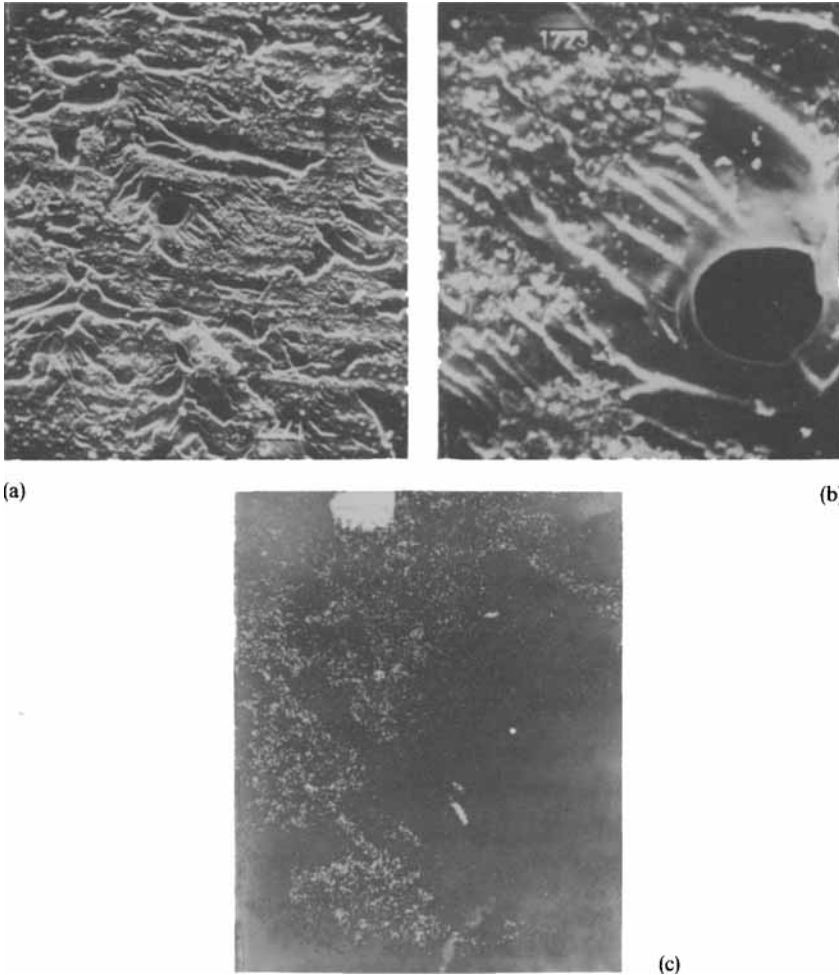
FIGURE 5 "Adhesive" side of an environmental fracture of bonded phosphoric-acid anodised aluminium-alloy. a. Scanning electron micrograph ($\times 200$) b. Scanning electron micrograph ($\times 800$) c. Distribution of aluminium in 5(b), using electron microprobe microanalysis ($\times 800$).

iii) *Phosphoric-acid anodised*: Figures 5a and 5b show typical areas from the “adhesive” sides of the joints prepared using phosphoric-acid anodising. Areas which appear to be adhesive are clearly visible and they correlate with the flakes of adhesive present on the “metal” side. However, apart from these observations which confirm that a relatively large amount of crack growth occurred through the adhesive itself, the results shown in Figure 5c indicate that the crack also propagated to a certain extent through the oxide. The Al X-ray image also showed that the thickness of oxide was about 400 Å. These results are in qualitative agreement with the visual and XPS analyses reported above.
