Characterization of Surface Pretreatments on Al/Li Alloy and Related Mechanical Properties of Polysulfone Adhesive Bonds

C. U. KO and J. P. WIGHTMAN

An investigation of polysulfone-Al/Li alloy interaction involved single lap shear joints and wedge samples following an FPL etch, sulfuric acid anodization (SAA) and phosphoric acid anodization (PAA). The study of the Al/Li surfaces involved the determination of the elemental composition and morphological features of the pretreated adherend before bonding and following fracture. When polysulfone was either thermally pressed or primed onto the microporous surface, the polysulfone indeed penetrated into the porous oxide and thereby provided a mechanical means of adhesion. The wedge test results for the adherend pretreated by PAA and SAA were superior to those for the FPL etched adherend. The failure path for the FPL etched samples was at the adhesive/oxide interface whereas the failure path for the PAA samples was within the adhesive but with occasional divergence of the crack into the oxide. The porous oxides on Al/Li alloy formed after PAA and SAA treatment were shown to undergo dramatic changes in morphology on short term (<95 hrs)

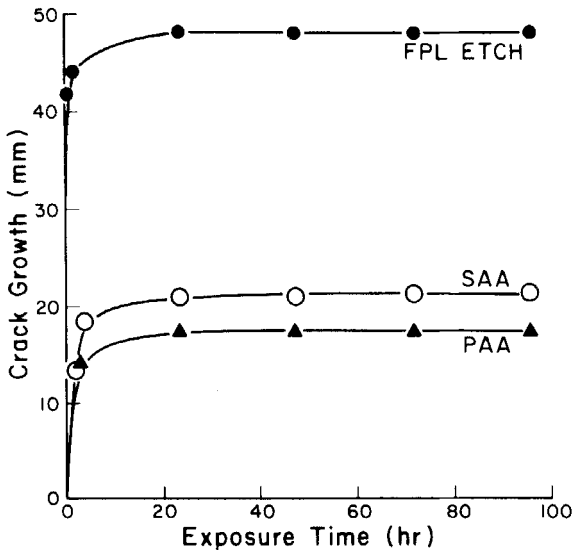
test is utilized. One can clearly observe the difference in bond durability following different pretreatments from the crack opening wedge test as shown in Figure 1. In the case of the FPL etch treatment, the crack grew to 42 mm after being exposed to a hot-humid environment for only 30 minutes and the crack growth finally leveled off at 48 mm after 24 hours of exposure.

The SAA pretreatment resulted in improved durability over the FPL pretreatment as evidenced by a smaller crack growth which was shown to be about one-half of the FPL value. Still, a significant growth of 12 mm was observed after 1/2-hour exposure in the hot-humid environment. The crack growth leveled off at 20 mm after 24 hours of exposure. The PAA pretreatment again showed improved bond durability over the FPL etch. The crack grew to 11.5 mm after 1/2-hour exposure and then leveled off at 17.5 mm after 24 hours of exposure. The wedge test results were reproducible to within 10%.

FIGURE 1 Crack growth *versus* time in 71°C and 100% R.H. environment.

Therefore, the STEM micrographs confirm that the fracture mode is mainly cohesive failure within the polysulfone with the crack occasionally diverging to the oxide. Comparing the effects of the PAA to the FPL etch pretreated samples, the extent of failure within the oxide appeared to have decreased for the PAA while the degree of the cohesive fracture of the adhesive has increased. These observations are in agreement with the improved durability exhibited by the joints prepared using PAA pretreatment as indicated by the wedge test results in Figure 1.

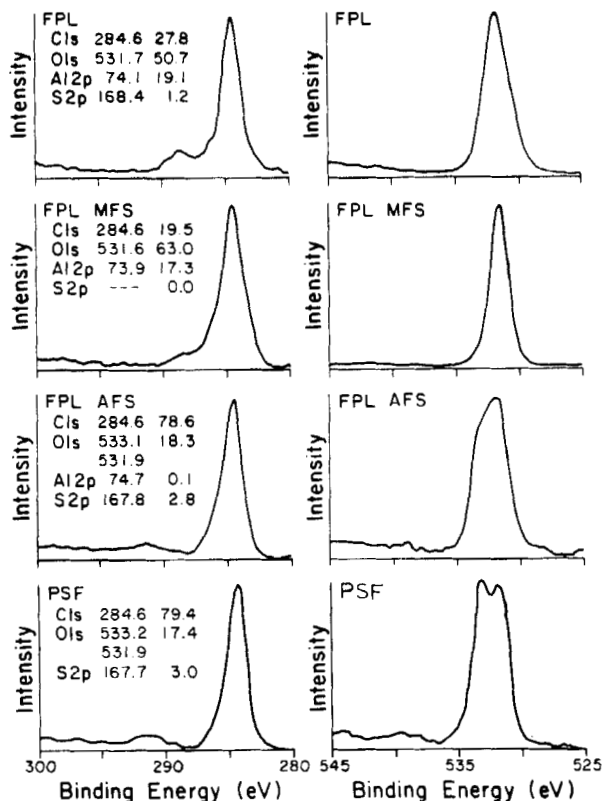
In Figure 2, the XPS C 1s and O 1s photoelectron peaks for four surfaces are shown with the binding energies (B.E.) in eV tabulated along with calculated values of the atomic percentages (A.P.).

The O 1s is photopeak assigned to aluminum oxide at 531.7 eV appears in the spectrum of the FPL etched surface. The observed S 2p peak is from the sulfuric acid used in the FPL etch solution. The Al 2p peak signal is weak from the adhesive failure side (AFS). In addition, the oxygen peak is broad and the atomic fraction of oxygen is low compared to that found on the FPL surface. The oxygen 1s photopeak is in fact a doublet resulting from two types of oxygen in polysulfone. There is a high atomic fraction of both carbon and sulfur which indicates that polysulfone used as the adhesive is attached to the AFS surface. The value of the O/S ratio of 6.5 agrees well with the value of 5.8 for neat polysulfone. The carbon and oxygen photopeaks of neat polysulfone are also included in Figure 2 for comparison.

In the spectrum of the metal failure side (MFS), the shape of the carbon and oxygen photopeaks is basically the same as seen for the pretreated FPL surface. However, S is not detected on MFS. If surface oxide is exposed, then the sulfur from sulfuric acid used in the FPL solution should be expected to be present in the top layer. The reason why sulfur is not detected is discussed below. The atomic fraction of carbon is low but the Al and O atomic fractions are high, indicating that the MFS is predominantly aluminum oxide. Therefore, the failure mode was interfacial. The absence of an Al 2p photopeak on the AFS side is additional confirmation of interfacial failure.

FIGURE 2 XPS spectra of C 1s and O 1s photopeaks with the binding energies in eV and atomic percentages of each element for the FPL etched surface before bonding (FPL), for the metal failure surface (MFS), for the adhesive failure surface (AFS), and for polysulfone (PSF).

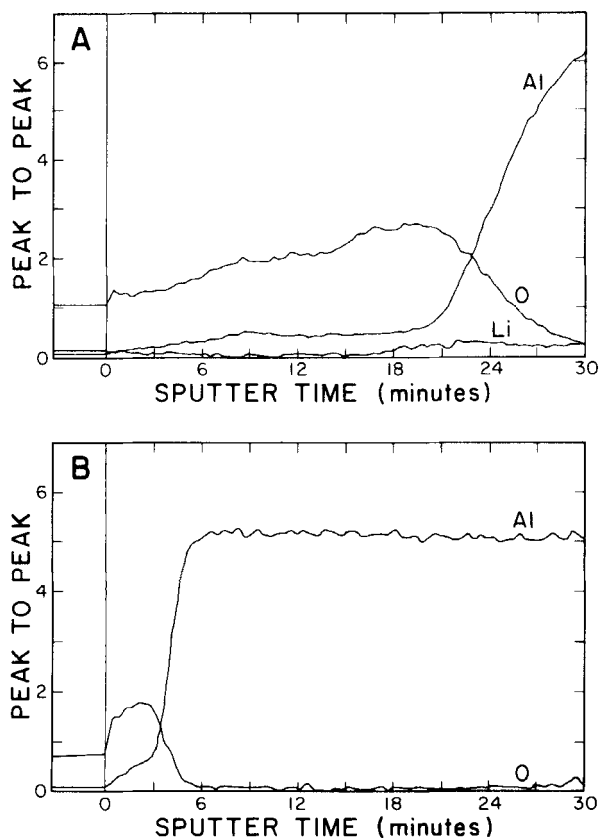
FIGURE 8 AES depth profile of (A) PAA Al/Li sample (B) PAA 2024 Al sample.

on the durability of Al/Li alloy, AES depth profiles of Al, Li and O were obtained. The peak-to-peak amplitudes of the Auger signals are plotted as a function of sputtering time in Figure 8A. Lithium is not surface concentrated as shown by the AES depth profile. Therefore, the effect of Li on the durability of the bonded alloy may be minimal. The PAA pretreated Al/Li sample has an oxide layer which takes 23 min to sputter through. The AES depth profile of Al 2024 alloy shown in Figure 8B indicates that the thickness of the oxide layer corresponds to 4 min of sputtering. Although direct comparison cannot be made between the two oxide thicknesses because of possible differences in surface roughness, surface porosity and sputtering efficiency,¹⁰ the standard PAA treatment on the Al/Li alloy leaves a thicker oxide layer than on the 2024 Al alloy.
