### Surface Properties and Adhesion of Flame Treated Sheet Molded Composite (SMC)

J. G. Dillard<sup>a</sup>; T. F. Cromer<sup>a</sup>; C. E. Burtoff<sup>a</sup>; A. J. Cosentino<sup>a</sup>; R. L. Cline<sup>b</sup>; G. M. Maciver<sup>bc</sup>

**To cite this Article** Dillard, J. G. , Cromer, T. F. , Burtoff, C. E. , Cosentino, A. J. , Cline, R. L. and Maciver, G. M.(1988) 'Surface Properties and Adhesion of Flame Treated Sheet Molded Composite (SMC)', *The Journal of Adhesion*, 26: 2, 181 – 198

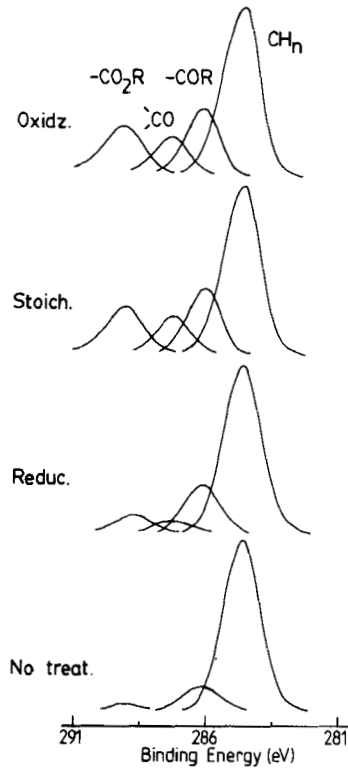
FIGURE 1 Curve resolved C 1s spectra for flame treated SMC samples.

Surface characterization results for the standard untreated SMC are given in Table II. The dominant element is carbon where the principal carbon component is  $\text{CH}_n$ , hydrocarbon. Additional carbon components are evident following curve resolution of the C 1s photopeak (Figure 1). The binding energies for these additional components occur at 286.8 and 289.3 eV and are assigned to ether or ester alcohol and ester carbonyl carbons, respectively. These assignments are based on binding energies reported<sup>13,16</sup> for
