Thermosonics: Detecting Cracks and Adhesion Defects Using Ultrasonic Excitation and Infrared Imaging*

XIAOYAN HAN^a, L. D. FAVRO^{b,†}, ZHONG OUYANG^b
and R. L. THOMAS^b

^a*Dept. of Electrical and Computer Engineering*, ^b*Institute for Manufacturing Research, Wayne State University, Detroit, MI 48202, USA*

We describe a new nondestructive evaluation technique which makes cracks and adhesion defects visible to infrared cameras. This is accomplished by infusing the sample with a short pulse of low frequency ultrasound. The sound causes the faying surfaces of defects to heat up by friction or clapping and, thus, makes them visible in the infrared. Surface or near-surface defects appear to the camera within milliseconds of the initiation of the ultrasonic pulse, while the appearance of subsurface defects is delayed by the thermal propagation time from the defect to the surface being observed.

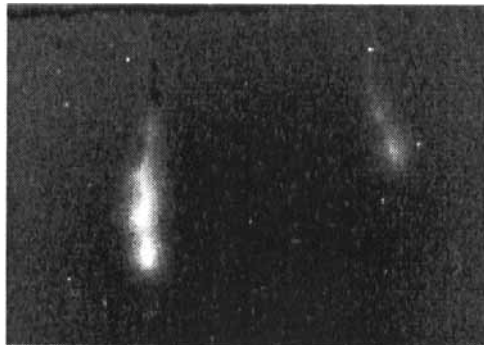
FIGURE 6 One frame from a sequence of IR video images of two cracks under a thermal-barrier coating on a metal part.

In Figure 6, we show a single frame from a sequence of IR video images of two cracks under a thermal-barrier coating on a nickel-based superalloy part. Even though this coating was designed to retard heat flow, one has no difficulty seeing the cracks through it. The images are, of course, somewhat blurred by lateral heat flow during the time that the thermal wave from the crack is propagating to the surface of the coating. This image demonstrates that the technique has excellent capability to detect cracks, both surface breaking and subsurface in a variety of materials, and combinations of materials.

The cracks shown in Figure 6 were a centimeter or two in length. However, we have imaged cracks as small as a fraction of a millimeter with no difficulty. An example of this is presented in Figure 7, which shows a 0.7 mm-long crack in an aluminum alloy fatigue test bar. This crack was initiated at a diagonal saw cut which shows as a darker bar starting at the top edge of the sample.
