**(NAVY) NAVAIR 17-15-50.3  
(ARMY) TM 38-301-3  
(AIR FORCE) T.O. 33-1-37-3  
(COAST GUARD) CGTO 33-1-37-3**

# **JOINT OIL ANALYSIS PROGRAM MANUAL**

## **VOLUME III**

### **LABORATORY ANALYTICAL METHODOLOGY AND EQUIPMENT CRITERIA (AERONAUTICAL)**

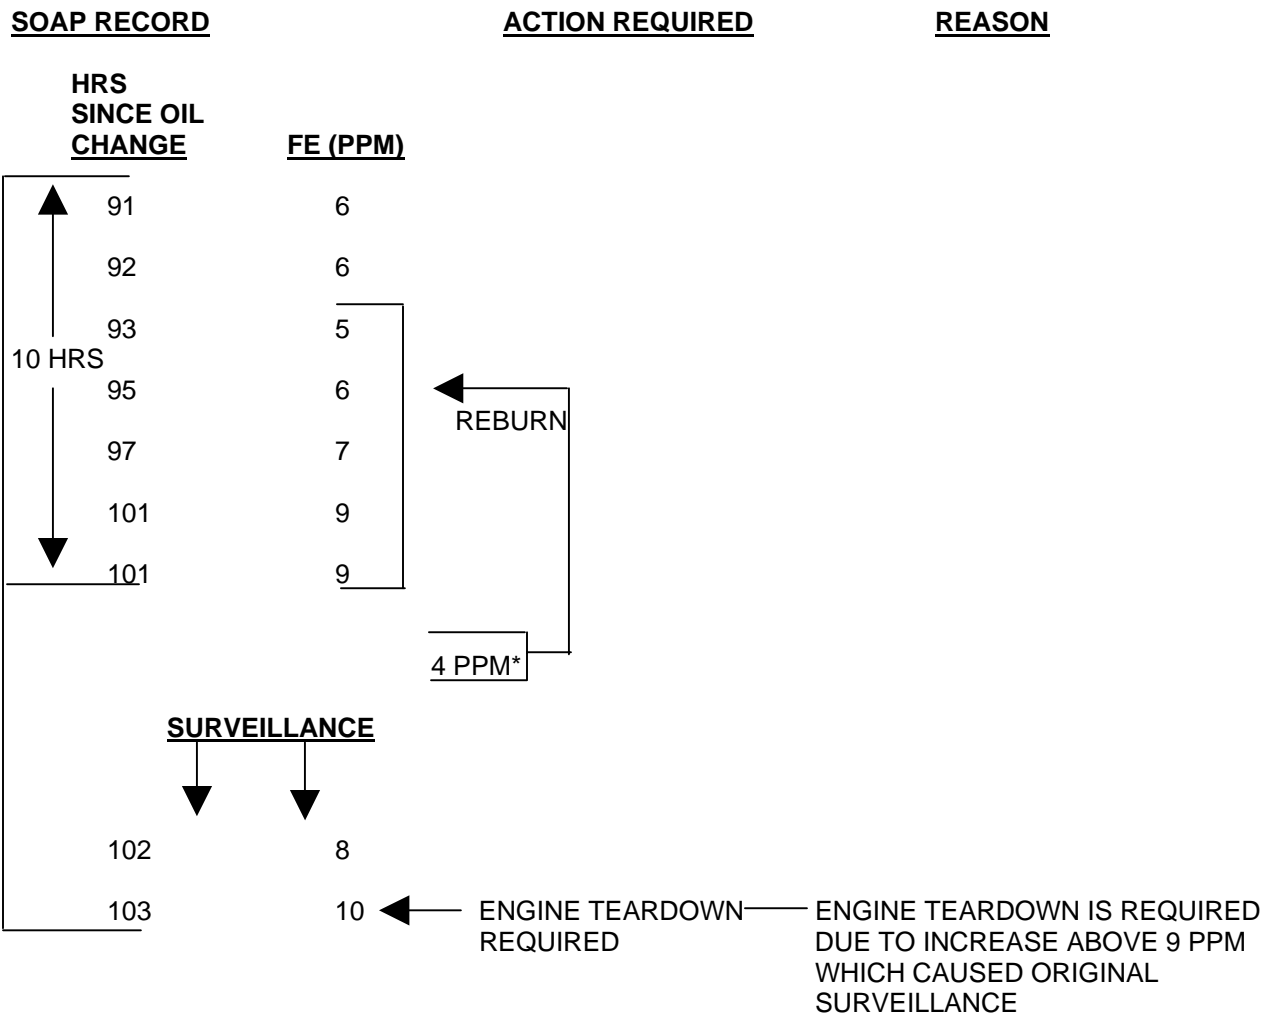
ENGINE: F100-PW-100/-200/-220/-229 (Cont.)  
 AIRCRAFT: (F-15) (F-16)

EXAMPLE: PRIOR TO SURVEILLANCE  
 (FOR FE INCREASE IN 10 ENGINE HOURS)

\* 4 PPM or greater using JOAP Atomic Emission

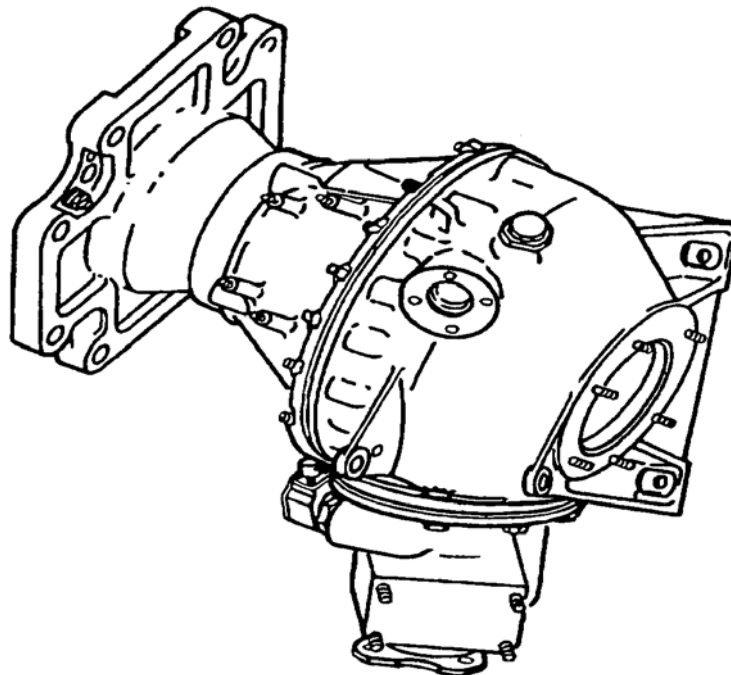
**Figure A-1. Tail Rotor Gearbox**

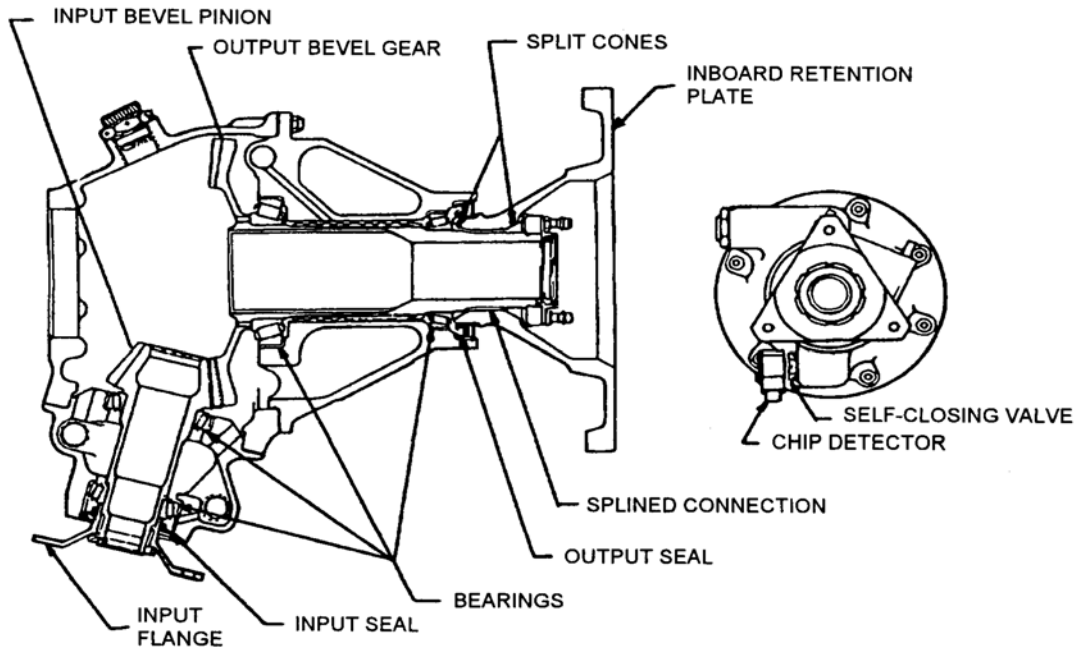
Figure A-2. Tail Rotor Gearbox Nomenclature

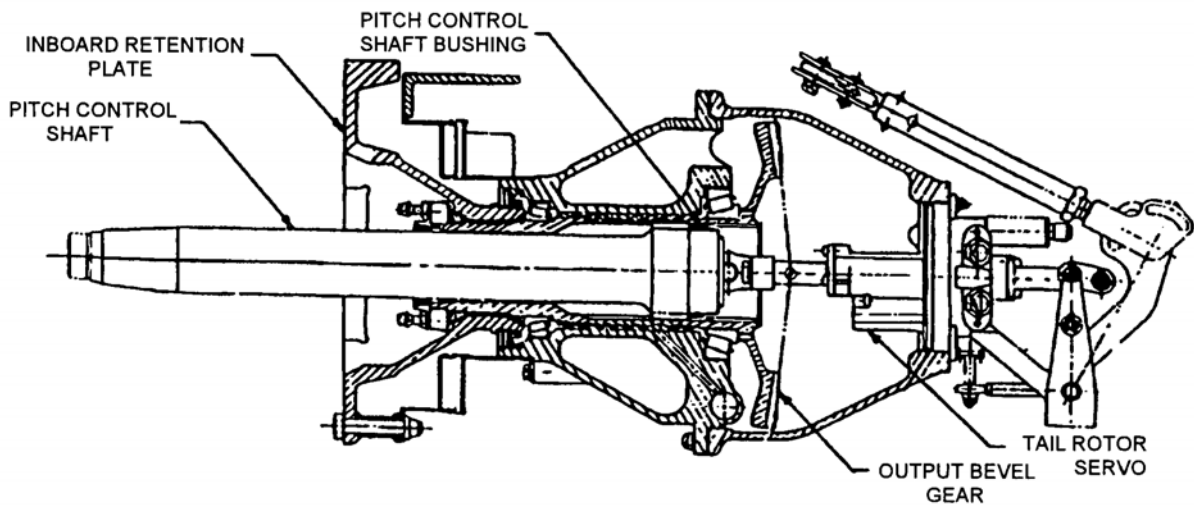
Figure A-3. Tail Rotor Gearbox, Tail Rotor Servo, & Pitch Control Shaft Assembly
