**JOINT OIL ANALYSIS  
PROGRAM MANUAL**

**VOLUME III**

**LABORATORY ANALYTICAL METHODOLOGY  
AND EQUIPMENT CRITERIA  
(AERONAUTICAL)**

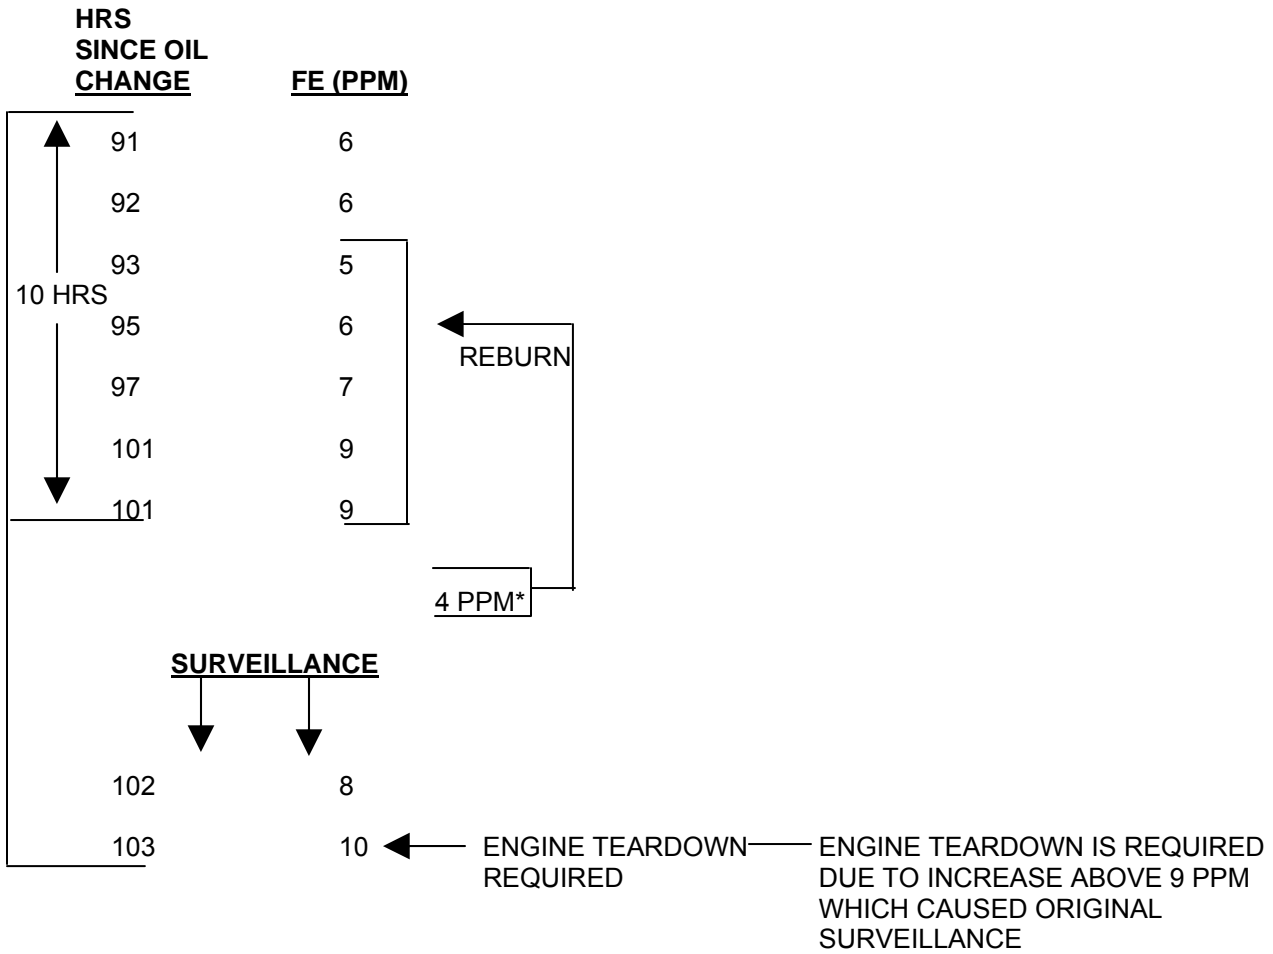
EXAMPLE: PRIOR TO SURVEILLANCE  
 (FOR FE INCREASE IN 10 ENGINE HOURS)

**JOAP RECORD    ACTION REQUIRED    REASON**

\* 4 PPM or greater using JOAP Atomic Emission.
