IBM 3745 Communication Controller
All Models

Problem Determination Guide

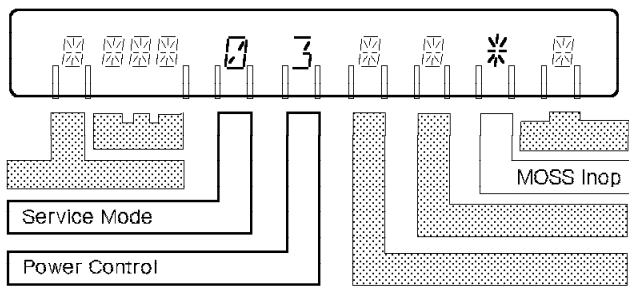
This drawing represents the control panel display. The control panel is fully illustrated and explained in the *3745 Basic Operations Guide* and on the *3745 Control Panel Reference Card*. (See Appendix A, "Control Panel.")

The highlighted name (for example: Service Mode) identifies the display position or the indicator to look at.

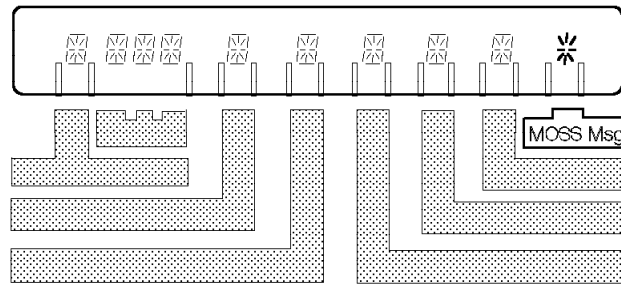
When an alarm is generated, the MOSS Msg indicator is lit on the control panel.

- If the console operator is logged on, the alarm is displayed and an audible signal is emitted.
- If the console operator is not logged on, log it on (refer to the *3745 Advanced Operations Guide*, SA33-0097).

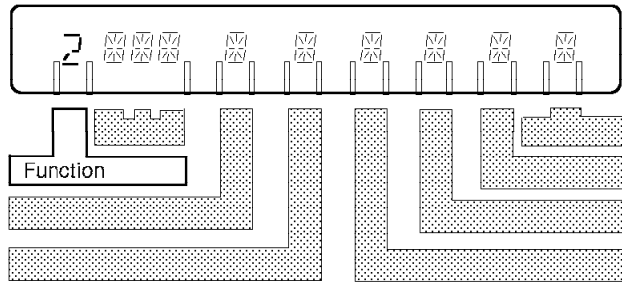
- Dump MOSS from the control panel. Press **Function** repeatedly until **2** is displayed; then press **Validate**:

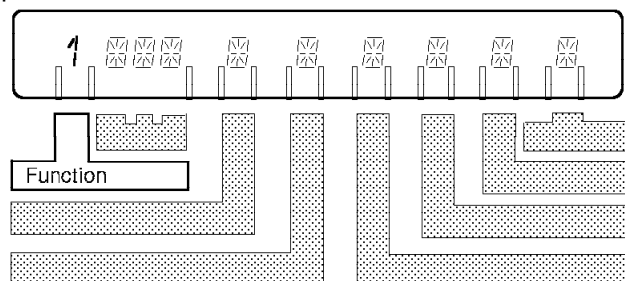
- Re-IML MOSS from the control panel. Press **Function** repeatedly until **1** is displayed; then press **Validate**:

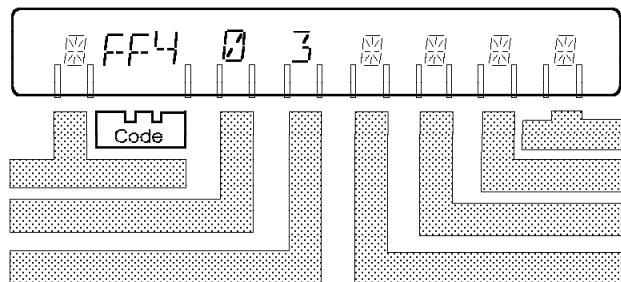
- The progression of a function (for example, IPL).
- The status of the components.
- An error. In this case, the code blinks.

Code	Explanation and Action
<u>0 0 0</u>	3745 IPL has been successfully completed. The control program is loaded and MOSS is online.
<u>0 0 1</u> or <u>0 0 2</u>

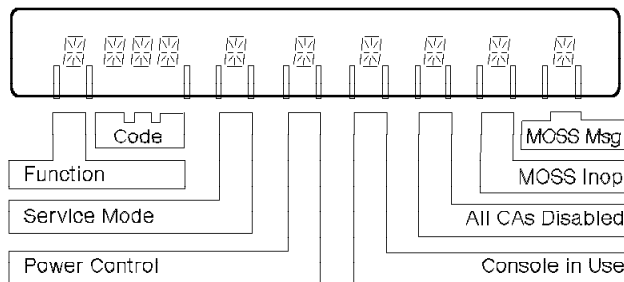
Nothing appears on the control panel display:

- Check your installation (for example, ac circuit breakers).
- If there is no problem in the installation:

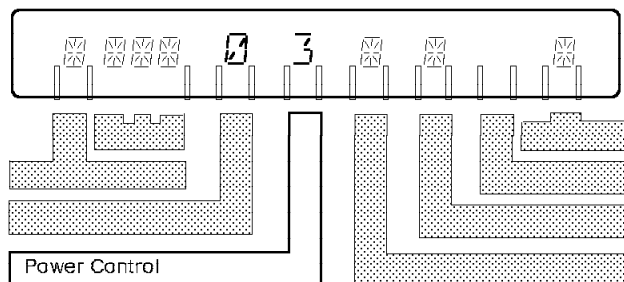
Power control on the control panel display is: **1, 2, or 3**

- If **1** Go to page 4-2
- If **2** Go to page 4-3
- If **3**
 - Power off
 - Wait 10 seconds
 - Select the function 1 (MOSS IML)
 - Power on
 - If the problem persists:

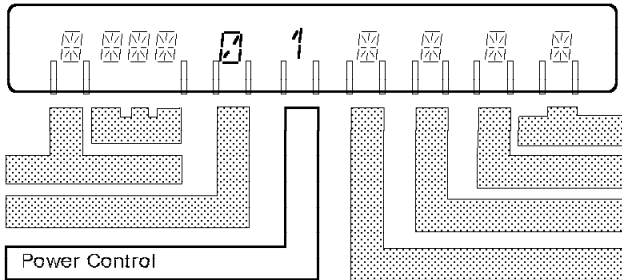
Power Control Display = 1

At least one connected host is powered on.

No connected hosts are powered on.

Normal condition. The 3745 will be powered on as soon as one host is powered on.

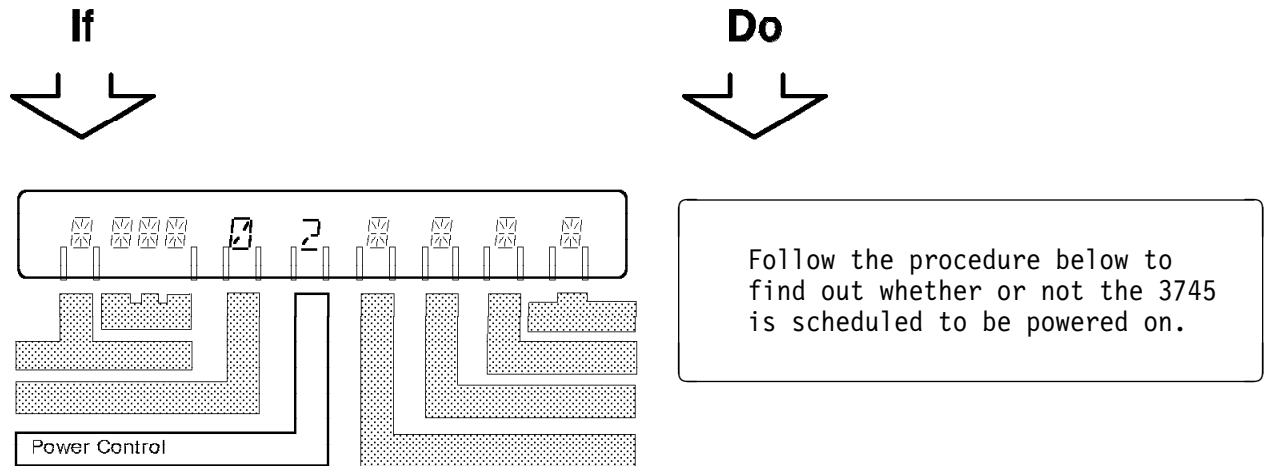
Power Control Display = 2

- 1** Power on and IPL the 3745 in **local mode**
 - Press **Power Control** repeatedly until 3 is displayed.
 - Press **Validate**.

- 2** Power on and log on the operator console. Refer to the *3745 Basic Operations Guide*. The following screen is displayed:

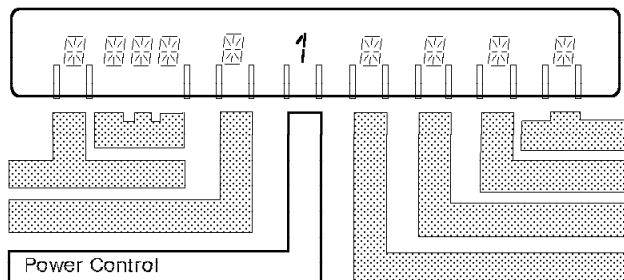
Power Control Display = 1

Ask the host operator if one connected host is powered on.

- If it is (normal condition): the 3745 will be powered off as soon as all hosts are powered off.
- If no connected host is powered on:

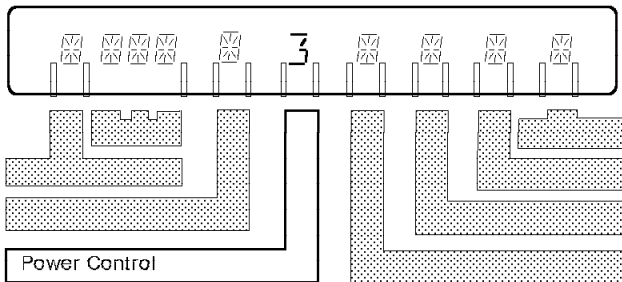
Power Control Display = 3

Make sure that you pressed **Power Off** correctly.

- If you have to power off the 3745 just after a power on, wait 10 seconds before pressing Power Off.
-

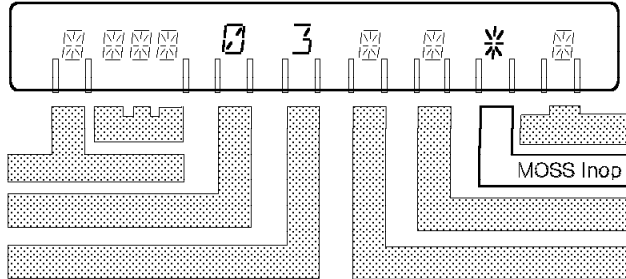
MOSS Inop on the control panel is on.

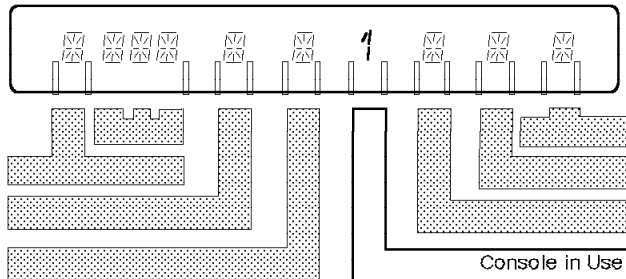
Console in use displays 1 or 2.

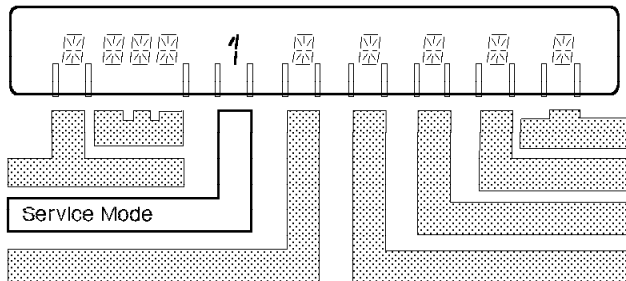
Service mode displays 1, 2, or 3, or the console displays the message:
PASSWORD REJECTED: PANEL SERVICE
MODE IS NOT 0.

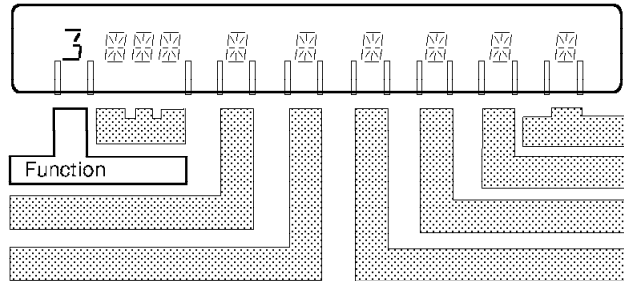
- 1 Press **Function** repeatedly until 3 is displayed, then press **Validate**. This informs the remote or RSF operator that you want to log on.

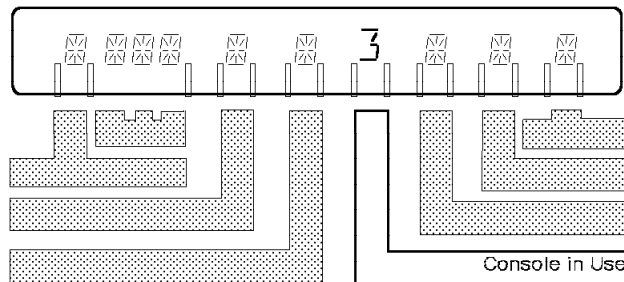
- 2 When **Console in Use** displays 3, the remote or RSF console is disconnected. You may log on at the local console. If 3 does not appear, go to next step.

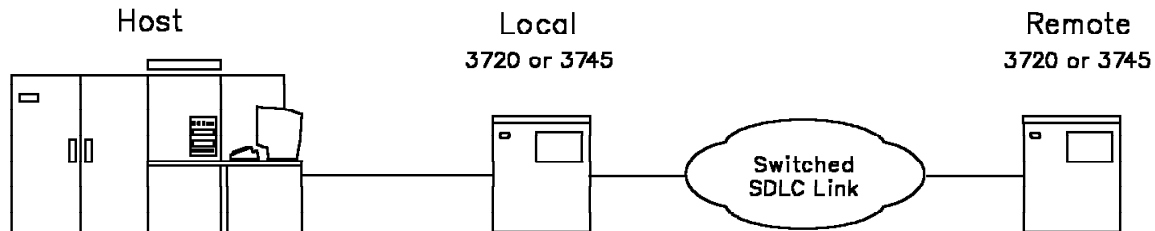
Figure 8-1. Initial Loading on Switched/Nonswitched SDLC and Nonswitched X.21 Links

- The remote initial loading can be performed by using VTAM* commands from the host.
- A link IPL port (LKP) must be defined in the remote controller.

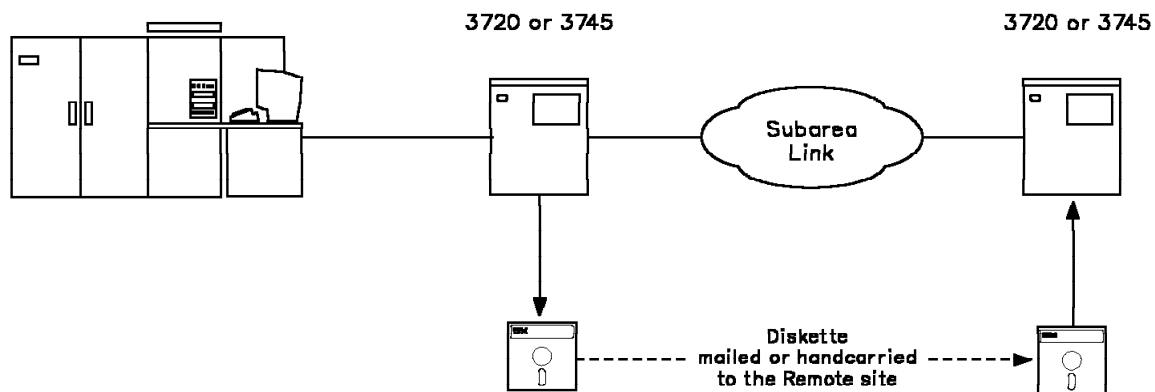
Figure 8-2. Initial Loading on Switched X.21, X.25 (SVC/PVC), and Token-Ring Links

- The remote initial loading can be performed only by using the diskette management procedure. Refer to the *3720/3745 Remote Loading/Activation Guide* or to the MOSS DII function described in the *3745 Advanced Operations Guide*.
- Those links do not require a link IPL port (LKP) definition in the remote controller.

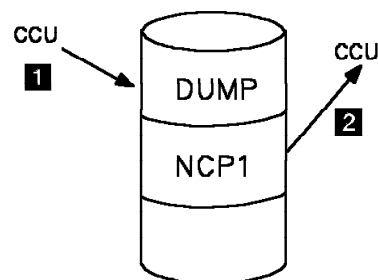
If the NCP1 fails or a hardcheck occurs:

- **1** The controller dumps NCP1 (which failed) onto the hard disk.
- **2** The controller reloads NCP1 from the hard disk, and you do not have to reload NCP using a diskette or an SDLC link.

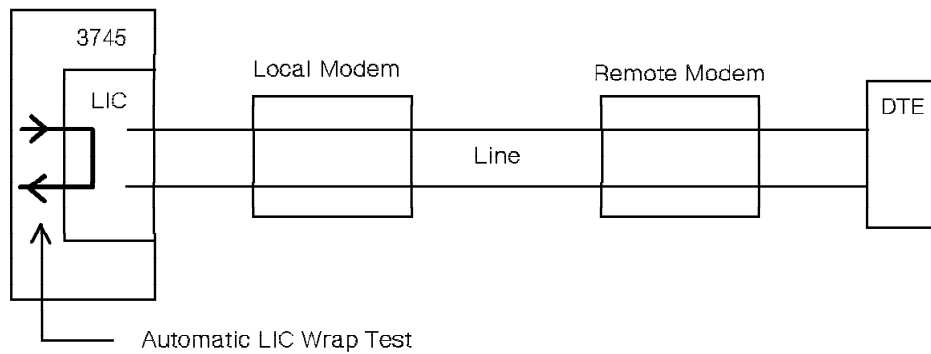
Figure 9-1. Automatic LIC Wrap Test (For LIC Types 1 to 4)

- 5** Enter the address of one of the lines of the suspected LIC, This screen is displayed:

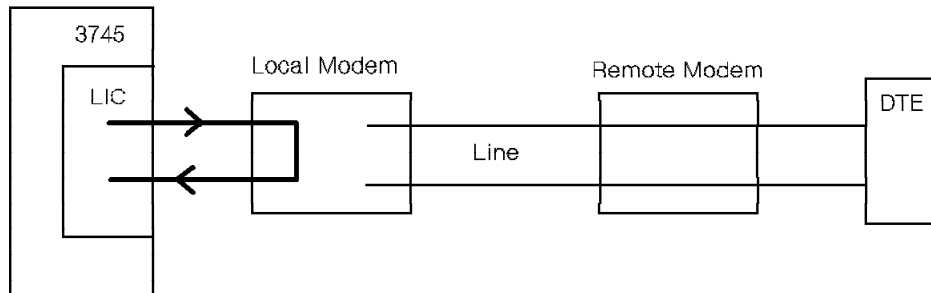
3. Local modem loopback test (loop 3)

Refer to the MOSS WTT function in the *3745 Advanced Operations Guide*.

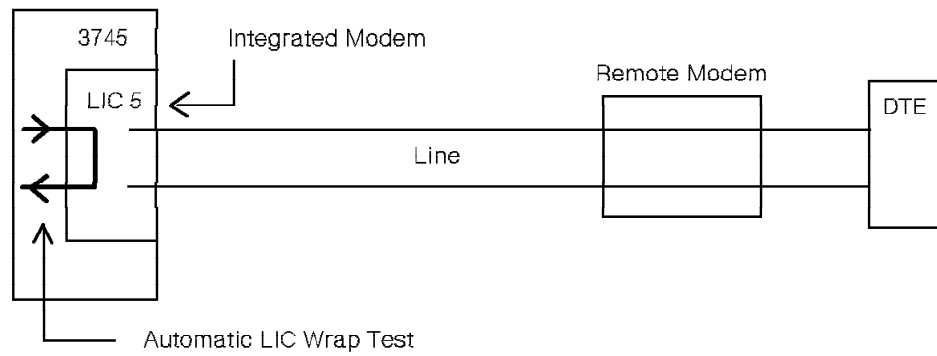
Figure 9-2. Automatic LIC Wrap Test on LIC5

5 Press the following keys to select the automatic wrap test at LIC level:

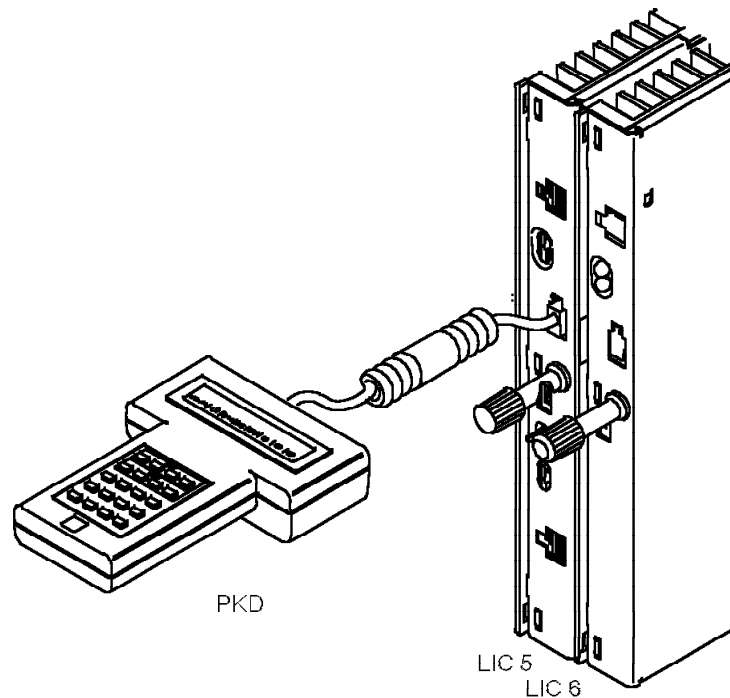
- 8** Locate the LIC to be tested and plug in the IBM 5869 Portable Keypad Display (PKD) as described in the *3745 Connection and Integration Guide*. Various messages can be displayed on the PKD before performing the LIC line analysis procedure (LLAP). These are described under “LIC Messages (LIC5)” on page 9-42.
- If the mode is CCITT (and you checked the configuration in step 3), and the problem persists, suspect your common carrier or the other modem.

Figure 9-3. IBM 5869 Portable Keypad Display (PKD) plugged to a LIC5 or a LIC6.

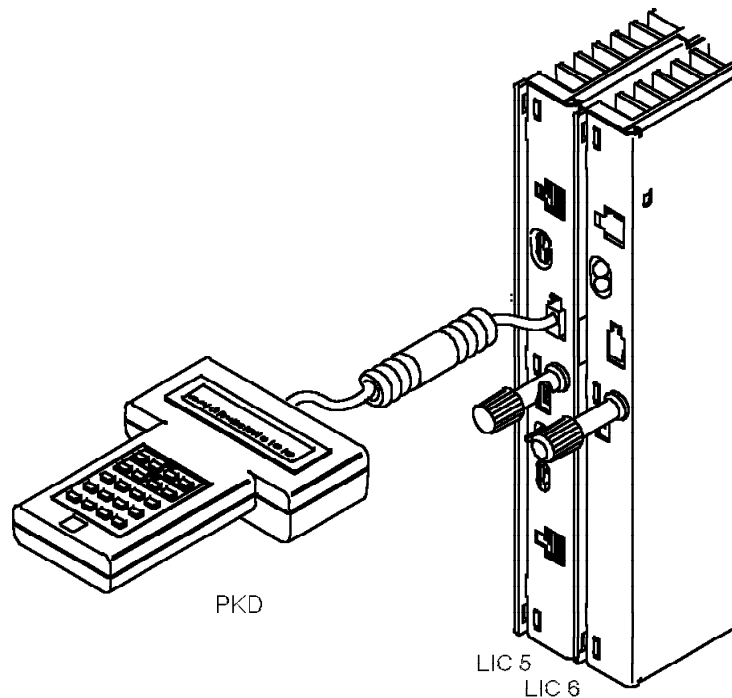
Locate the LIC to be tested and plug in the IBM 5869 Portable Keypad Display (PKD) as described in the *3745 Connection and Integration Guide*. Various messages can be displayed on the PKD before you perform the LIC line analysis procedure (LLAP). These are described under “LIC Messages (LIC6)” on page 9-51.

Figure 9-4. IBM 5869 Portable Keypad Display (PKD) plugged to a LIC5 or a LIC6.

- To check the lights, plug the PKD in (refer to Figure 9-4 on page 9-48 for connection); press the **Go** or **Stop** key; then the green and yellow lights should be on.

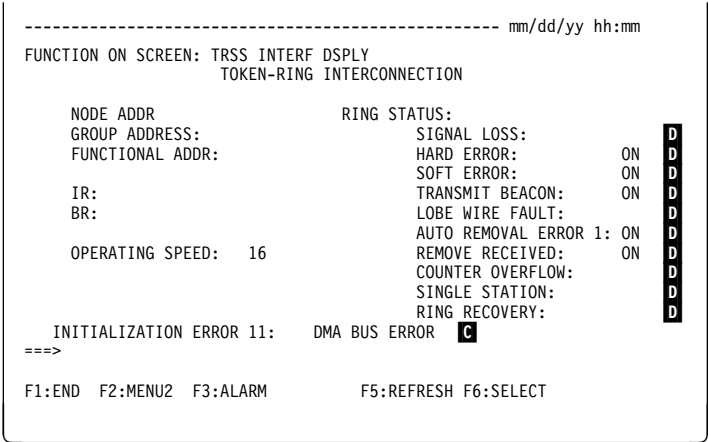
Interpreting Fields **D**

The meaning of each ring status indicator and the actions to perform are given below.

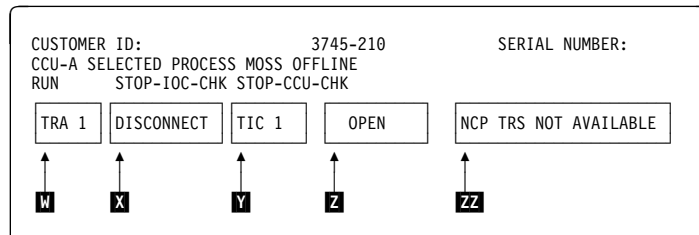
Figure 12-1. MSA Fields definition (Token-ring Information)

Token-Ring information is displayed on line 4 for CCU-A, and on line 7 for CCU-B.

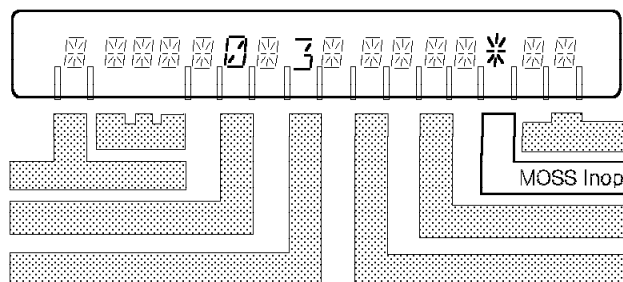
- 1 Note the hex code on the control panel, if:
 - **000** or **blank**, go to the next step.
 - Not **000** or **blank**, perform action required for that code. (See Chapter 3, "Hexadecimal Codes on the Control Panel.")

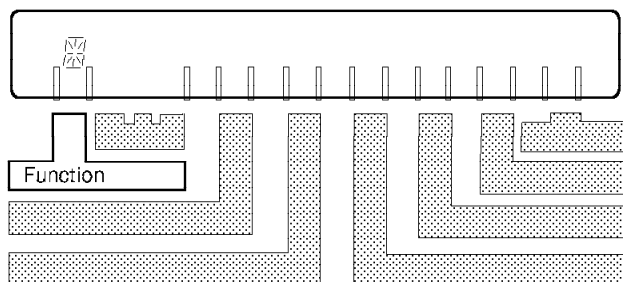
- 6** Press **Function** a second time.
The three digits of the Code display are tested one after each other.
Press **Function** again to test the next digits.

- If all segments of the Code display are lit, go to next step.
- If at least one segment is not lit, press **Exit** and

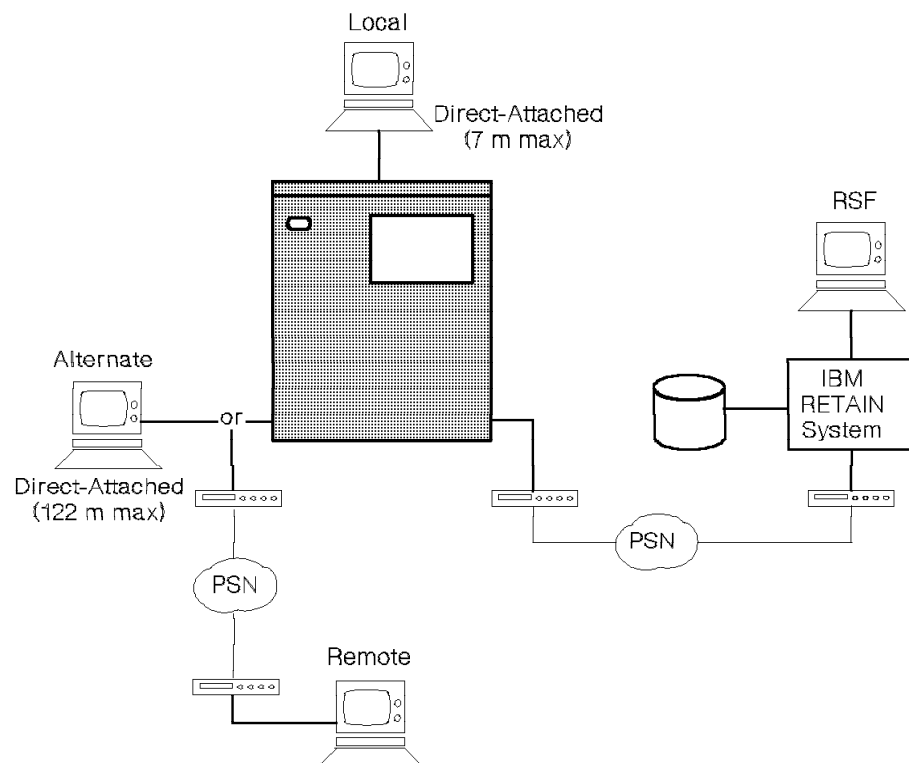
- Local console
- Alternate console
- Local modem (at the 3745 end) for a remote console
- Local modem (at the 3745 end) for an RSF connection.

Figure 17-1. IBM 3745 with its Four Different Types of Consoles

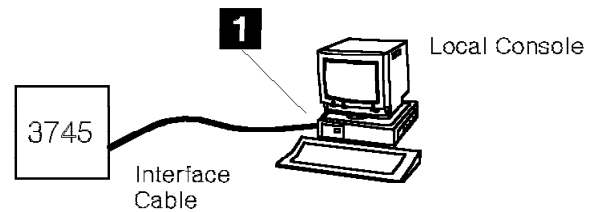
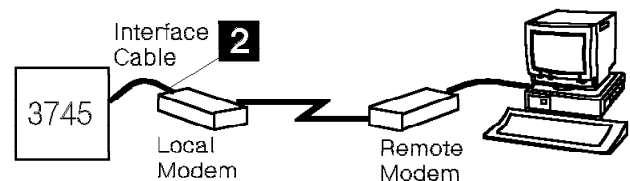
- 4** For the local or alternate console: Disconnect the cable **1** from the local or alternate console.
- For the remote console or the RSF connection: Disconnect the cable **2** or **3** from the local modem at the 3745 end.

Figure 17-2. Local, Remote, and RSF Console Links

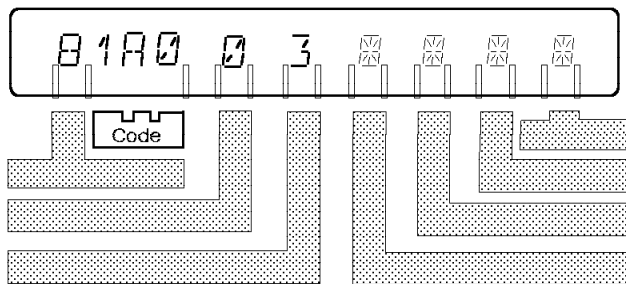
Hex Display Codes are 1A0, 1A3, or 1A6

- 1** **1A0** = Problem on local console cable or cable connector.
1A3 = Problem on remote or alternate console cable or cable connector.
1A6 = Problem on RSF console cable or cable connector.

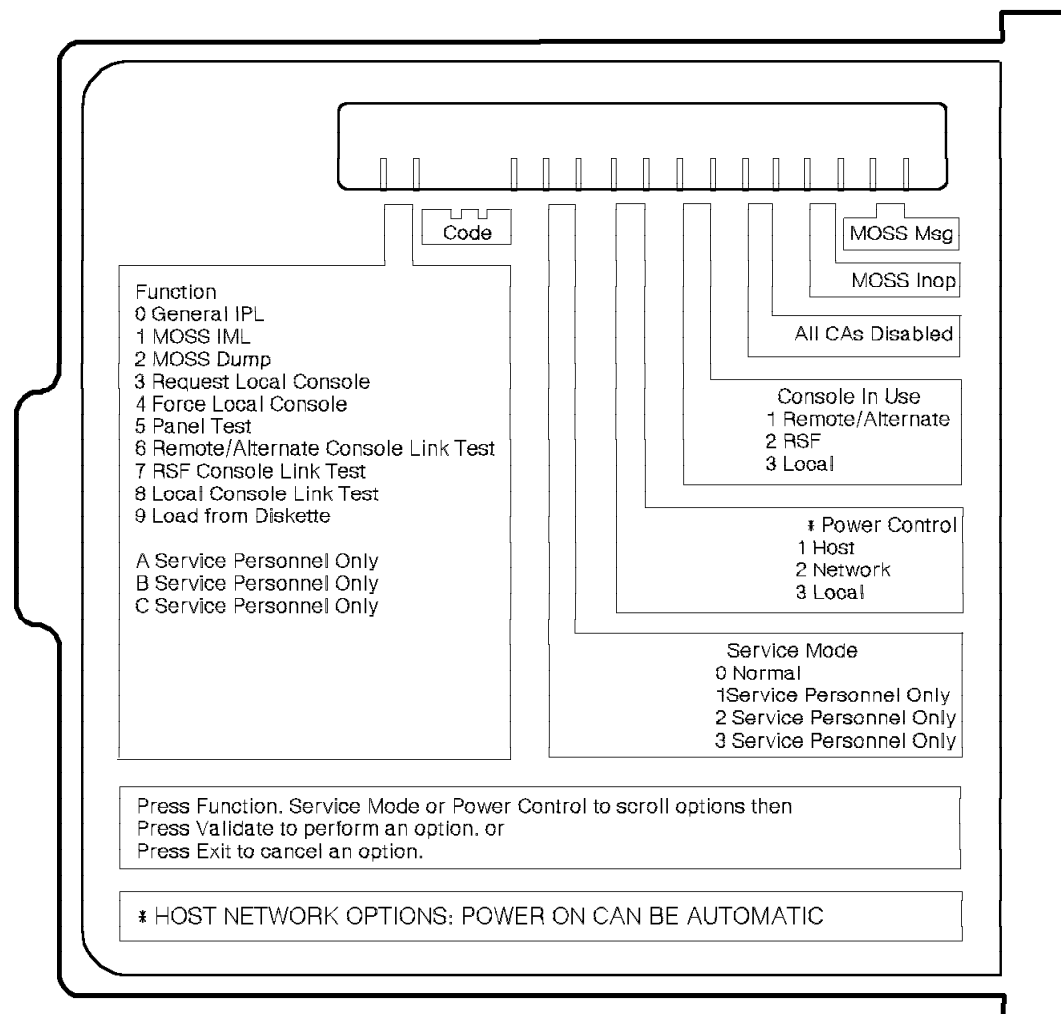
Figure B-1. IBM 3745 Control Panel Reference Card

The following control panel reference card (PN 65X8930) is attached to the diskette housing of the 3745 front panel and can be slid out for reading.

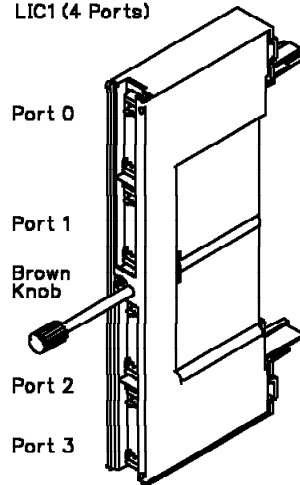
LIC1 (4 Ports)

Figure C-1. LIC Types

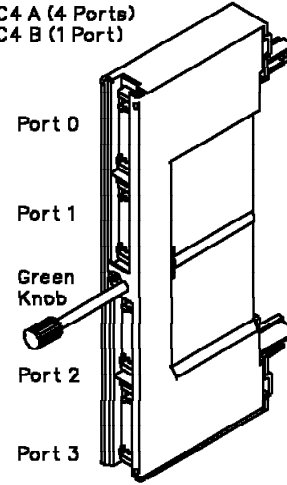
LIC4 A (4 Ports)
LIC4 B (1 Port)

- Use upper port for DCE attachment.
- Use lower port for direct attachment.
- LICs 4A and 4B are physically identical, the choice being made at configuration time.
- LIC 4B uses port 0 only.

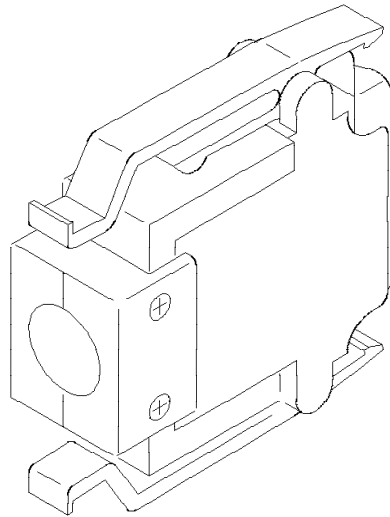
Figure C-2. LIC Type 1 and 4 Wrap Plug (P/N 65X8927)

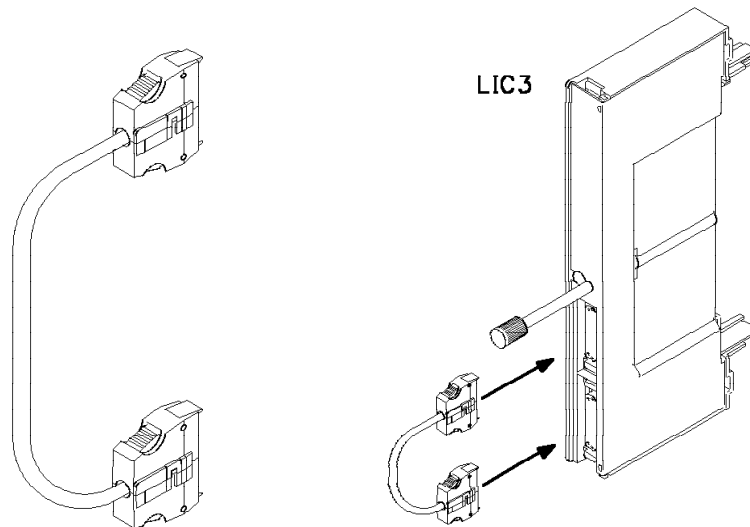
Figure C-3. LIC Type 3 Wrap Cable (P/N 65X8928)

Note: In order to test a **LIC3** card, it is necessary to reverse the LIC3 wrap cable after the first test pass, then run the test again.

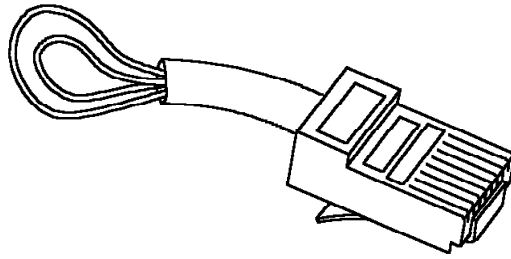
Figure C-4. LIC Type 5 and 6 Tail Gate Wrap Plug (P/N 11F4815)

Note: In addition to the tail gate wrap plug, a wrap block is also shipped with the machine. This wrap block may be plugged at the end of the cable (at the customer wall frame side) to test the line up to the customer wall frame. The part number of this wrap block is obviously country-dependent.

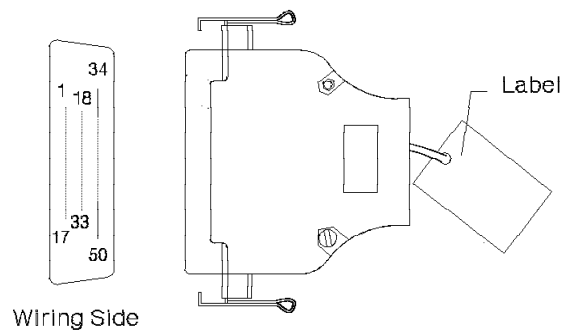
Figure C-5. HSS Lines Wrap Test Plug

HSS wrap plug for V.35 lines, P/N 58X9349

HSS wrap plug for X.21 lines, P/N 58X9354

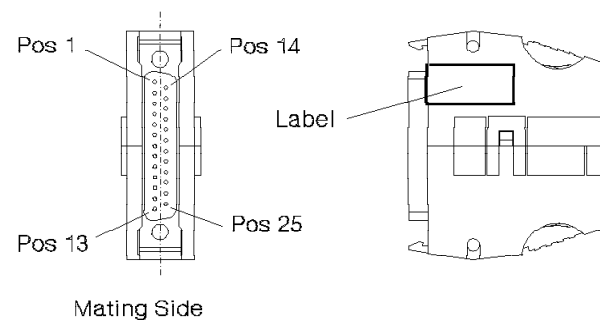
Figure C-6. Console Wrap Plug

Wrap plug for the 31xx console, P/N 6398697
