**Field Bill of Material (FBM)
or
Field Feature Bill of Material (FFBM)**

INSTALLATION of MICROCODE Level H10000A

**On 3746-900 attached to 3745-xxA
or 3746-950
or 3745-xxA alone**

**With Service Processor Type: 6578 Model RAU, or
6563 Model 65U (FC 5054), or 6275 Model 56U
or 83U (FC 5053), or 7585-P02 (FC 5052)**

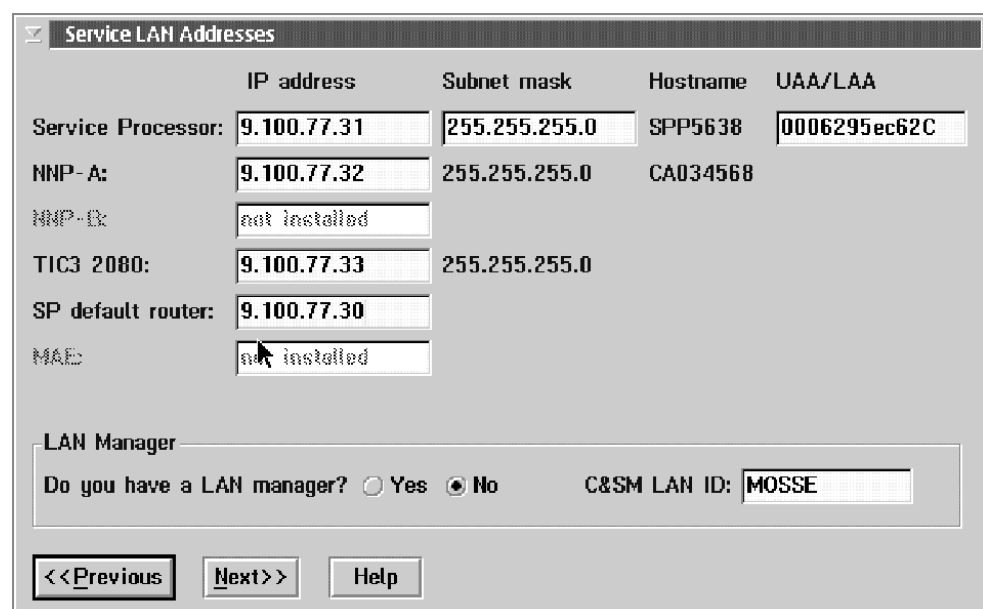
Service LAN Addresses

IP address	Subnet mask	Hostname	UAA/LAA
Service Processor:	9.100.77.31	255.255.255.0	SPP5638	0006295ec62C
NNP-A:	9.100.77.32	255.255.255.0	CA034568	
NNP-B:	not installed			
TIC3 2080:	9.100.77.33	255.255.255.0		
SP default router:	9.100.77.30			
MAE:	not installed

- ___ 18. Check the information recorded and make the necessary changes.
- Note:** If a controller is down, IP addresses cannot be changed.
