Switch Settings

Using Micro Channel Software on the AT bus or ISA software on the Micro Channel or PCMCIA bus will cause the CARD NOT FOUND ... error. Be sure the emulation software was purchased for the bus configuration you are currently using. The following chart will confirm what software you have installed on your PC.

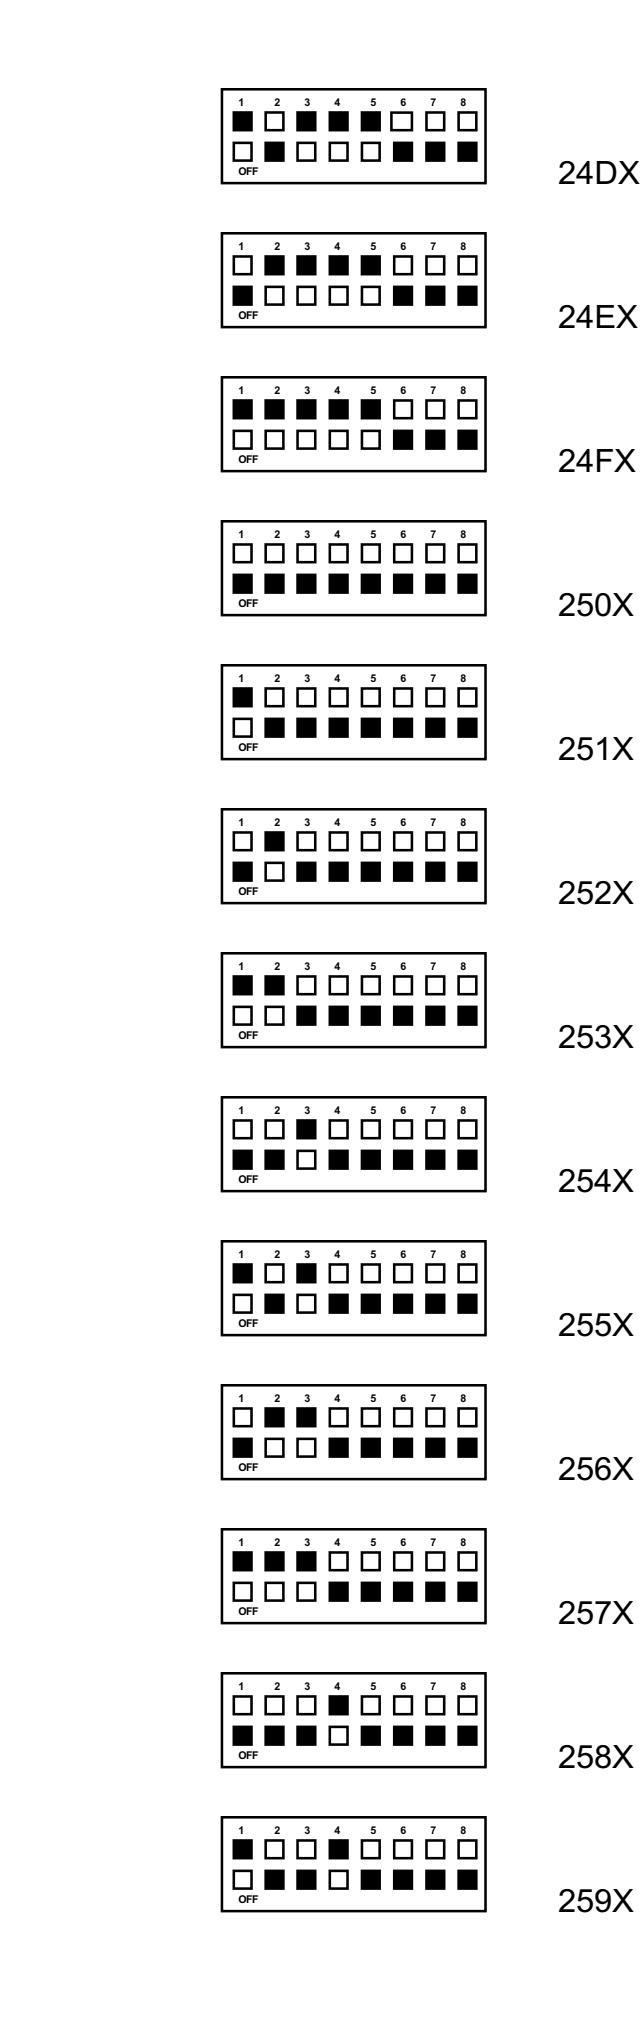
Page 2 of 4 ISA settings

The other area of concern should be the DIP switches located on the top rear of the adapter card. (ISA/AT machines ONLY) These switches are set with #1 and #6 to the ON position in their DEFAULT CONFIGU-RATION. That is where the AT software expects to find the adapter. If you change these DIP switches, then you MUST change the software settings to match. This setting is controlled in the Advanced Options Menu, option 3, then option 6. The chart on the following page will assist you in configuring your ISA bus adapter.

NOTE: Switches #7 and #8 are currently **UNUSED** by this adapter, and should be in the **OFF** position

The black squares represent the switch in a depressed state. Using your pen, firmly depress the switches on the card to match the diagram, then set your software to match. **THE PC MUST BE POWERED OFF** during this operation.
