PIC16C73A Rev. A Silicon Errata Sheet

The PIC16C73A (Rev. A) parts you have received conform functionally to the Device Data Sheet (DS30390E), except for the anomalies described below.

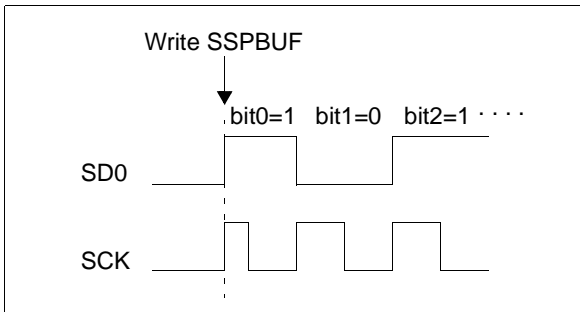
FIGURE 1: SCK PULSE VARIATION USING TIMER2/2

When the SPI is using Timer2/2 as the clock source, a shorter than expected SCK pulse may occur on the first bit of the transmitted/received data (Figure 1).

To avoid producing the short pulse, turn off Timer2 and clear the TMR2 register, load the SSPBUF with the data to transmit, and then turn Timer2 back on. Refer to Example 1 for sample code.

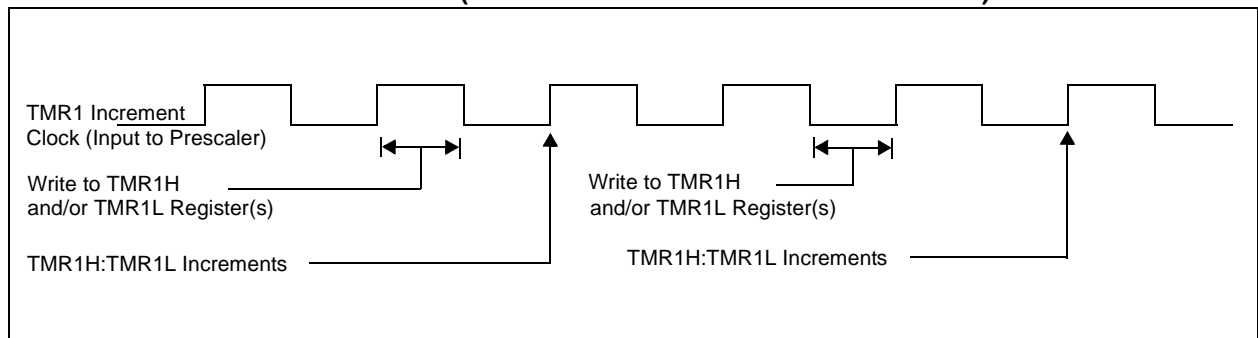
FIGURE 1: WRITES TO TIMER1 (EXTERNAL CLOCK/OSCILLATOR MODE)

The internal clock signal that is the input to the TMR1 prescaler affects the incrementing of Timer1 (TMR1H:TMR1L registers and the Timer1 prescaler). When the Timer1 registers are NOT written, the Timer1 will increment on the rising edge of the TMR1 increment clock.

When the TMR1H and/or TMR1L registers are written while this clock is high, TMR1 will increment on the next rising edge of this clock.

When the TMR1H and/or TMR1L registers are written while this clock is low, TMR1 will not increment on the next rising edge of this clock, but must first have a falling clock and the rising clock, for TMR1 to increment.

Figure 1 shows the two cases of writes to the TMR1H and/or TMR1L registers. Due to the V_{IH} and V_{IL} thresholds on the oscillator/clock pins, external Timer1 oscillator components, and external clock frequency, the Timer1 increment clock may not be of a 50% duty cycle.

The TMR1 increment clock is out of phase of the T1OSO/T1CKI pin by a small propagation delay.
