## PIC16C63 Rev. A Silicon Errata Sheet

The PIC16C63 (Rev. A) parts you have received conform functionally to the Device Data Sheet (DS30234D), except for the anomalies described below.

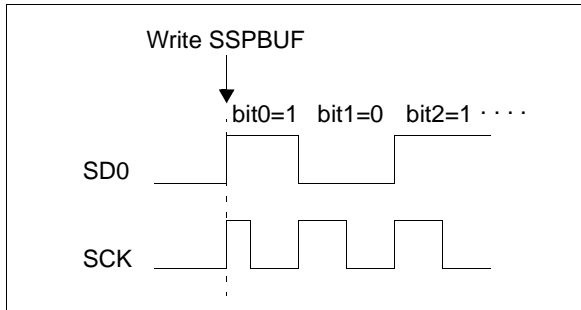
**FIGURE 1: SCK PULSE VARIATION USING TIMER2/2**

When the SPI is using Timer2/2 as the clock source, a shorter than expected SCK pulse may occur on the first bit of the transmitted/received data (Figure 1).

To avoid producing the short pulse, turn off Timer2 and clear the TMR2 register, load the SSPBUF with the data to transmit, and then turn Timer2 back on. Refer to Example 1 for sample code.

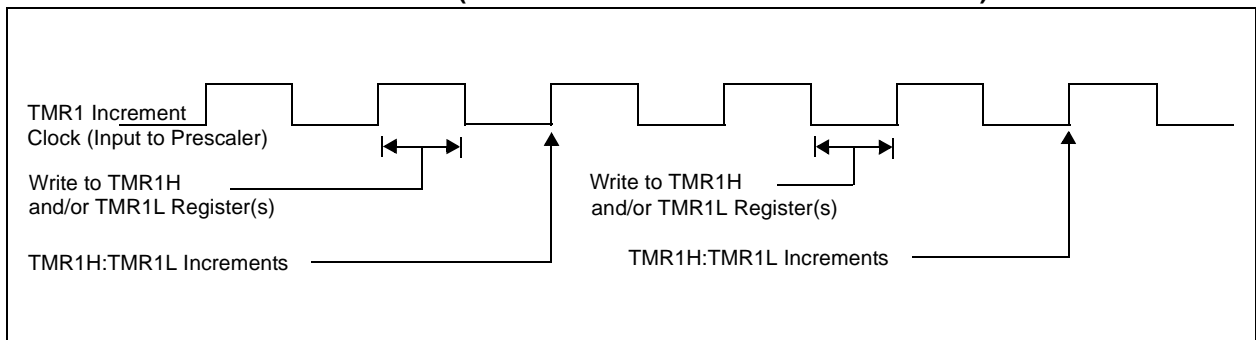
**FIGURE 1: WRITES TO TIMER1 (EXTERNAL CLOCK/OSCILLATOR MODE)**

Figure 1 shows the two cases of writes to the TMR1H and/or TMR1L registers. Due to the  $V_{IH}$  and  $V_{IL}$  thresholds on the oscillator/clock pins, external Timer1 oscillator components, and external clock frequency, the Timer1 increment clock may not be of a 50% duty cycle.

The TMR1 increment clock is out of phase of the T1OSO/T1CKI pin by a small propagation delay.

The internal clock signal that is the input to the TMR1 prescaler affects the incrementing of Timer1 (TMR1H:TMR1L registers and the Timer1 prescaler). When the Timer1 registers are NOT written, the Timer1 will increment on the rising edge of the TMR1 increment clock.

When the TMR1H and/or TMR1L registers are written while this clock is high, TMR1 will increment on the next rising edge of this clock.

When the TMR1H and/or TMR1L registers are written while this clock is low, TMR1 will not increment on the next rising edge of this clock, but must first have a falling clock and the rising clock for TMR1 to increment.
