# Service Technical Information

MODEL NO. ADC-M65 / M105 / EX108 / V107
SUBJECT Combinations of the Series-7 car stereo sets Do not sounds.

REF.No. :G - A0 - 087 - E0

DATE :25. OCT. 2000

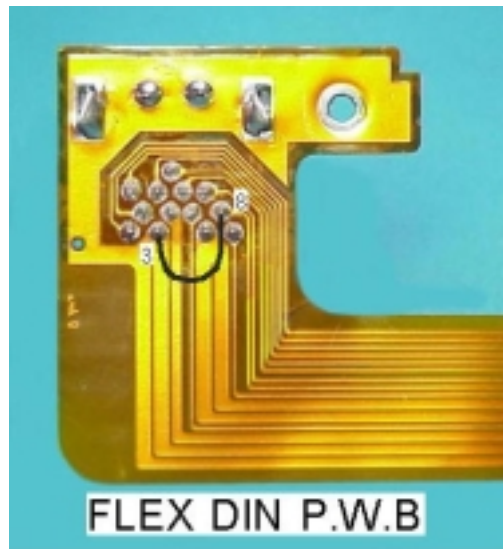
In combination of car stereo CD changer and a Series-7 car stereo head unit (see the model numbers listed below), no speaker sounds may be generated when a CD is played. If the actual occurrence of this problem is reported, please undertake the following countermeasure:

Connect a conductor between Pins 3 and 8 of the DIN connector connected to the FELX DIN P.W.B. of the car stereo CD changer. Use a conductor about 2 cm long.
