Service Technical Information

MODEL NO. NSX-F959, KF979, F958, F969, MT960, AVF960, A959
SUBJECT FL No DISPLAY

REF.No. :G - 99 - 014 - E0

DATE :24. MAY. 1999

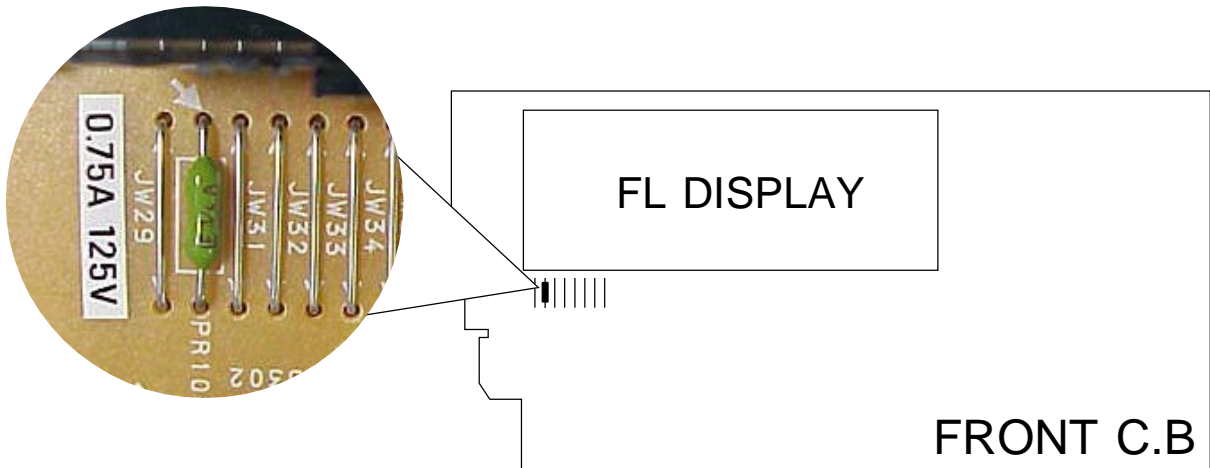
In the case that PR107 is open circuit in the above model, FL No DISPLAY may occur.

Replace the PR107 on FRONT C.B., and must affix the new LABEL FUSE as specified in the following table.
