Service Technical Information

MODEL NO. LCX-137 / 157 / 337 / 356 / 357 / AC1 / DR37
SUBJECT No power

REF.No. :G - A0 - 070 -E0

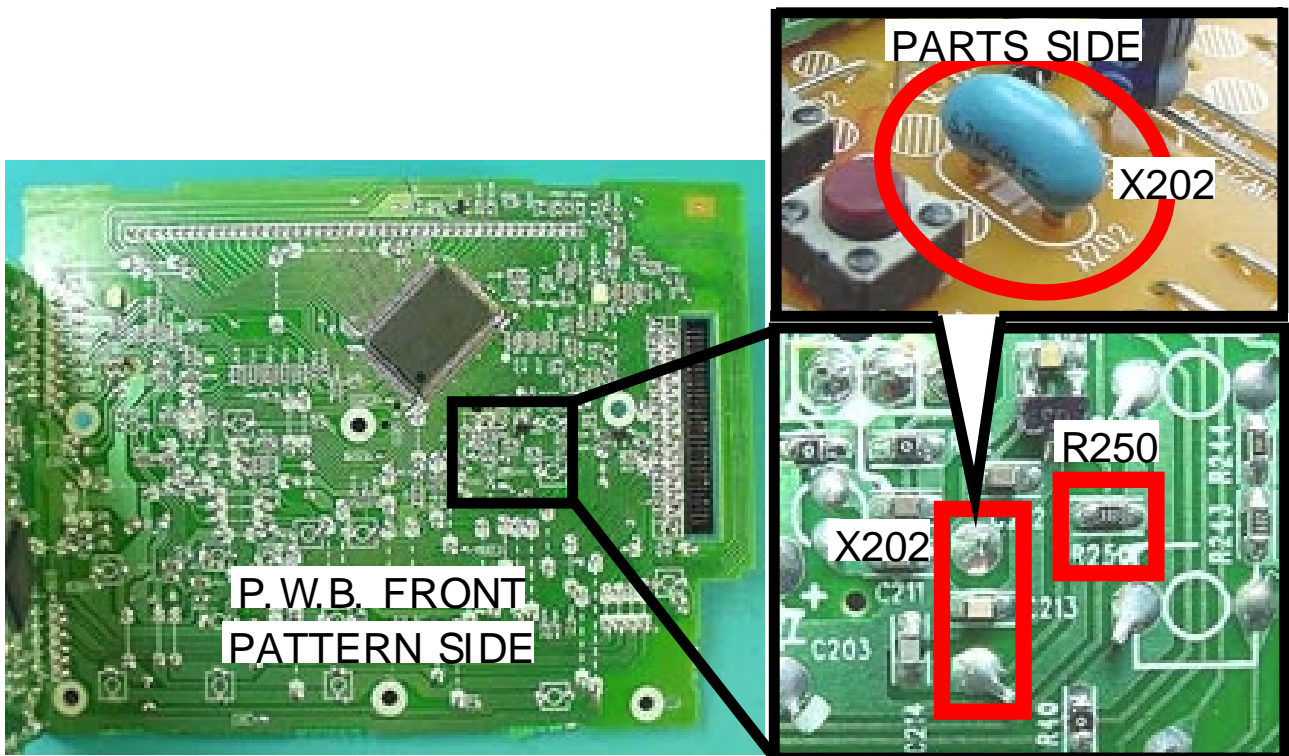
The clock is not displayed when AC Plug in, and pressing the power button does not bring any effect.

1. Remove the P.W.B FRONT from the front cabinet.
2. Change R250 from 3.3 kΩ to 1 kΩ.
3. Check if X202 on the P.W.B FRONT is oscillating. If not oscillating, change X202 to the new one shown in the table below.
