SERVICE BULLETIN

Service Bulletin #: SB 01

Title: Compact Flash Removal/Replacement.

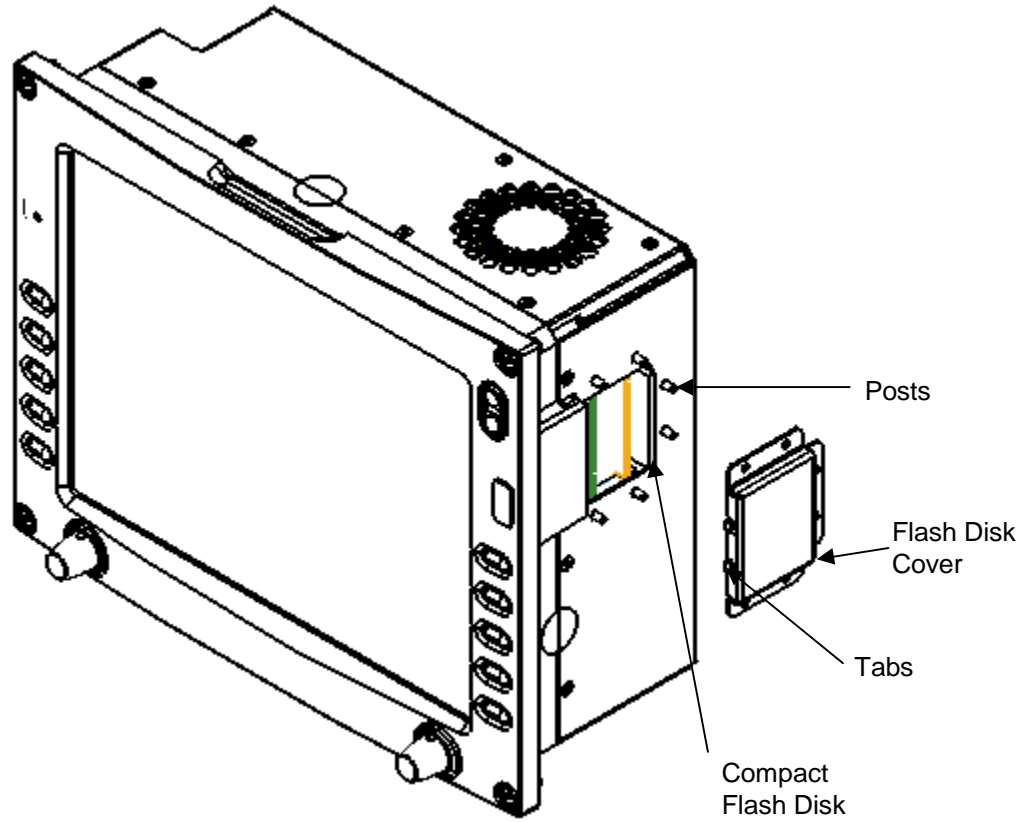
Figure 1: MFD with Compact Flash Cover Removed

This procedure should be performed on the bench. Ensure NO power is applied to the unit. Refer to Figure 1.

1. Remove the Flash cover by unscrewing the 6 nuts and lifting the cover off the posts.
2. Remove the 530-00112-000 Rev 00 compact flash by pulling it from the connector and sliding it out (as shown in Figure 1).

1. Orient the compact flash by locating the red arrow. This indicates which edge of the device slides in first. The compact flash is keyed, so it will only slide in one way. Look for two small indentations on opposite edges of the device. They should be on the side of the compact flash that faces the front of the unit.
2. Slide the 530-00112-000 Rev 01 compact flash into the slot.
3. Ensure the compact flash is fully seated.
4. Replace the compact flash cover.
5. Secure cover with the nuts.
