**BOEING**  
757  
FAULT ISOLATION/MAINT MANUAL

CHAPTER 30 - ICE AND RAIN PROTECTION

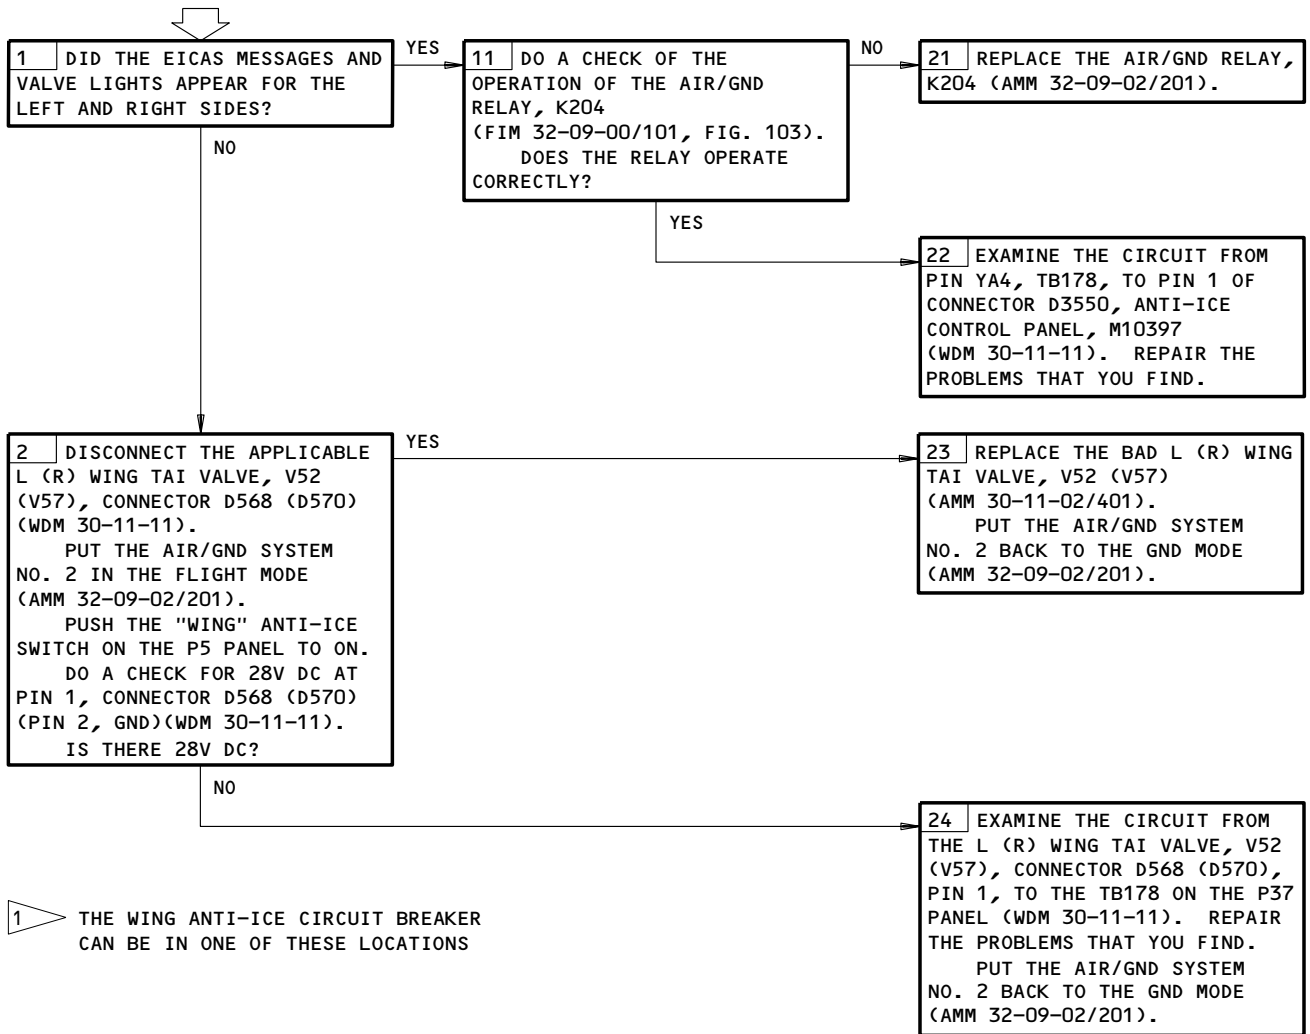
1 ▷ THE WING ANTI-ICE CIRCUIT BREAKER CAN BE IN ONE OF THESE LOCATIONS

EICAS Msg L (R) WING ANTI-ICE Displayed. Wing Anti-Ice VALVE  
Lgt(s) Remained Illum with Sw Placed to (On,Test)

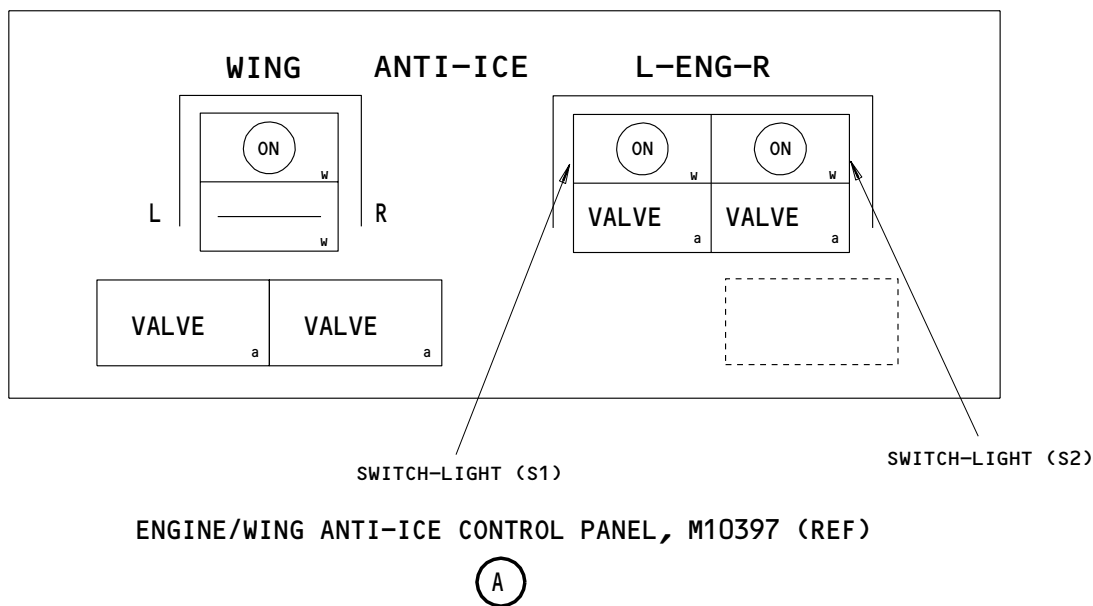
Engine Inlet Thermal Anti-Ice System - Component Location  
Figure 102 (Sheet 1)

ENGINE/WING ANTI-ICE CONTROL PANEL, M10397 (REF)

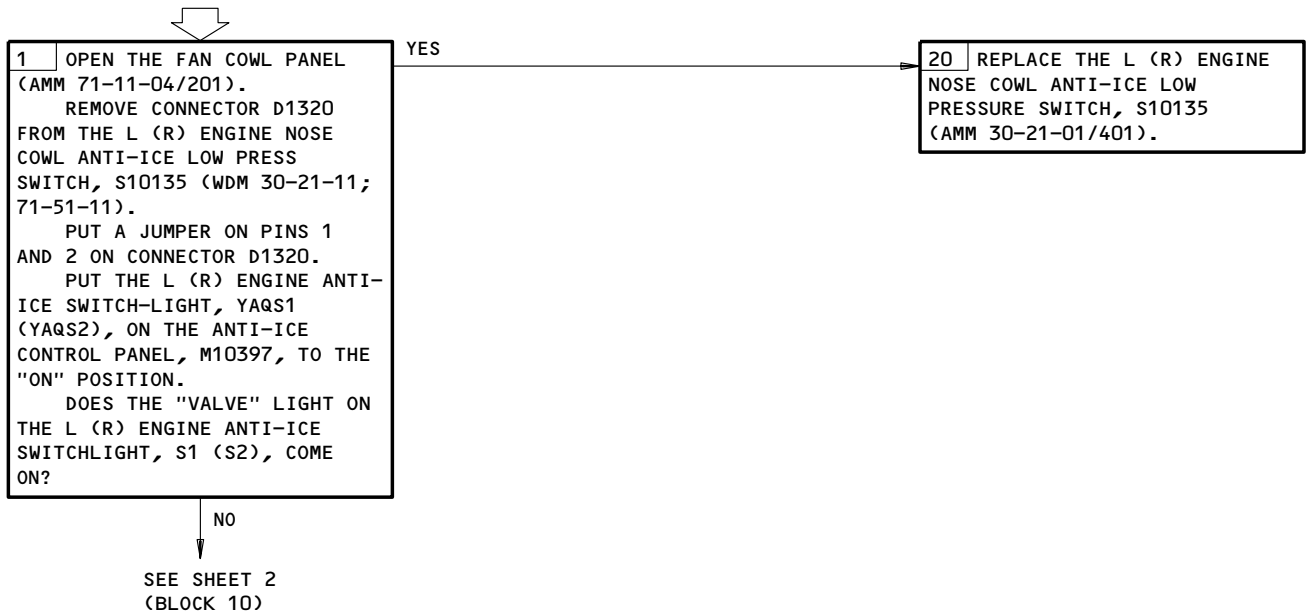
When the L (R) Eng Anti-Ice Sw Is Placed to ON, the VALVE Lgt Stayed Off.  
No EICAS Msg Shown  
Figure 103 (Sheet 1)

WHEN THE L (R) ENG ANTI-ICE SW IS PLACED TO "ON", THE "VALVE" LGT STAYED OFF. NO EICAS MSG SHOWN

**21** REMOVE THE JUMPER FROM D1320 AND REPLACE THE L (R) ENG PRESSURE SENSE RELAY, K10060 (K10062), IN THE P36 (P37) PANEL (WDM 30-21-11).

**22** REMOVE THE JUMPERS FROM CONNECTOR D6326 AND REPLACE THE L (R) ENG ANTI-ICE DISAGREE RELAY, K10601 (K10602)(WDM 30-21-11).

**23** REMOVE THE JUMPERS FROM CONNECTOR D6326 AND INSTALL THE L (R) ENG ANTI-ICE DISAGREE RELAY, K10601 (K10602)(WDM 30-21-11).  
REPLACE THE ANTI-ICE CONTROL PANEL, M10397 (AMM 30-11-01/401).

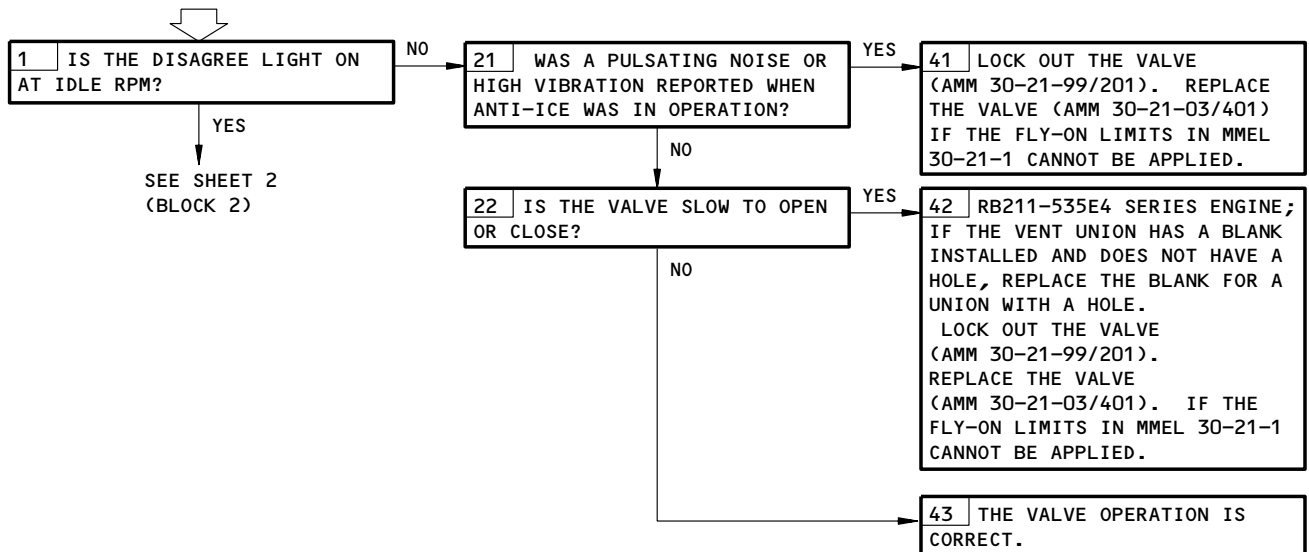
When the L (R) Eng Anti-Ice Sw is placed to ON, EICAS Msg "L (R) ENG ANTI-ICE" Displayed and Eng Anti-Ice Valve Light Remained On  
Figure 104 (Sheet 1)

**NOTE:** THIS FIGURE IS TO BE USED FOR TROUBLESHOOTING A VALVE FAILURE TO OPEN, INDICATES OPEN OR INCORRECT VALVE REGULATION.

WHEN THE L (R) ENG ANTI-ICE SW IS PLACED TO "ON", EICAS MSG "L (R) ENG ANTI-ICE" DISPLAYED AND ENG ANTI-ICE VALVE LIGHT REMAINED ON

A. The fault isolation procedures given in Fig. 103, Fig. 104, Fig. 105 and Fig. 106 will troubleshoot most known valve failure modes.

Fig.	Valve Cond.	Troubleshooting Cond.
103	ON	Problem in disagree circuit
104	ON	Valve fail to open, or indicate open, or regulate
105	OFF	Valve fail to close, or indicate closed
106	ON	Valve overpressure

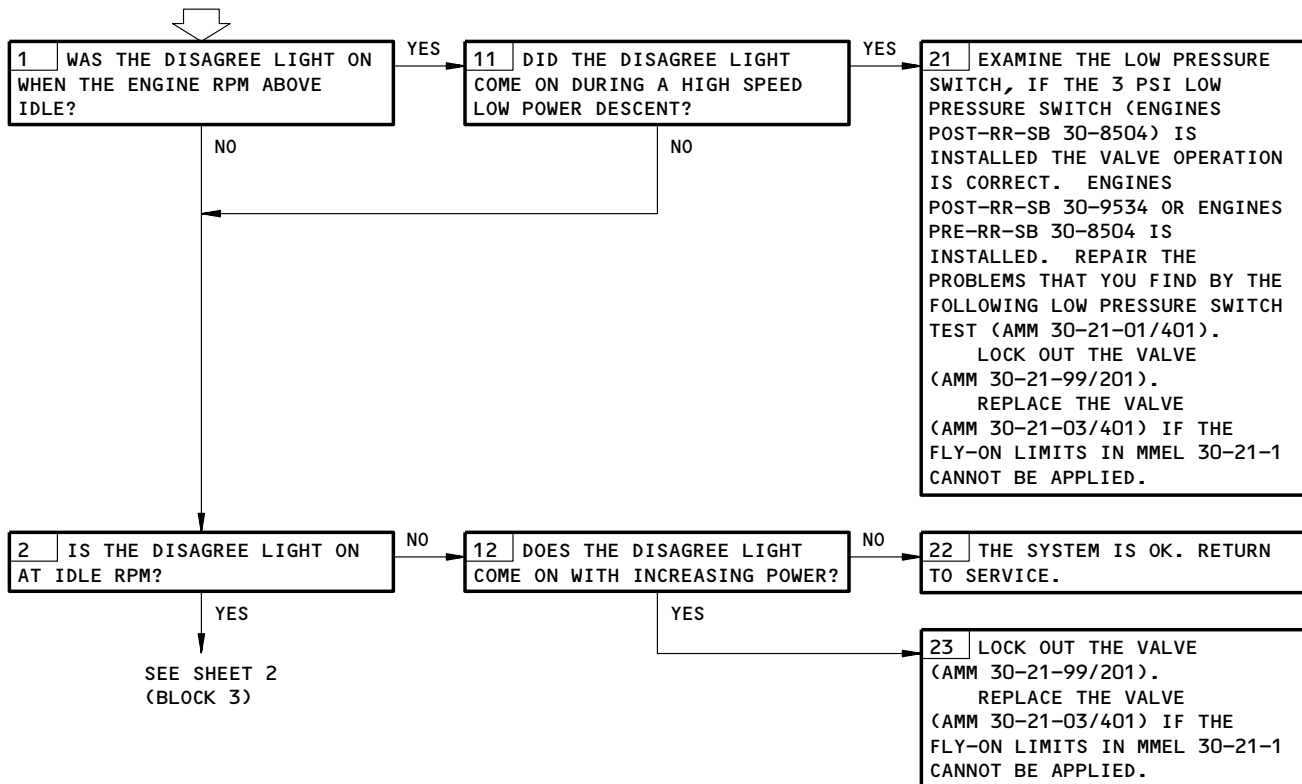
When the L (R) Anti-Ice Sw is placed OFF, EICAS Msg "L (R) ENG ANTI-ICE" Displayed and Eng Anti-Ice Valve Light Remained On  
Figure 105 (Sheet 1)

**NOTE:** THIS FIGURE IS TO BE USED FOR TROUBLESHOOTING A VALVE FAILURE TO CLOSE OR INDICATE CLOSED.

WHEN THE L (R) ANTI-ICE SW IS PLACED OFF, EICAS MSG "L (R) ENG ANTI-ICE" DISPLAYED AND ENG ANTI-ICE VALVE LIGHT REMAINED ON

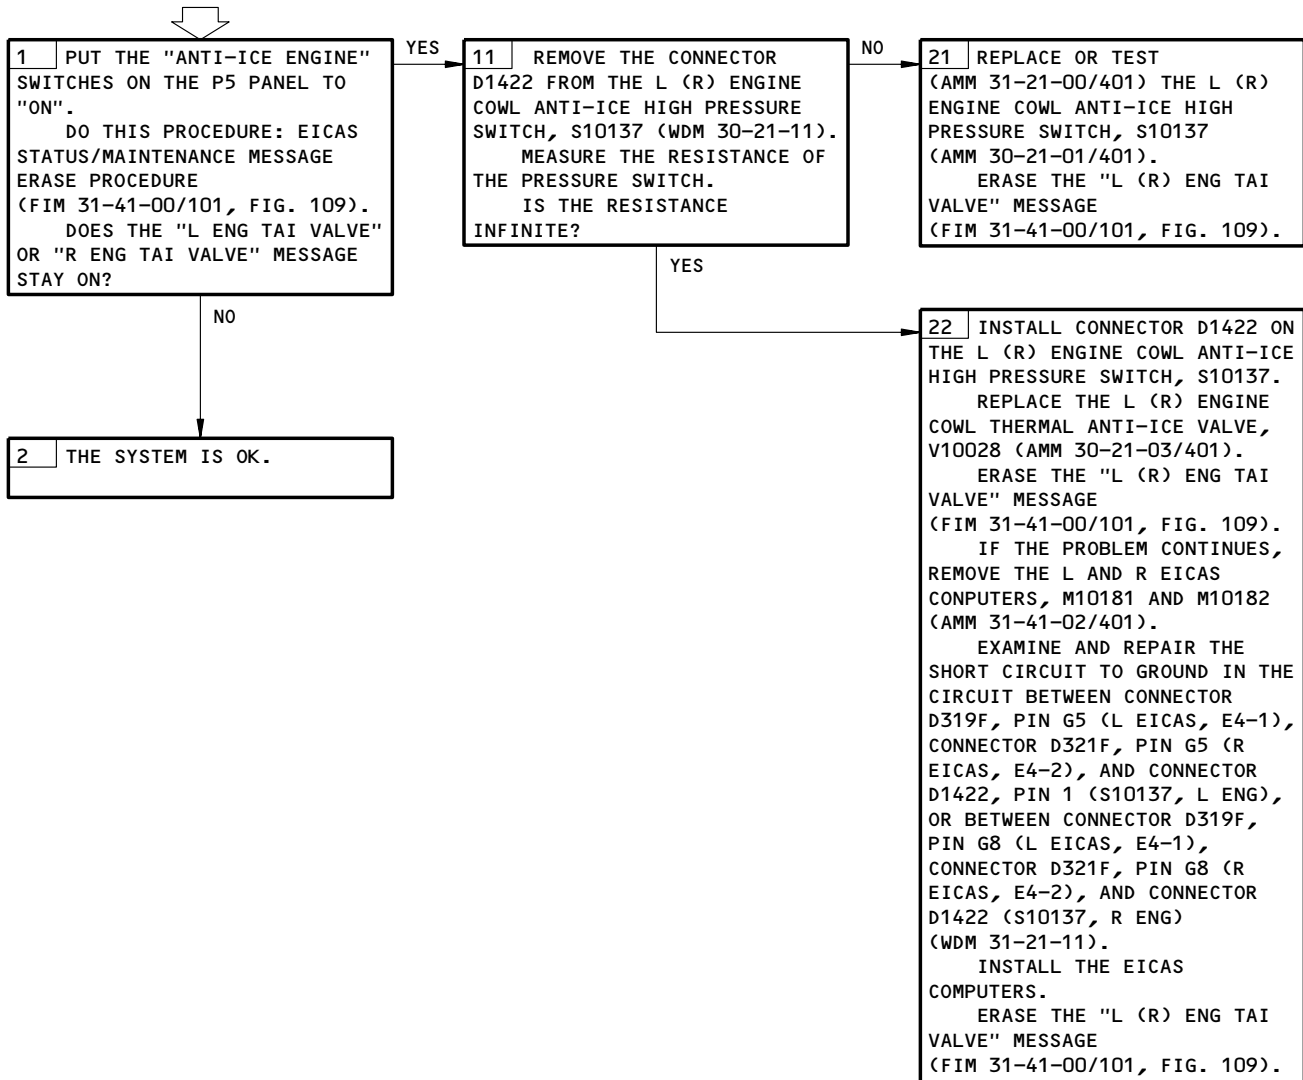
EICAS Msg (O1=L, O2=R) ENG TAI VALVE Displayed.  
Eng Anti-Ice VALVE Light Extin with Sw ON  
Figure 106

**NOTE:** THIS FIGURE IS TO BE USED FOR  
TROUBLESHOOTING AN ANTI-ICE SYSTEM OVER  
PRESSURE.

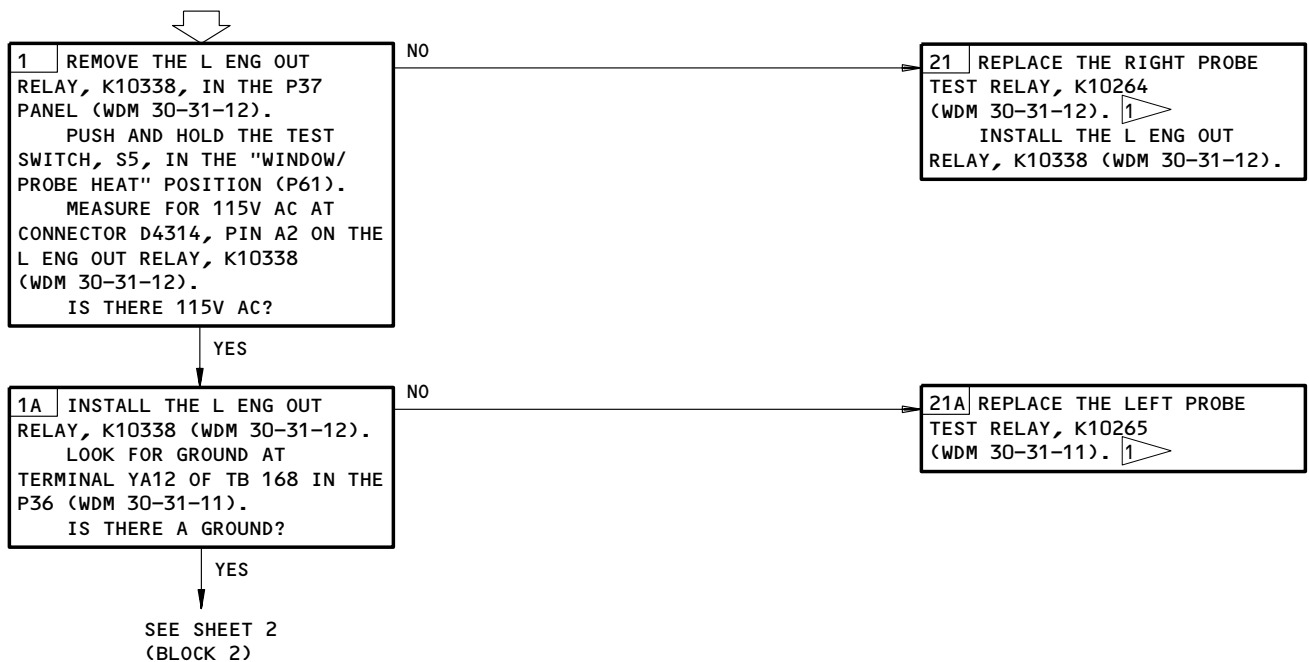
**EICAS Message CAPT (F/O) PITOT Displayed. Capt (F/O) Pitot  
Light Remains Illum during Probe Heat Test  
Figure 103 (Sheet 1)**

**EICAS MESSAGE  
"CAPT (F/O) PITOT"  
DISPLAYED. CAPT  
(F/O) PITOT LIGHT  
REMAINS ILLUM DURING  
PROBE HEAT TEST**

- A** THE PITOT HEAT CAPT MAIN CIRCUIT BREAKER CAN BE IN ONE OF THESE TWO LOCATIONS.
- 1** ERASE THE "CAPT (F/O) PITOT HEAT" MESSAGE (FIM 31-41-00/101, FIG. 109).
- 2** REMOVE THE SIMULATION OF THE FLIGHT MODE WITH THE AIR/GROUND RELAY SYSTEM (AMM 32-09-02/201).
- 3** REMOVE THE ENGINE RUNNING SIMULATION (AMM 77-12-03/201).

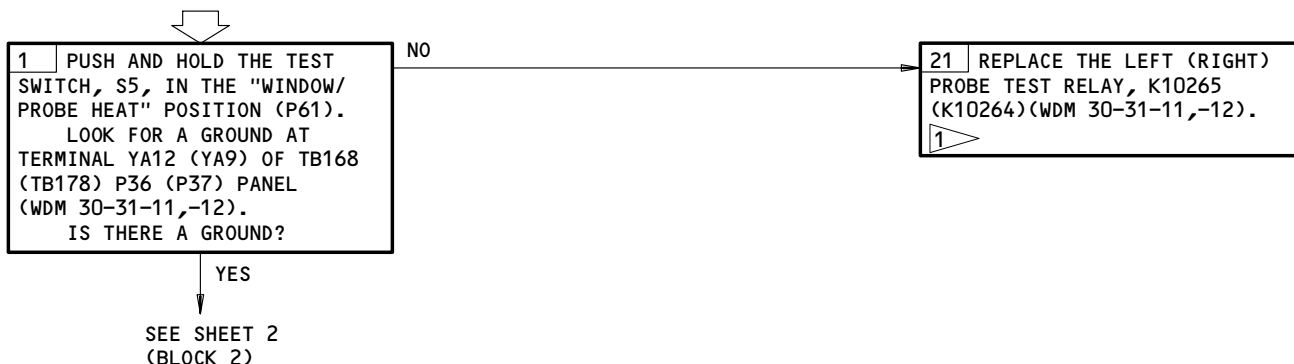
EICAS Message L (R) AUX PITOT Displayed. L (R) AUX PITOT Light Stays On during Probe Heat Test  
Figure 104 (Sheet 1)

EICAS MESSAGE  
"L (R) AUX PITOT"  
DISPLAYED. L (R)  
AUX PITOT LIGHT  
STAYS ON DURING  
PROBE HEAT TEST

- A** THE PITOT HEAT L AUX CIRCUIT BREAKER CAN BE IN ONE OF THESE TWO LOCATIONS.
- 1** ERASE THE "L (R) AUX PITOT" MESSAGE (FIM 31-41-00/101, FIG. 109)
- 2** REMOVE THE SIMULATION OF THE FLIGHT MODE WITH AIR/GROUND RELAY SYSTEM (AMM 32-09-02/201).
- 3** REMOVE THE ENGINE RUNNING SIMULATION (AMM 77-12-03/201).

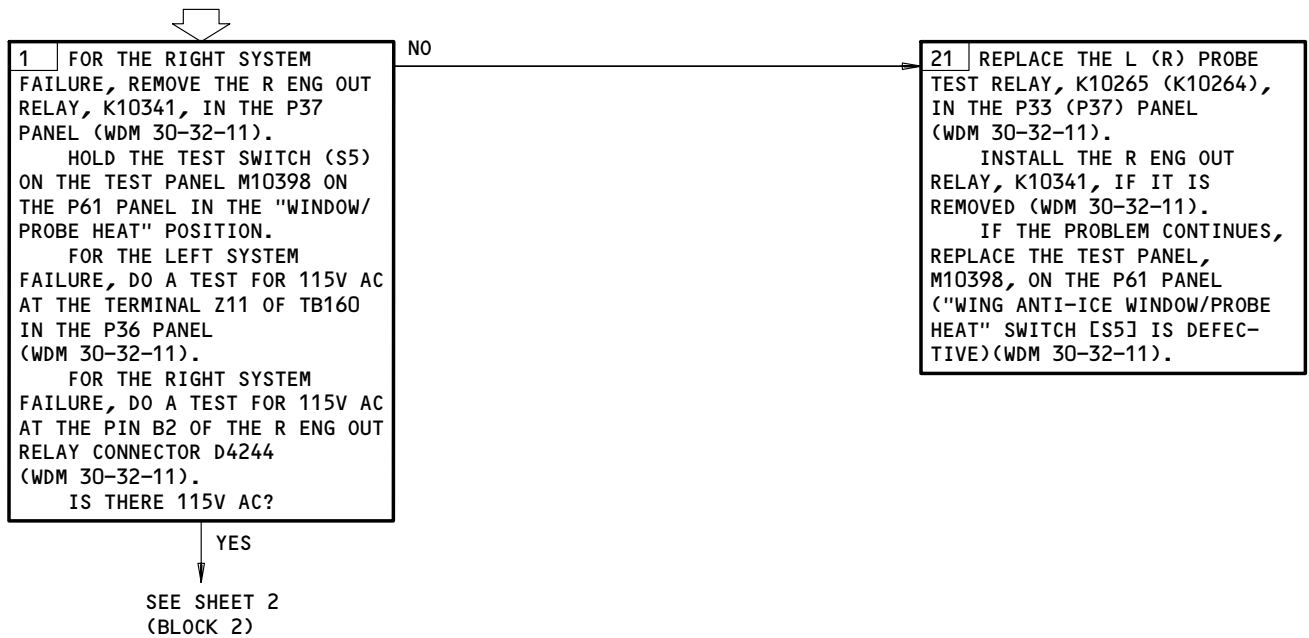
EICAS Msg L (R) AOA PROBE Displayed. L (R) AOA Probe Heat Lgt Remains Illum During Probe Heat Test With Apl on Gnd and Eng Off.

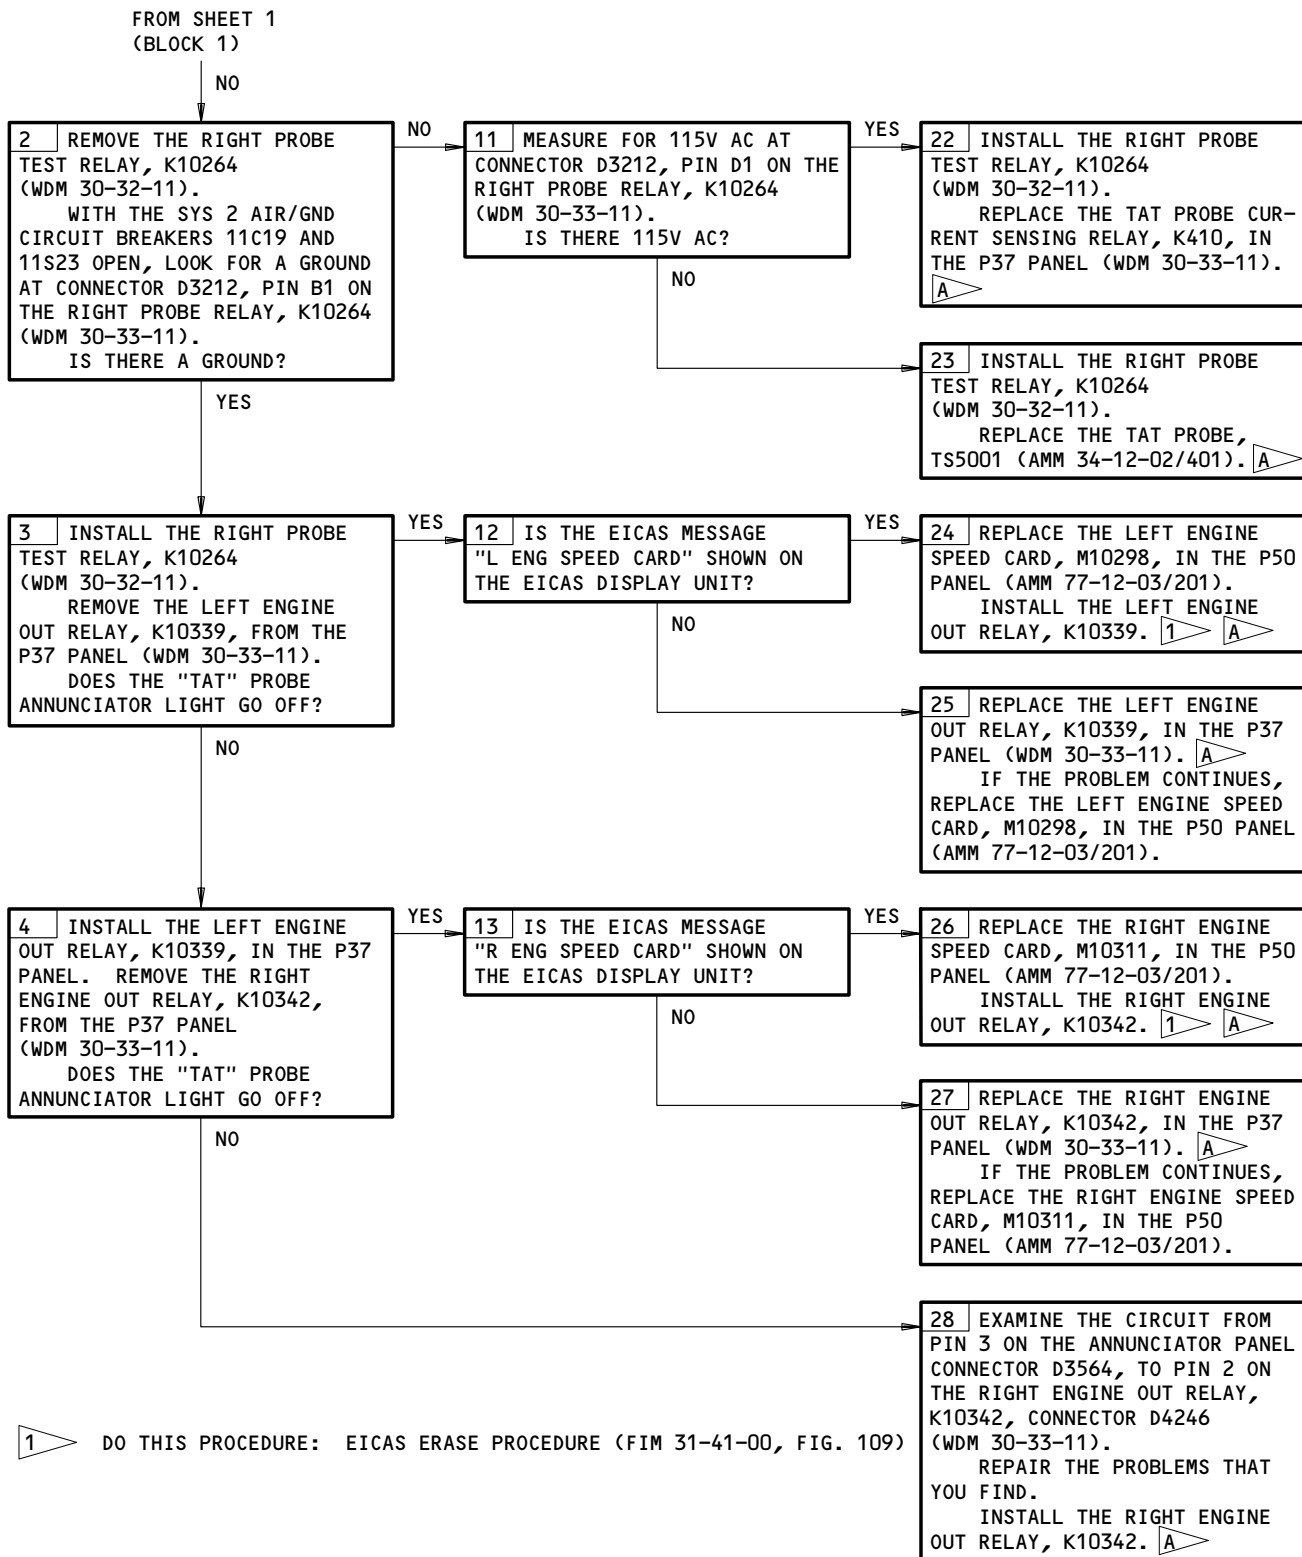
EICAS Message TAT PROBE Displayed. TAT Probe Heat Light Remains Illuminated during Probe Heat Test with Airplane on Ground and Engines Off.  
Figure 103 (Sheet 2)

**21** REPLACE THE RIGHT PROBE TEST RELAY, K10264, IN THE P37 PANEL (WDM 30-33-11). **A**

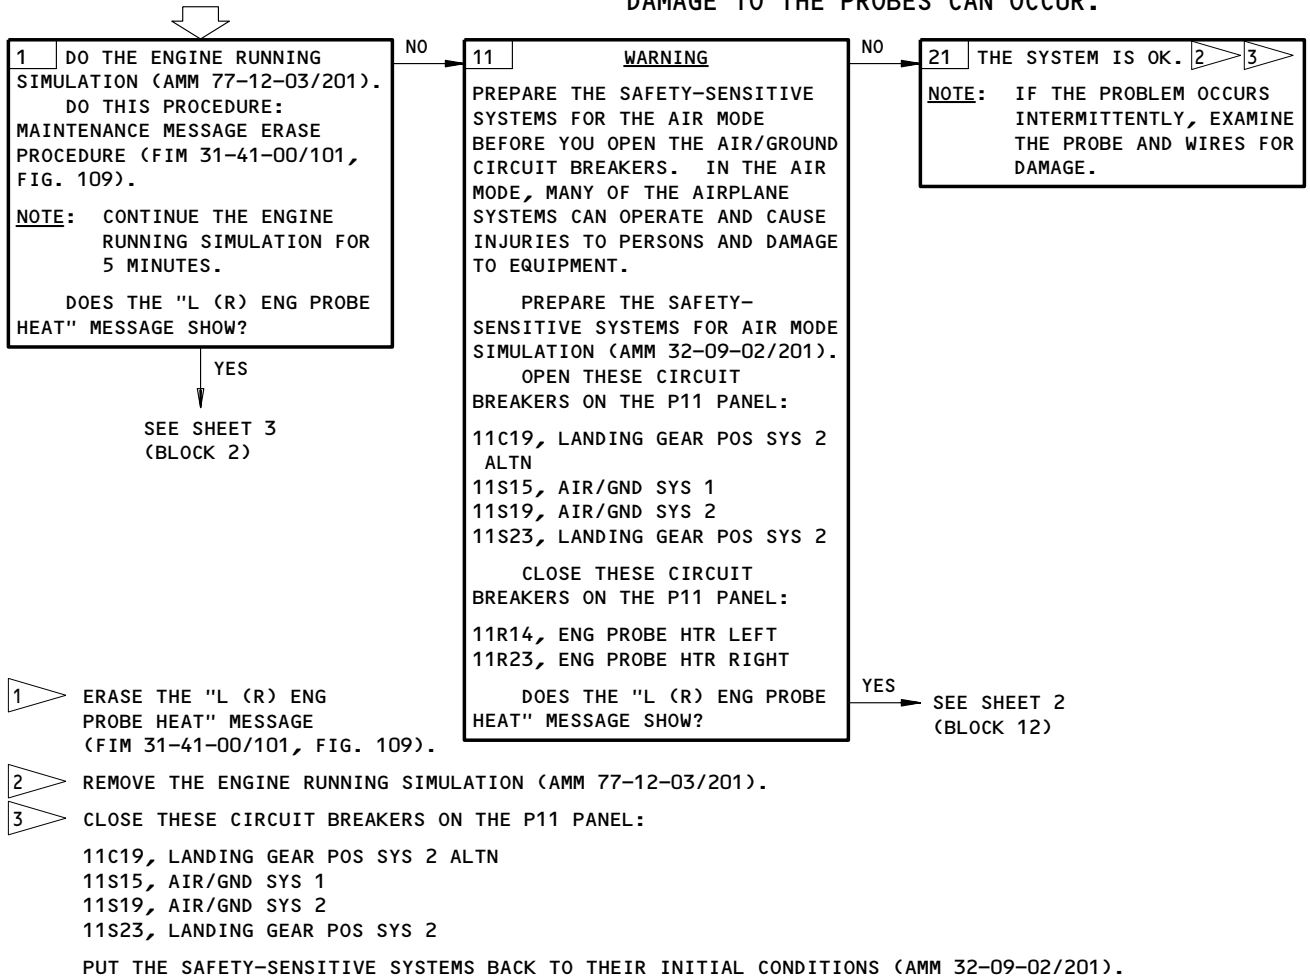
EICAS Msg L (R) ENG PROBE HEAT Displayed  
Figure 103 (Sheet 1)

**EICAS MSG  
"L (R) ENG PROBE  
HEAT" DISPLAYED**

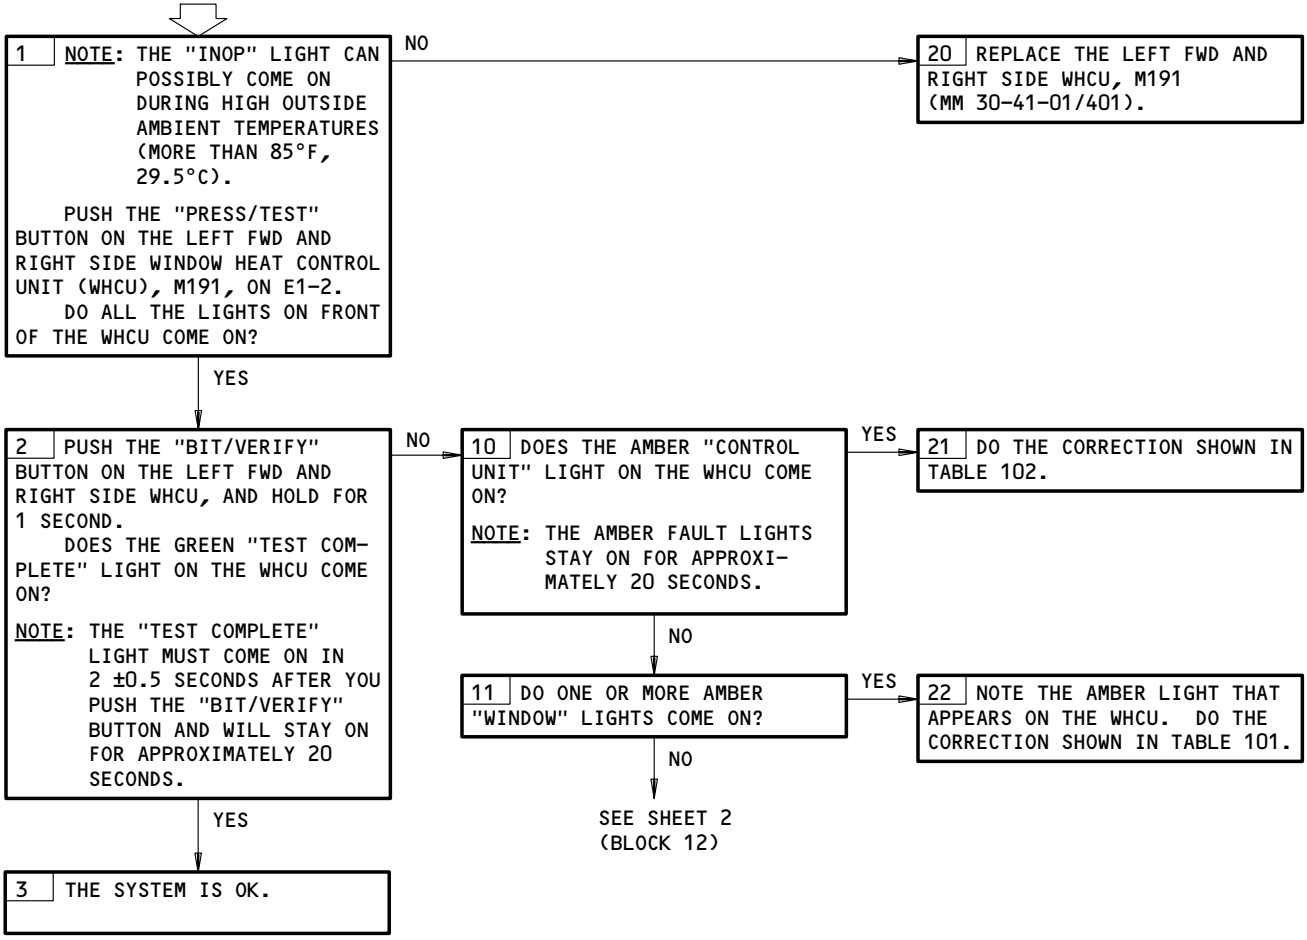
**NOTE:** BITE DOES A TEST OF THESE SYSTEM COMPONENTS:  
 HEATER, LEFT NUMBER 1 WINDOW  
 HEATER, RIGHT NUMBER 2 WINDOW  
 HEATER, RIGHT NUMBER 3 WINDOW  
 LEFT FORWARD WINDOW HEAT CONTROL UNIT  
 RIGHT SIDE WINDOW HEAT CONTROL UNIT

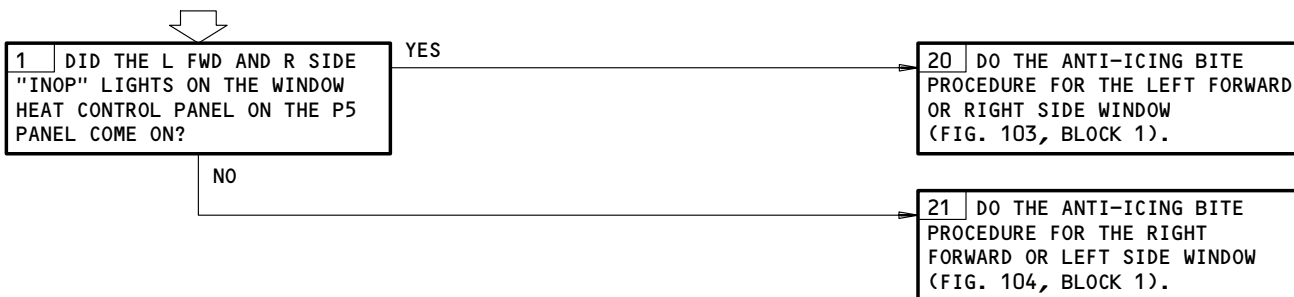
EICAS Message WINDOW HEAT Displayed and  
 Two Window Lights are Illuminated  
 Figure 106

NOTE: THE "INOP" LIGHT CAN POSSIBLY COME ON DURING HIGH OUTSIDE AMBIENT TEMPERATURES (MORE THAN 85°F, 29.5°C).
