MODEL: **GP 605**

SUBJECT: **Potential Hazard - Retrofit**

LOCATION: **Paper Decks**

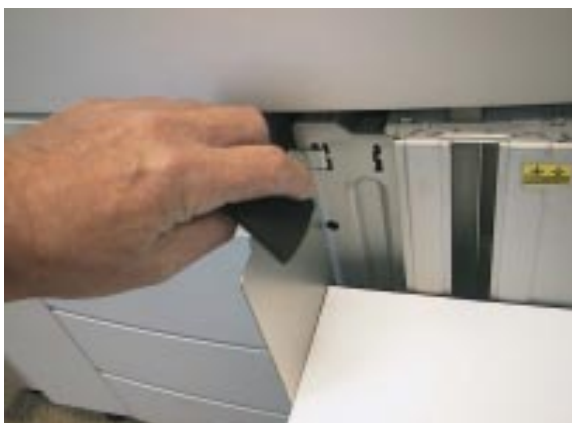
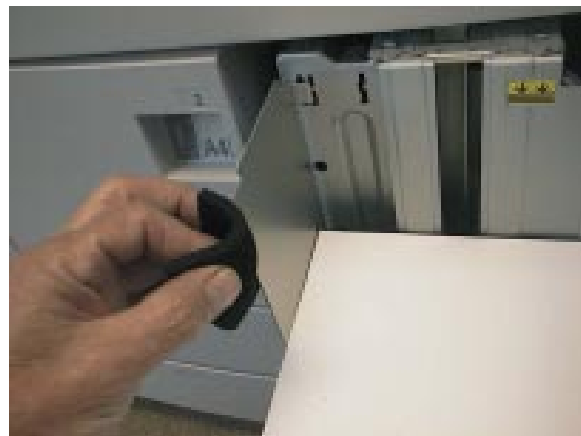
Injury to the hands can occur when clearing paper jams from either of the front paper decks due to sharp edges.

Smooth edges of paper retaining plate as shown with a fine grade of emery cloth.
