Model: DADF-H1

Ref. No. : FF-T01-X-000041-01

Subject: Addition of a damper to the left hinge unit to alleviate noise generated when closing the DADF

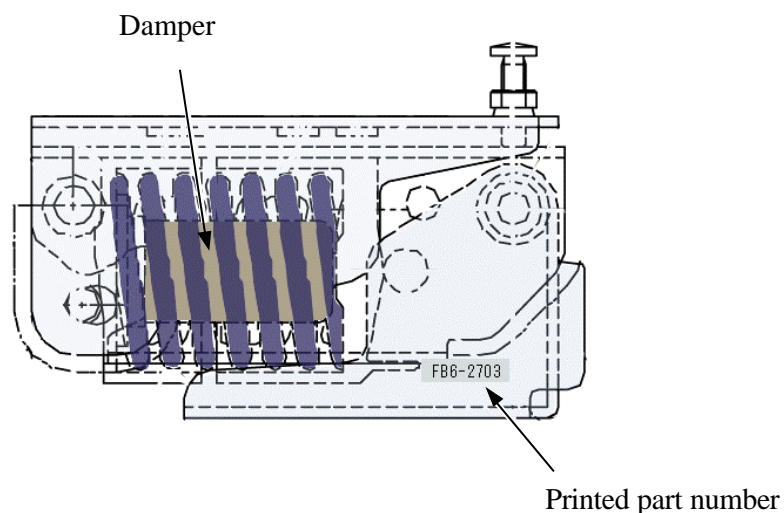
Figure: New type of left hinge unit

Noise when closing the DADF (Banging noise is created when the DADF is closed.)

Add a damper to the left hinge unit in order to alleviate the shock when the DADF is closed so that the noise can be also alleviated. (See the figure below.)

If you receive a complaint about the noise when closing the DADF, replace the left hinge unit with the new type.
