## Fibre Optic Connectors:

Why Expanded Beam types are essential in military  
and other harsh environment applications

## **Abstract**

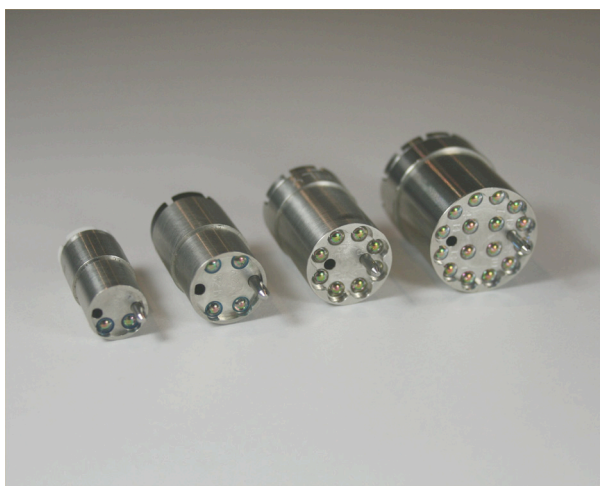
Multi-channel expanded beam connector inserts have been developed to offer a practical method of packaging the expanded beam concept. Typical expanded beam inserts comprise a stainless metal housing containing 1 to 16 spherical lenses (optical channels).

The front face of the expanded beam insert has a mating surface, an alignment pin and socket and one or more spherical lenses which are epoxy sealed. The lenses have an extremely hard anti-reflection coating. The Fibreco expanded beam insert has been carefully designed to avoid “dirt traps” and the largely flat front surfaces facilitate easy cleaning.

Fibreco Mini, Junior, Senior and Maxi Expanded Beam Inserts

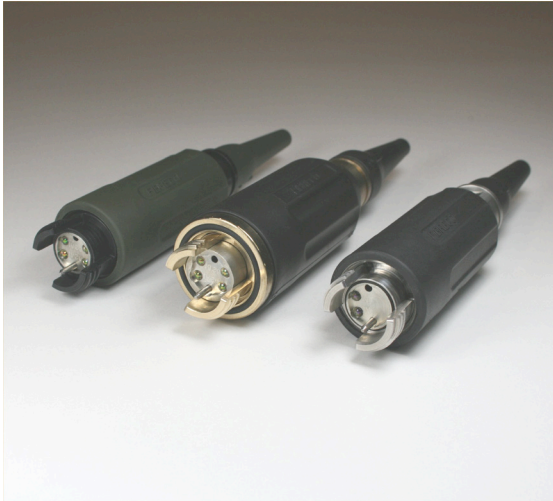
Hermaphroditic type expanded beam connectors have been designed specifically for external harsh environment applications and are widely used in military tactical communications, outside broadcast, mining and many other industrial applications. Cable assemblies with hermaphroditic connectors can be easily daisy-chained and there is no requirement for male / female adaptors.

Connector shell materials to suit a wide range of environments are offered including Aluminium Alloy, Stainless Steel and Nickel Aluminium Bronze.

Fibreco hermaphroditic tactical connectors are fully sealed (IP68) mated or unmated and with or without dust-cap fitted.

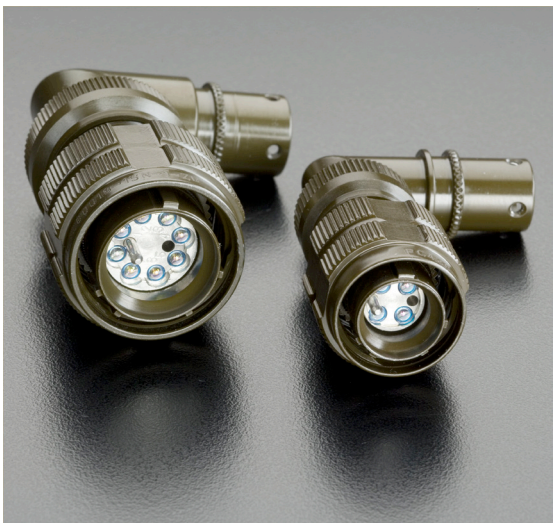
MIL-C-38999 Series III expanded beam connectors are used in electronic equipment interface applications on military vehicles, aircraft and ships.

Size 11, 13, 15 and 17 connector shells are offered with 1 to 16 optical channels.

The connector features the generic MIL-C-38999 Series III tri-start thread and one turn self-locking, anti-vibration coupling mechanism.

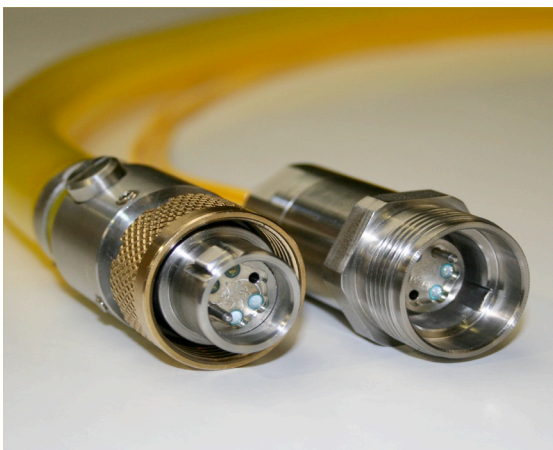
Dry-mate sub-sea connector with four channel expanded beam insert.

Stainless Steel and Silicon Bronze shells with a depth rating of 3000 metres for ROV applications.

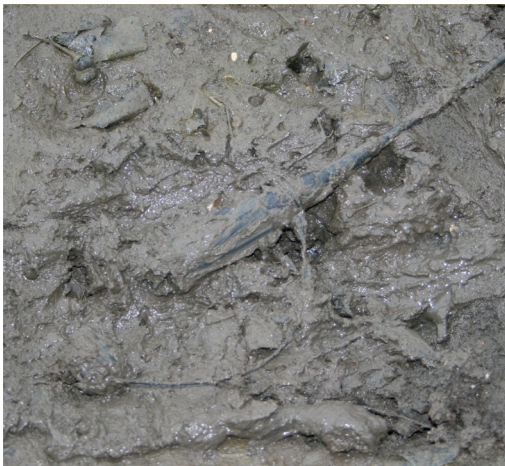
1. Plug connector immersed in mud. The connector is fully sealed even without the dust cap fitted.

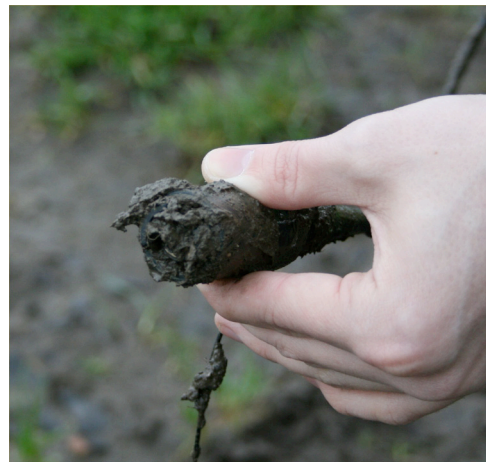
2. The mud will not cause damage to the expanded beam insert. A butt-contact connector would almost certainly already be destroyed in this state.

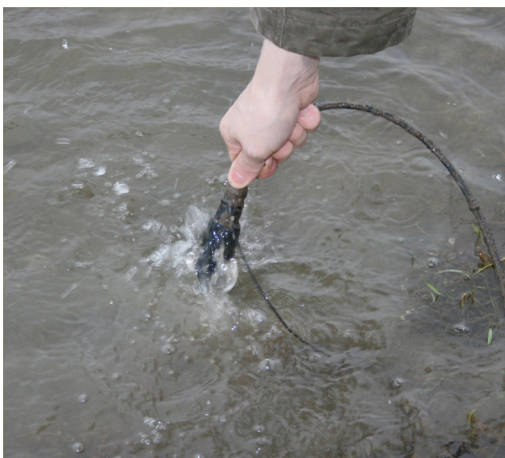
3. Initial cleaning to remove mud and debris from the connector face can be done by rinsing in water. A hose, bucket of water, stream or muddy puddle will do.

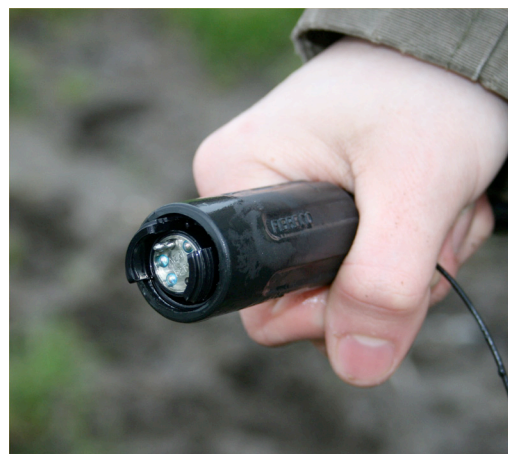
4. Connector end-face is clean after rinsing.

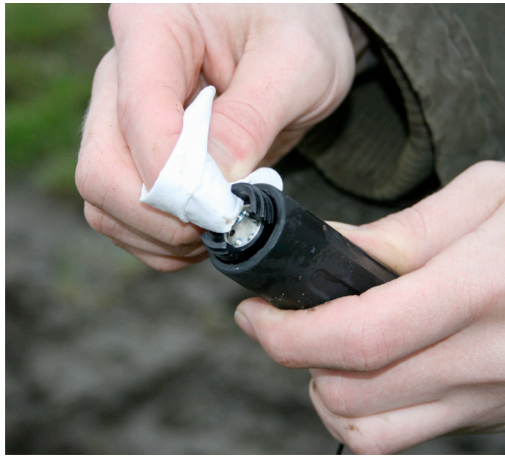
5. The insert face is dried and wiped clean. Ideally a clean cloth or tissue is used but if these are not available the bottom of your coat will suffice.

No damage to the insert surfaces or lenses will occur.

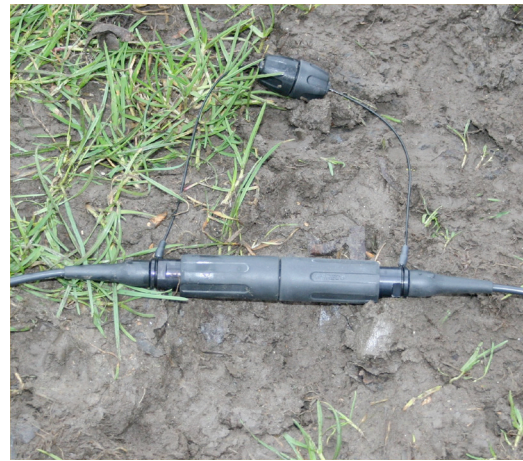
6. Connectors plugged and ready for service.

The whole cleaning cycle was completed in under 5 minutes.

Insertion loss was measured between  $-0.90\text{dB}$  to  $-1.15\text{dB}$  (9/125 4 channels) with an Optical Time Domain Reflectometer.
