# Restoration of a an Eddystone 'Classic' from the 1950's – an S.680X Reborn into the SPARC Museum Fold, by Gerry O'Hara, G8GUH

## Background

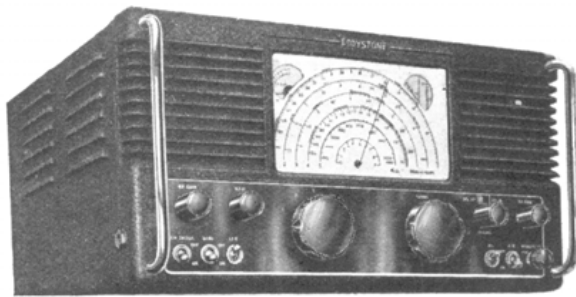
"The company was without a good professional HF receiver, the S.504 having flopped, and Harold Cox was eager to get things moving. He specified that it should use the new B7G miniature valves, be fitted into the 640 cabinet and use the same mains transformer (we had loads in stock!).

"If you look at the Radiolympia report in the Wireless World for October 1947 you'll see a photo of the new S.680. But it's smaller than the 680 which was finally released two years later! The problem was heat . . . too much of it.

"The 640 transformer was pushing it to start with and the extra load of the 680 caused it to burst into flames when left permanently operational in high ambient temperatures. Not exactly the sort of reliability which Stratton were seeking to promote.

Above: excerpt from the 'Cooke Report' by Bill Cooke, recalling the development problems with Eddystone's 'hottest' post war receiver... Above left: the S.680. Top of next page, the S.680X

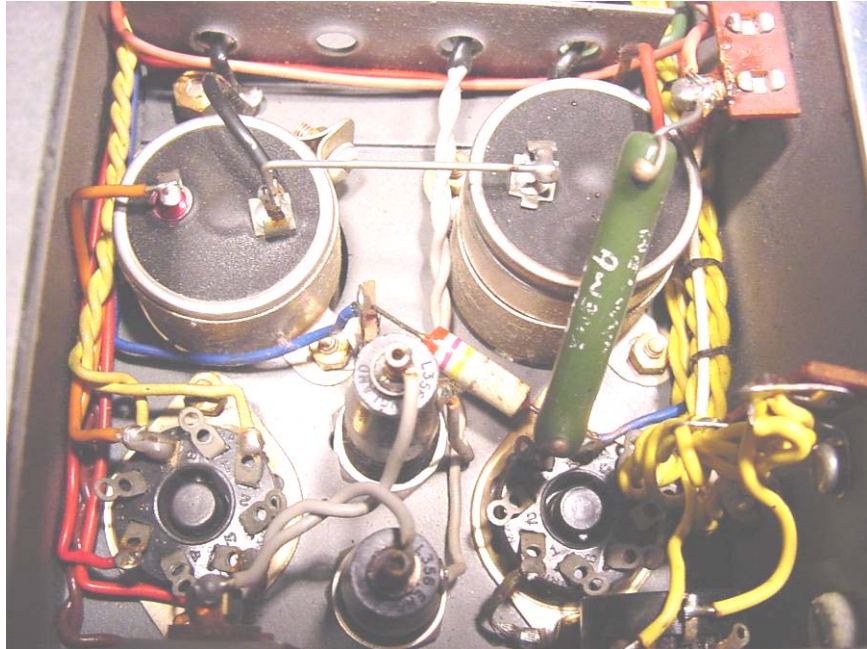
Above: beneath the power supply chassis – all neat and tidy (almost as new!). Below left: above view of the power supply chassis before cleaning – the 5Z4G on the right and VR150/30 on the left

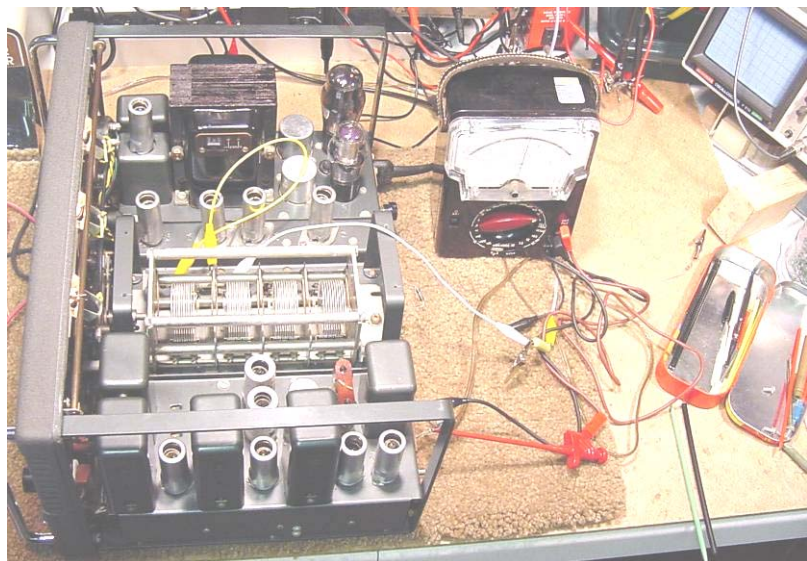
- Short out the local oscillator (LO) gang of the tuning capacitor, C63 (the one nearest the front panel) using a short jumper lead to stop the LO working (see photo at base of previous page – yellow jumper), and connect the signal generator output to the grid of the mixer valve, V3 (couple the signal generator to the stator of the mixer gang of the tuning capacitor, C44 using a 0.01uf capacitor and croc clip – white jumper);

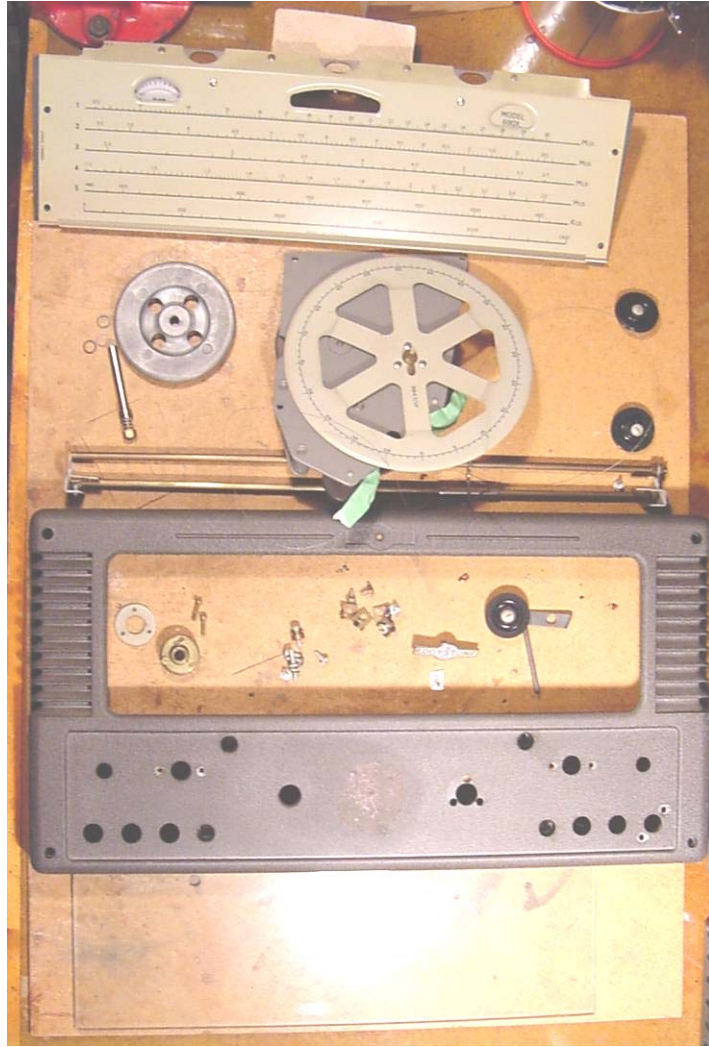
- Remove the dial plate (four screws) and the dial glass (four screws). Pulled the tuning knob spindle out of its bushing (be careful as there are small fibre washers between the flywheel and the brass bushing mounted on the front panel);
- Remove the upper idler pulleys and pointer guide bars by removing their (2) screws from the front panel casting;
- Remove the all-important Eddystone logo – a nice grey enamel one in the case of the S.680X (photo, below right) - by unscrewing its small retaining plate and, finally remove the tuning drive bushing from the front panel casting (3 brass screws). All the component parts are shown in the photo, right.
- I cleaned-up the gearbox and applied a small spot of high quality light machine oil to the

- bearing points (photo, left) and some moly grease to the spool pulley gears and the pointer shaft and guide bar;
- I cleaned the scale plate and circular vernier dial plate by dusting off the loose fluff and dead bugs and then wiping them using warm soapy water and cotton wool (be very gentle as they are easily damaged);

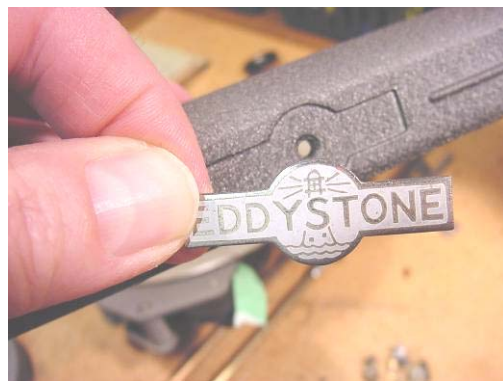
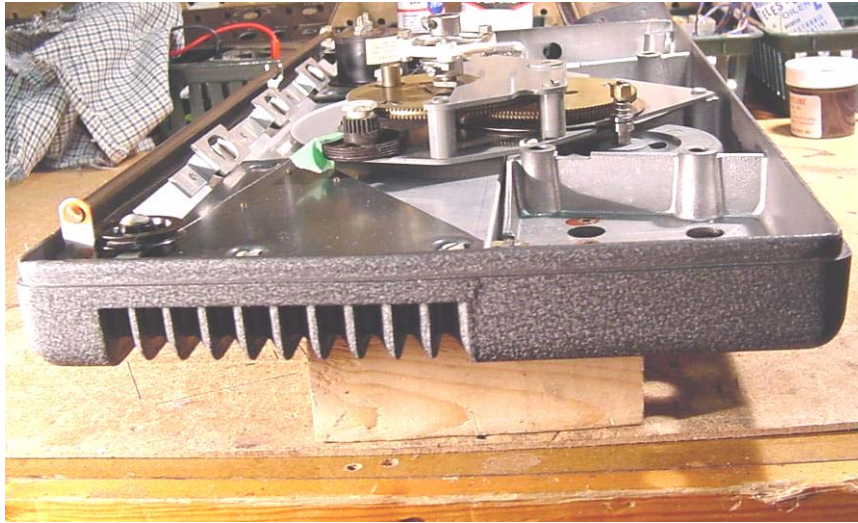
- While the front panel casting is off the set (photo, base of next page), use the great access this provides to clean up the front panel switches, variable capacitors (BFO and crystal phasing) and Yaxley switch mechanisms – also apply a little De-Oxit (or Servisol/Electrolube cleaner) on contact surfaces and into the AF and RF gain pots. While you are at it, clean the main tuning gang rotor connections, applying a little De-Oxit to the contact points and a dab of moly grease into the roller bearings;

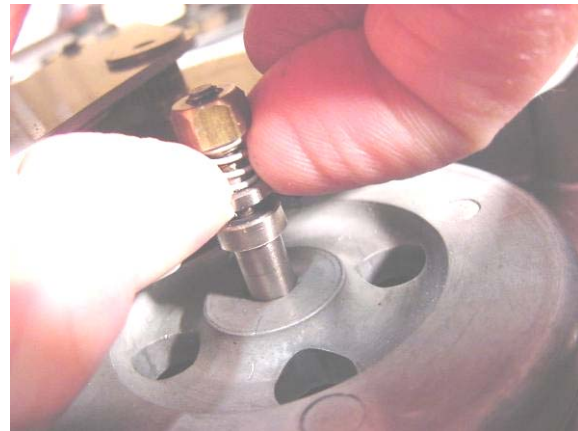
- The tuning knob shaft was coated with moly grease prior to installation in its bushing;  
- When re-fitting the gearbox, tuning shaft and friction drive, place the front panel casting on a couple of wooden blocks (photo at top of page) so that the shaft can protrude from the front panel without being forced back through. Close-up views of the flywheel and friction drive mechanism are shown in the photos above (note that the spring exerts

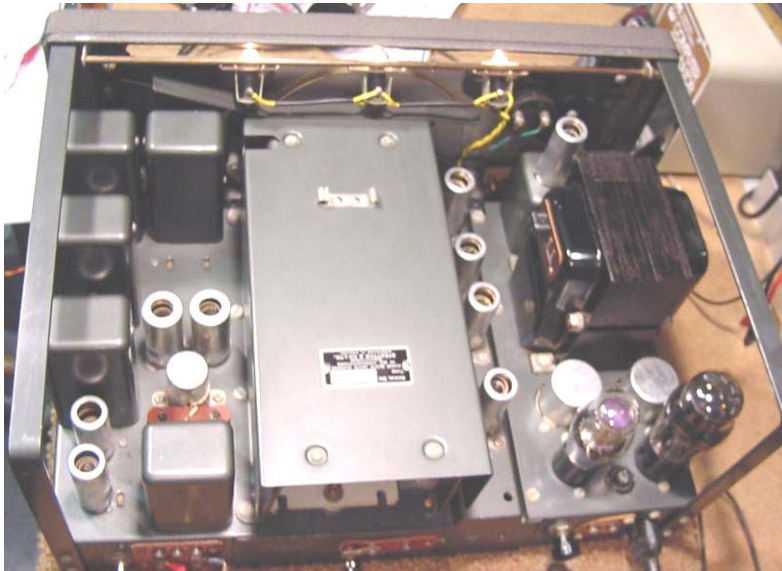
above and below: it now looked 'Bath Tub fresh' – quite an incredible condition for a 50 year old (check out the photos);

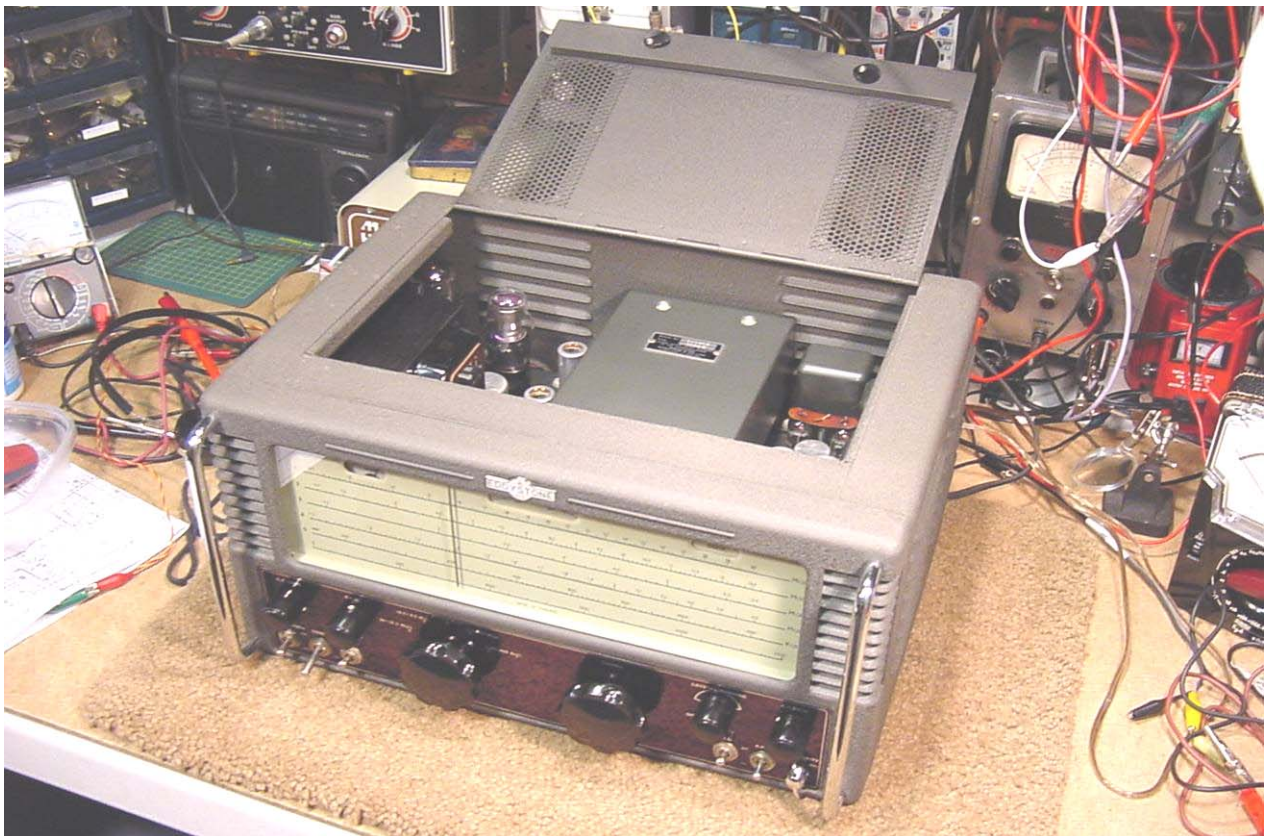
Below: the S.680X on the G8GUH workbench following re-assembly and undergoing soak-testing

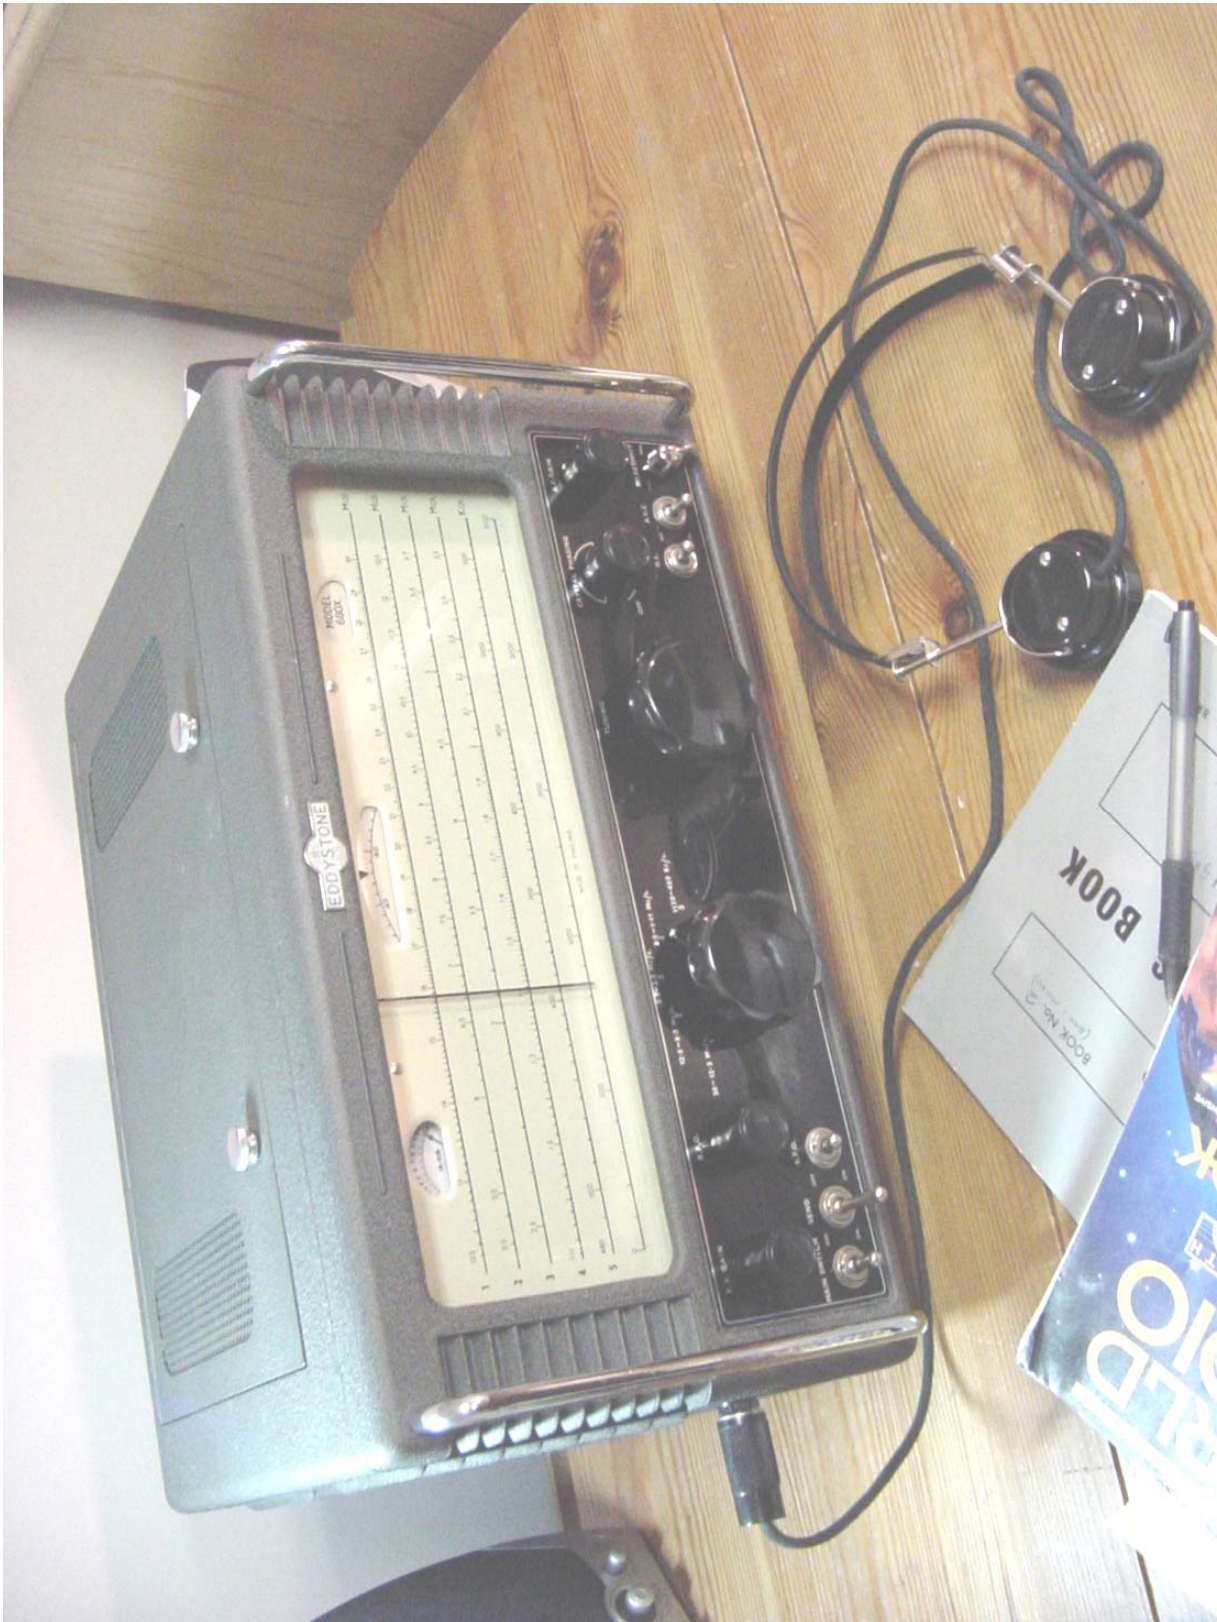
Above: time to put the S.680X through its paces before I returned it to the SPARC Museum. It easily held its own against my top performing S.830/4 and S.940 sets – indeed, it is a real pleasure to use
