EFRATOM LPRO-101

Repair reference guide
By Fred de Vries, PE1FBO, 2008

Revision 2, August 2008, © PE1FBO

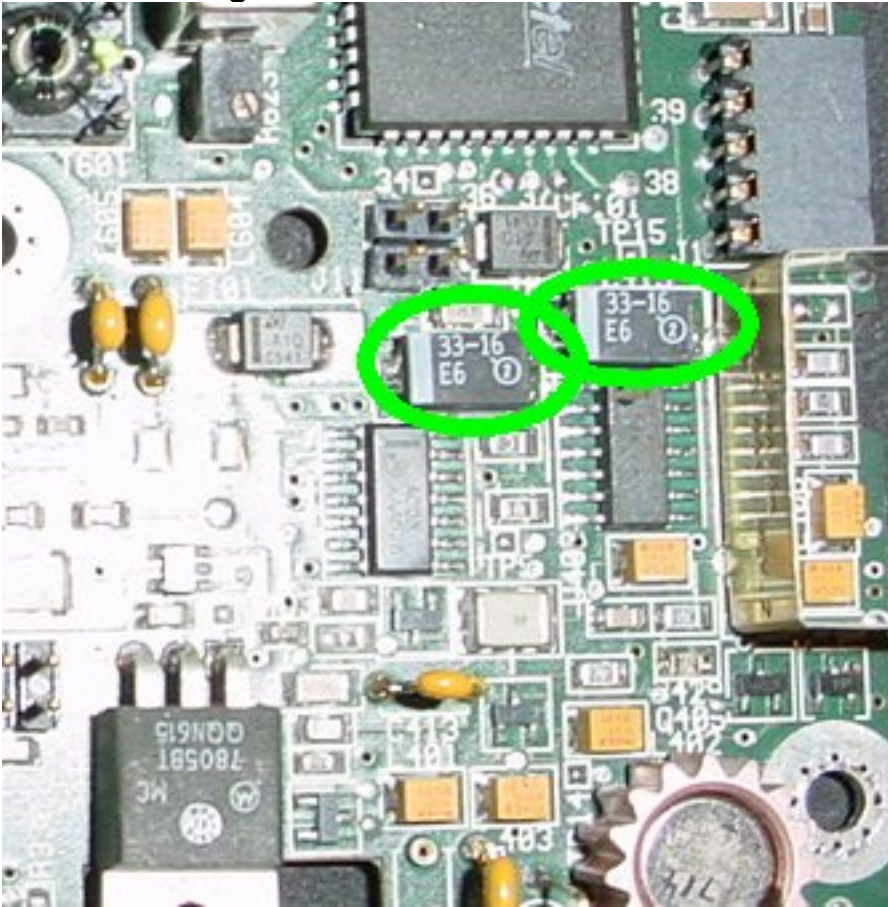
Fig 5, 5 Volts filtering

The two SMD tantalum capacitors can be replaced by SMD tantalum ones of a different value.

The original ones were 68 μ F/16Volts. The new ones I used are 33 μ F/16 Volts.

The positive terminal of C419 is about 4.6 Volts, the other cap's voltage is about 4.4 Volts (to GND)

Both are used to filter the 5 Volts supply.

On an old unit, the tantalum caps have possibly a high ESR or are completely open. I would replace them with new ones since the units run at high temperatures and this has an accelerated aging effect on the tantalum caps.
