EFRATOM LPRO-101
Repair reference guide
By Fred de Vries, PE1FBO, 2010

Revision 6, Januari 2010, © PE1FBO

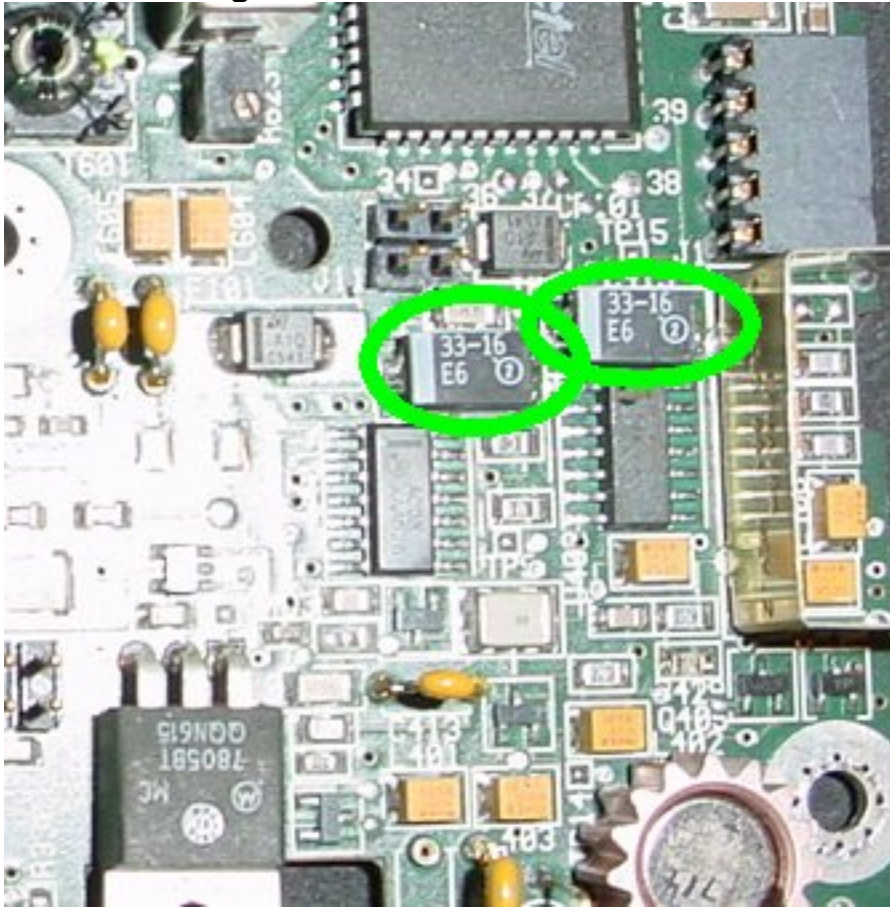
Fig 5, 5 Volts filtering

The positive terminal of C419 is about 4.6 Volts, the other cap's voltage is about 4.4 Volts (to GND)

Both are used to filter the 5 Volts supply.

The two SMD tantalum capacitors can be replaced by SMD tantalum ones of a different value.

The original ones were 68 μ F/16Volts. The new ones I used are 33 μ F/16 Volts.
