EFRATOM LPRO-101
Repair reference guide
By Fred de Vries, PE1FBO
Revision 7, October 2011

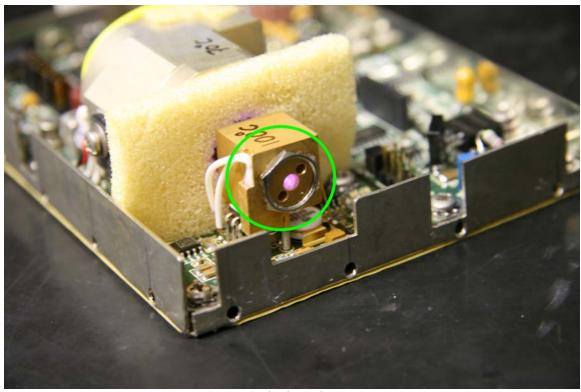
Fig 2, Rubidium lamp

When the rubidium lamp section reaches 40 to 60° Celsius it ignites, you will see the purple light coming from the back of the lamp.

Mind you, that when stray light (50Hz or 60Hz) enters the rubidium cell, the whole unit starts to behave very strange and looses lock, so be aware of this when trouble shooting!

Lamp voltage (pin 5) can be as low as 3 Volts, below 3 volts an atomic lock becomes difficult. Healthy units are ranging from 6 to 9 Volts.

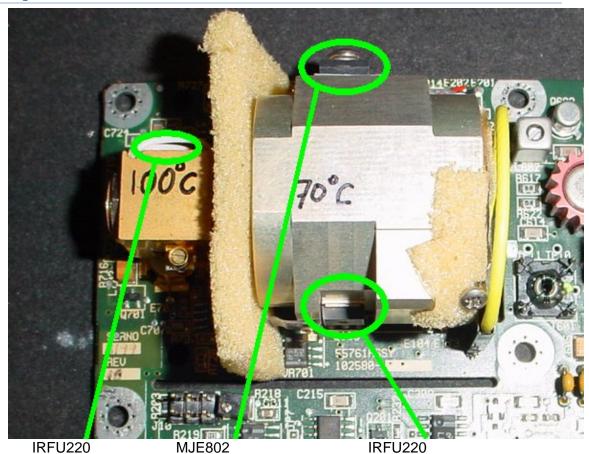
Fig 3, Temperature controlled assembly

The rubidium lamp housing is about 101° Celsius The rubidium cell is about 71° Celsius

The official temperatures (according to the manual) are 110° C for the lamp, and 79° C for the Rb cell.

The housing of the heated assemblies measures lower. It is also depending where you measure the temperature.

The TO202 heater transistor is a MJE802 (NPN darlington, 4A, 40Watt), this can be replaced with an BD679 or BD681.

The TO251 transistors on the lamp and Rb-cell are IRFU220 MOSFETS, 4.6A/200V, 40 Watt. They can be replaced with an IRFU420 or STD3NB30

The Rb lamp exciter transistor is an MRF160, it's a MOSFET from Motorola. Ft 500 Mhz, 4W, 28 volts. A possible substitute could be the PD57006 from ST

# The base plate needs to be mounted on a heat sink to prevent loss of lock and cooling of the internal electronics.

As a test, you can operate the unit without heat-sink for about half an hour to check if the electronics work reliable at higher ambient temperatures.

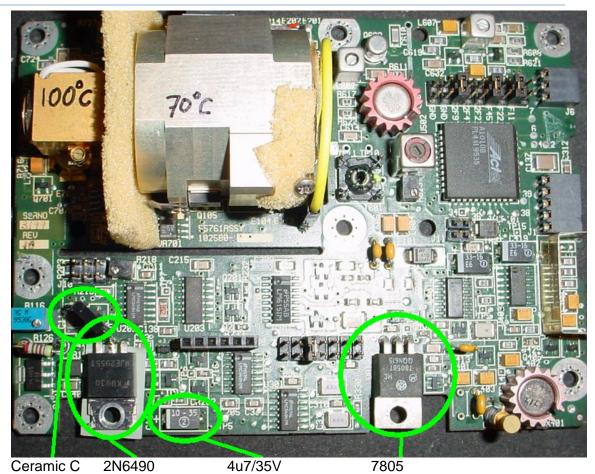
Fig 4, 17 Volts section and 14 Volts section

Power transistor Q106 is originally a 2N6490, it is a 15Amp, PNP, low hfe type. It can be replaced by an MJE2955T or BD912 if faulty.

The collector (mounting tab) of Q106 should be at 17.0 Volts (to GND) Q106 is isolated from the chassis.

The additional black capacitor is 1uF/50Volts ceramic. I had to remove the original one on the back side, which was suspected to be short at higher temps. There is not enough clearance on the back side to fit the new one.

The capacitor C116 is a tantalum one, 4.7uF/35V
The positive terminal of this capacitor is about 14.4 Volts (to GND)
The voltage regulator VR102 is an 7805, it's output is at 5 Volts (to GND)

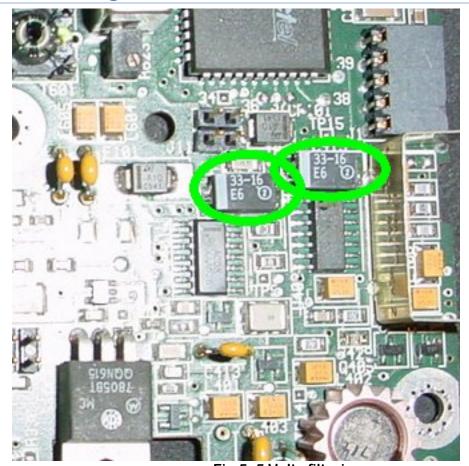
Fig 5, 5 Volts filtering

The two 68uF/16Volts SMD tantalum capacitors can be replaced by SMD tantalum ones of a different value.

The new ones I used are 33uF/16 Volts.

The positive terminal of C419 is about 4.6 Volts, the other cap's voltage is about 4.4 Volts (to GND)

Both are used to filter the 5 Volts supply.

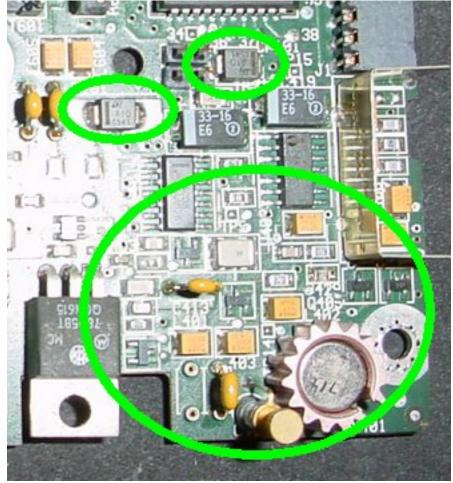
Fig 6, input protection diodes and VCO

Both diodes CR101 and CR 106 (F101) are SMBYW02 diodes, with a forward voltage drop of 650 mV.

Both anodes are connected to the input of 24 Volts, the cathode of F101 is at 23.35 Volts.

Oscillator VCO range is rather big +/- 150 Hz for the 10Mhz output. 9.999 850 .. 10.000 180 Hz

Total time for a complete scan takes about 105 seconds. (60s ramp up, 45s ramp down) The internal VCO works on 20MHz.

The 20 MHz crystal is housed in the round package with heat-sink on it.

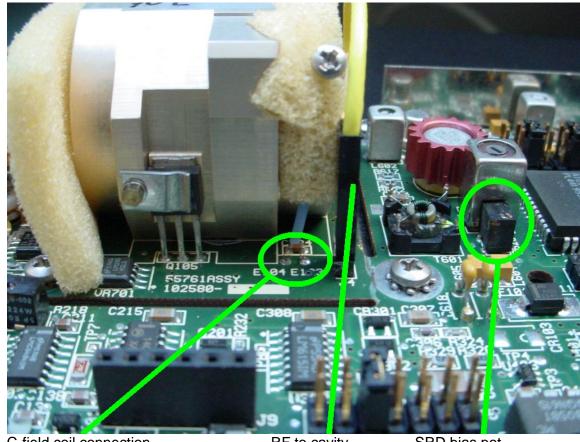
RF to cavity Fig 7, Rb cell connections

C-field coil connection

SRD bias pot

The SRD bias potentiometer is typical set between 1.5 and 4 kOhms

If you disconnect the yellow coax cable you can measure the SRD forward voltage drop of 0.7 Volts (centre to shield).

The SRD is an HP 5082-0833. It is located inside the cavity.

To set the bias correctly, refer to the adjustments section.

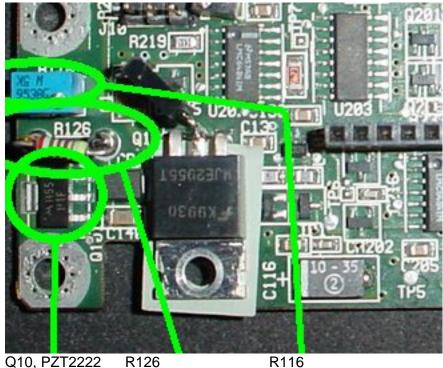
Fig 9, C field resistor

Q10, PZT2222 R126

Frequency	Resistor value R126	
9.999.999.908	>100k	
9.999.999.964	6k2	
9.999.999.976	5k2	
10.000.000.002	4k2	
10.000.000.050	3k2	
10.000.000.165	2k2

With increasing current trough the C field coil, the frequency increases.

By adapting R126, you can tune the unit with potmeter R116 to exactly 10 MHz

The C field coil is approx. 22 Ohms, @ 70°C, Voltage aprox. 140 mV, @ 6.4mA

Q10 is a PZT2222A, P1F marking, This is a 2N2222 in SOT223 SMD package.

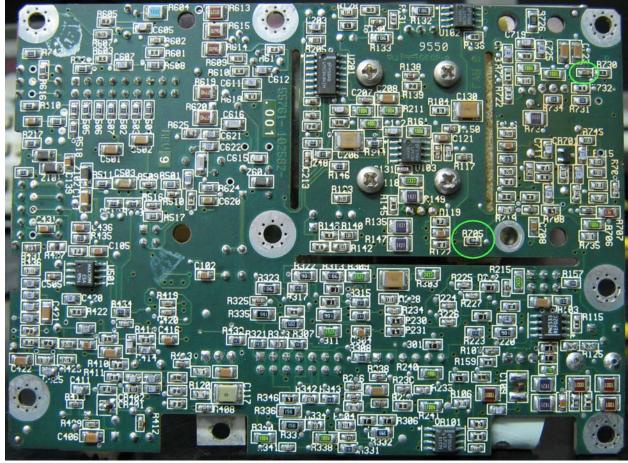
Fig 10, Location of R705 and R729

Experience has shown that all 100k resistors of this size on the board are suspect. They are of the 0603 SMD size, and marked with 104 (The smallest parts on the board) In particular R705 (82k in-circuit) and R729

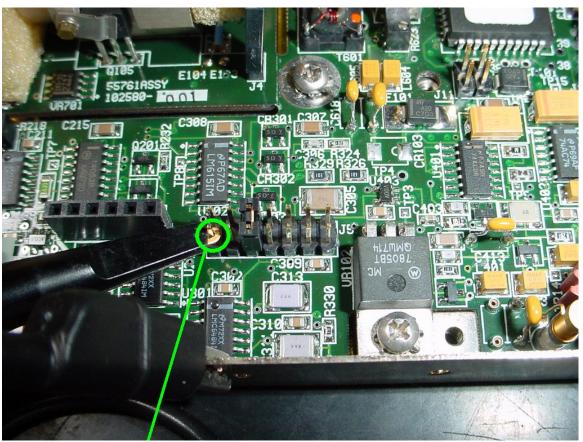
Fig 11, Test point J5, corner pin

Once you have a locked unit you can tune the SRD bias and the 6.8 GHz cavity. Allow the unit to warm-up for 10 minutes. You can only do this after a lock has been established. If you don't have a lock, you probably make things worse by adjusting the settings on the unit.

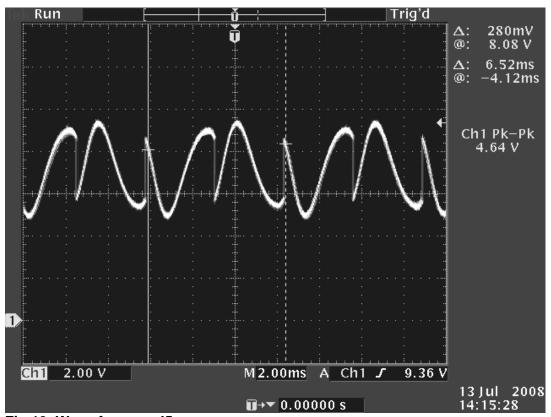
Fig 13, Wave form on J5

Tune both adjustments for maximum Vpp

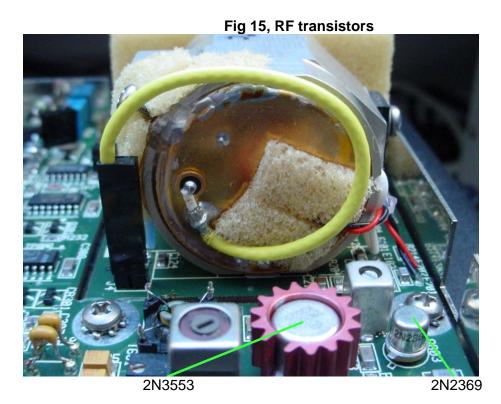
Signal levels: 2N3553 Collector (case) 18Vpp, **60 Mhz** 2N2369 Collector (case) 4.5Vpp, 60 MHz
