KRX3A SUB RECEIVER INSTALLATION AND OPERATION MANUAL ERRATA

Rev. H1-1, December 23, 2016

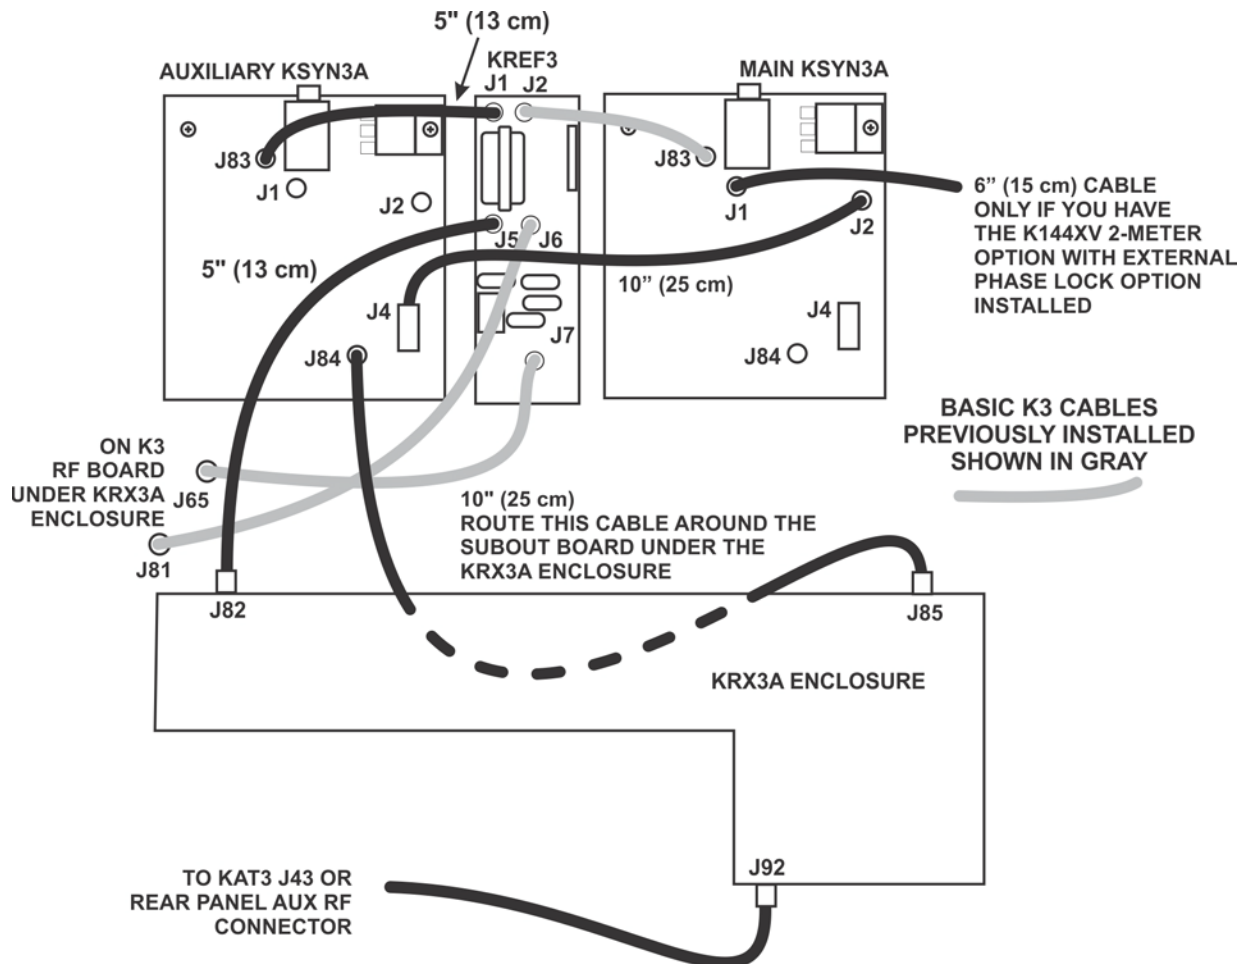
- Page 43, Figure 47:** Replace the figure with the following which corrects the connection of the TMP cable from a K144XV with the External Phase Lock option to J1 of the Main KSYN3A.
