Evaluation of Failure in Low-k Films Using Stiffness Mapping and Dynamic Imaging

Application Note

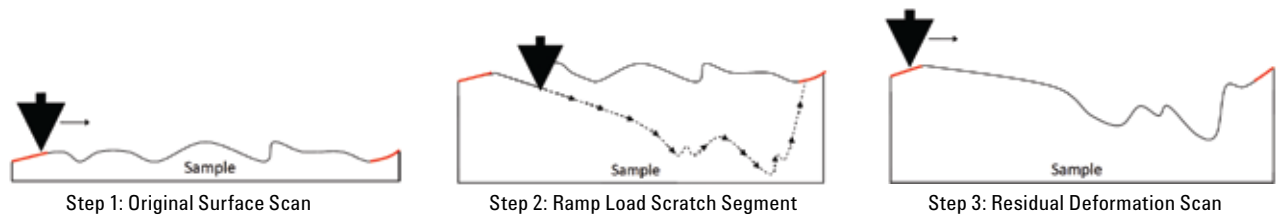
Figure 1. Diagram of the three-step ramp load scratch test. Red lines show the areas of pre and post profile scans used to perform leveling of the 3 steps.

Ramp-load scratch testing was also conducted using a cube-corner tip. In a ramp-load scratch test, the tip is brought into contact with the sample; then, the tip is loaded at a constant loading rate while simultaneously translating the sample. Prior to and following the scratch test, a single-line-scan of the surface topography is completed for comparing the original surface to the deformation caused by the scratch test. Therefore, each scratch test consists of three steps: a single-line pre-scan of the area to be scratched, the ramp load scratch test, and a final scan to evaluate the residual deformation. Before and after each step, a pre-scan and a post-scan, usually equal to 10% or 20% of the scratch length, is performed so that the software can automatically align the data in the three steps. The original and residual single-line scans allow for the

evaluation of deformation mechanisms and the quantification of deformation. The scratch process is diagrammed in Figure 1.

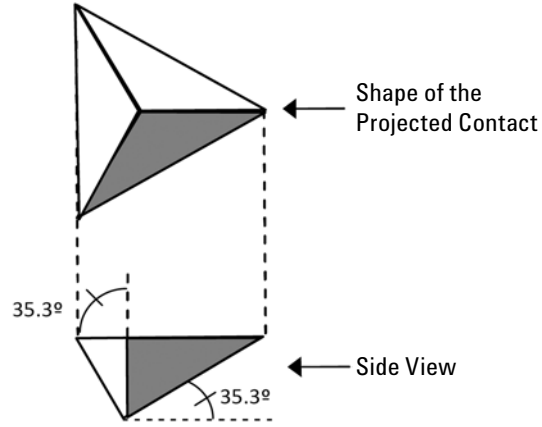
Figure 2. Diagram of cube corner tip.

The tip chosen for conducting the scratch tests was a cube-corner tip with a tip radius that was, nominally, less than 50 nm. A cube-corner tip creates a triangular projected contact with the sample; this tip geometry creates high levels of stress in the material during the scratch. Scratches can be performed either face-forward or edge-forward when using a pyramid shaped indenter. Scratching face-forward with the cube-corner tip acts like a snow plow and pushes the material out of the way, while edge-forward cuts the material

like a knife. A diagram of a cube-corner tip is shown in Figure 2. The low-k samples were tested using the cube-corner tip positioned so that it scratched face-forward.

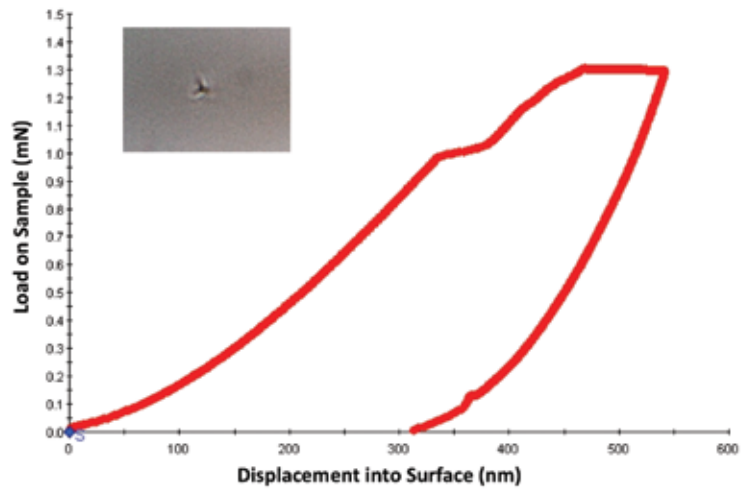
Figure 3. Load displacement curve of an indentation performed on the low-k film to introduce cracking. The residual impression is displayed in the upper-left (1000X magnification).

Fractures were created in the low-k film using a cube-corner indentation tip and performing a quasi-static indentation test up to 1.3 mN of force. Fracture of the film can be seen in the load versus displacement curve shown in Figure 3 when the load reached a value of 0.99 mN. These cracks continued to propagate as the sample was loaded to 1.3 mN—small signs of continued fracture were apparent at forces of 1.16 mN and 1.26 mN. The residual microscope image, at 1000X magnification, of the indentation test is shown in the upper left corner of Figure 3. While small cracks are apparent, measurements of the crack lengths would not be possible. Therefore, dynamic imaging of the residual indentation was performed to provide a means for measuring the crack lengths in the material without having to transfer the sample to another instrument, such as a scanning electron microscope, for imaging.

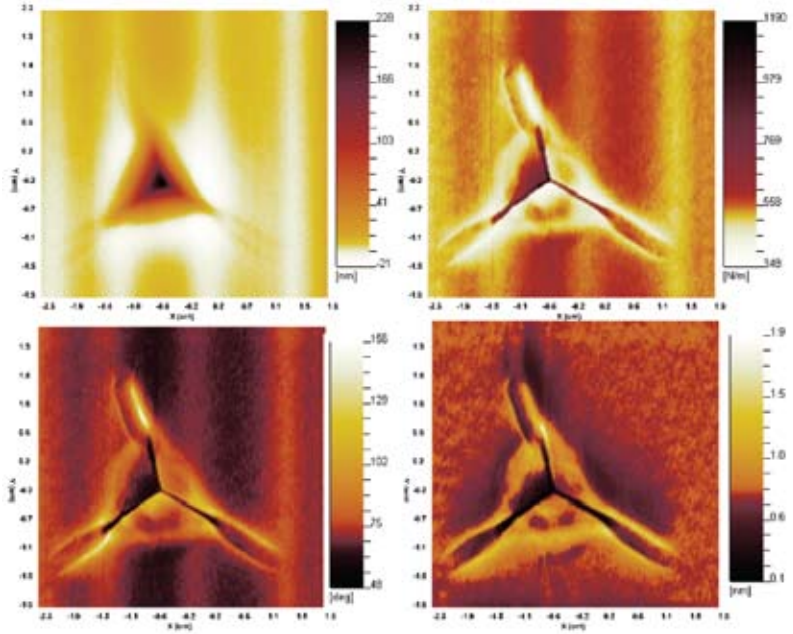
Figure 4. Topography (upper left), stiffness (upper right), phase angle (lower left), and harmonic displacement (lower right) maps of the residual impression left from the indentation test performed in Figure 3. (4.2 μm scan)

One dynamic scan provided the necessary data to produce topography, stiffness, phase angle, and harmonic displacement maps of the residual indentation; the four maps are all shown in Figure 4. The topographical map showed evidence of fracture; however, the crack lengths were unclear due to the poor contrast between the large displacement range used in scanning the indent and the small scale displacements seen in fracture. Stiffness, on the other hand, showed much more contrast because only small stiffness changes were apparent due to topographical changes; but, when cracked or blistered material was encountered, the stiffness changed dramatically. During scanning, when the tip falls into a crack or a sharp edge impression, the contact area increases abruptly and a large stiffness is detected, while just removed from the crack or on a blistered section of the film the stiffness decreases abruptly due to the limited support of the surrounding material. Dynamic imaging takes advantage of the contrast created when abrupt changes in contact areas are detected. Figure 4 shows that the stiffness and phase angle maps provided the best contrast for measuring the crack lengths. The harmonic displacement map was not used in measuring the crack length because a short lag in harmonic displacement control was apparent after scanning the top crack.

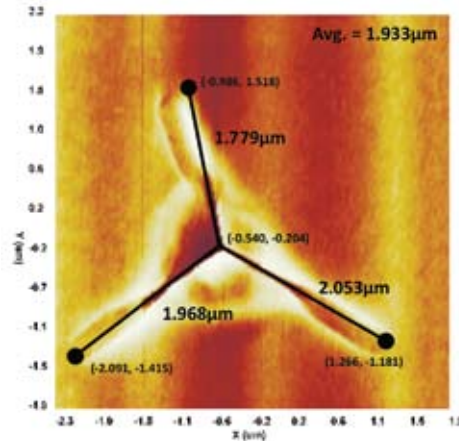
Figure 5. Crack length measurements using the stiffness map produced through dynamic imaging.

Each crack was measured using the stiffness map in Figure 5 and an average crack length of 1.933 μm was determined. A first order approximation of the fracture toughness can be determined using the elastic modulus (E) and hardness (H) of the film along with the maximum load (P) and crack length (c) from an indentation test with a cube-corner tip using the relationship in Equation 1 [1].

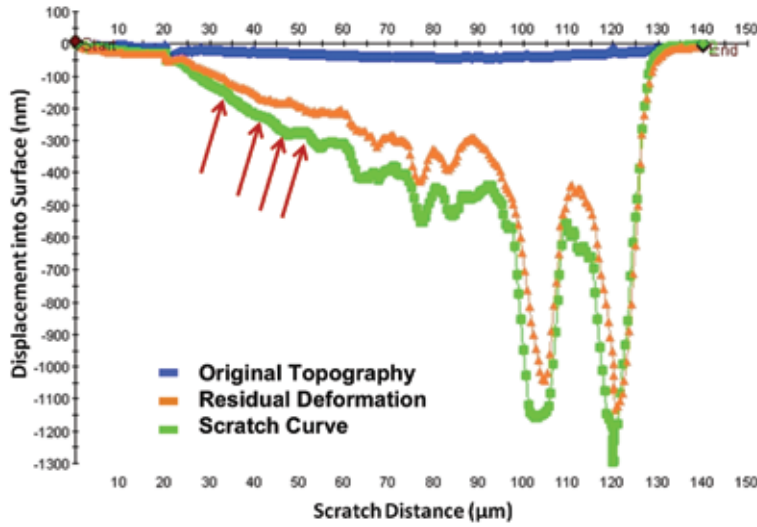
Figure 6. The scratch results (original topography, scratch cycle, and residual deformation) from a typical ramp-load scratch test on the low-k film using a maximum force of 1 mN. Arrows indicate failure in the film.

Scratch testing was conducted on the low-k film to better understand failure modes of the film and to better understand separation of the film from the substrate. A ramp-load scratch test to a maximum load of 1 mN was used to conduct $100 \mu\text{m}$ long scratches. In examination of the resulting scratch curves, multiple points of failure were apparent—the scratch curves for a typical test are shown in Figure 6 with arrows indicating the locations of multiple failure points and possible locations of interface failure. Figure 6 also shows the scans of the original topography (blue), scratch cycle (green), and the residual scan (orange). There was a significant amount of plastic deformation observed in the scratch curves—plastic deformation is depicted by the area between the original topography and the residual deformation, while elastic deformation is depicted by the area between the residual deformation and the scratch cycle—leading up to failure. However, there was insufficient information in the data to decouple deformation mechanisms such as plastic deformation, blistering, and chipping; dynamic imaging of the failure region was used to decouple the three deformation mechanisms and correlate the results to the scratch curves.

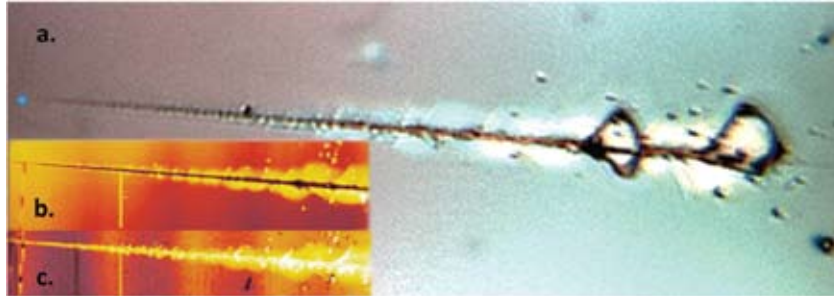
Figure 7. Microscope image (a.) of the residual scratch at 1000X magnification aligned with the topography scan (b.) and the stiffness map (c.) of the region of failure.

The topography scan and stiffness map of the failure region are shown in Figure 7 aligned with the microscope image of the residual scratch taken at 1000X magnification; this figure shows that failure of the low-k film occurs far before it can be observed in the microscope image. The topography

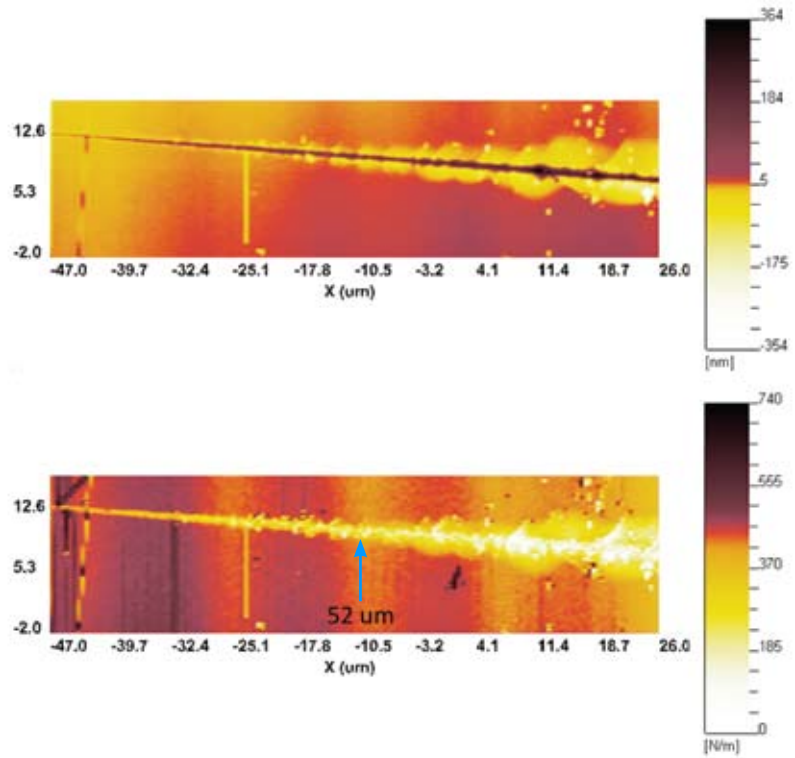
Figure 8. Topography and stiffness maps of the failure region.

and stiffness maps are shown in greater detail in Figure 8. While the topographical image shows early failure of the film, this failure is dominated by minor pile-up and possibly chipping which does not classify as interfacial failure. By examination of the stiffness map, clear blistering does not start until a scratch distance of $52\ \mu\text{m}$ is reached; this region is indicated on the stiffness map in Figure 8. Blistering was determined from the stiffness map when the area surrounding the scratch path showed clear radial propagation of low stiffness signifying that the area has separated from other material in the system and was not well supported. The critical load, defined as the first location of delamination or blistering, was located at this point. Figure 9 shows the stiffness map aligned with the scratch data and an arrow indicating the critical load point in the 2-D scratch curves.

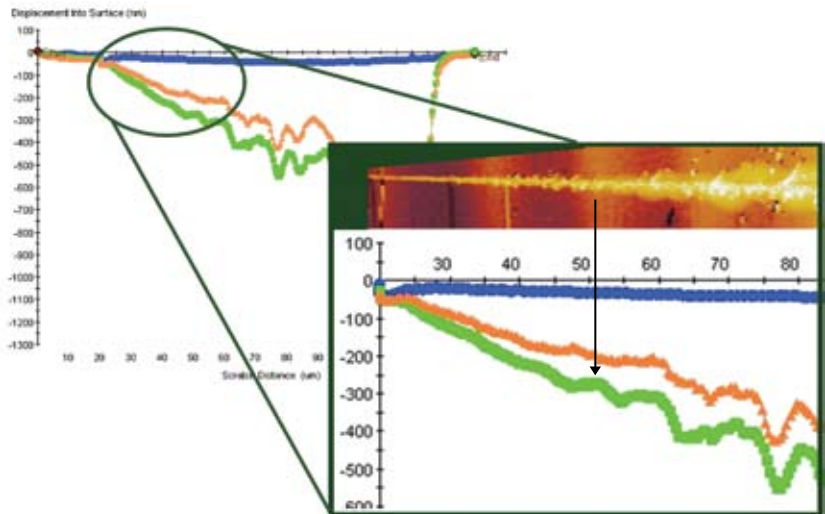
Figure 9. Scratch curves with an outset of the curves aligned with the stiffness map. The arrow locates the *finger print* of failure that indicates major failure of the film.

With the examination of the “finger prints” of failure in the scratch curves, the other scratch data on similar samples were analyzed without the need for imaging. Figure 9 shows that the scratch curve may possess dithers that represent minor chipping of the film—at scratch distances of $35\ \mu\text{m}$ and $42\ \mu\text{m}$ there are noticeable events that occur in the scratch curves—but an arrest of the penetration rate followed by an abrupt acceleration of penetration represented major failure of delamination or blistering in this sample. From analysis of all tests performed on this sample, failure, defined by blistering or delamination, occurred at a normal force of $0.260 \pm 0.03\ \text{mN}$.
