Tackling Advanced Technology Boards: Combining X-Ray and ICT

By Ed Crane, Ed Kinney and Bill Jeffrey

A combination of in-circuit test and automated x-ray inspection may help you lower overall costs, improve product quality, and speed time to market.

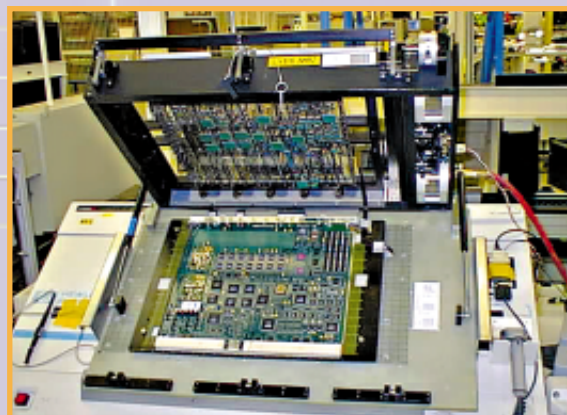
FIGURE 1: This complex in-circuit test fixture is shown with the over-clamp assembly raised. The board under test can be seen in the middle of the fixture. A fixture such as this one can weigh as much as 200 pounds and is unique to each board design.

that exceed a 5,000-node count are a concern to us as they approach the resource limit of our current in-circuit test (ICT) equipment (Figure 1). We presently manufacture approximately 800 different PCBAs or “codes.” Of the 800 codes, approximately 20 are in the 5,000 to 6,000 node range. That number, however, is growing quickly.

In-circuit testing (ICT) is the process of verifying the electrical integrity of a circuit subassembly by probing test points scattered across the board's surface. For automated testing, the probes are spring-loaded "pins" mounted on a thick phenolic plate and wired separately to a switching matrix. The switching matrix is an array of relays that connects the appropriate pins to the current sources and voltage-measuring instruments required at each step in the test procedure.

The phenolic plate carrying hundreds to thousands of spring-loaded pins resembles a bed of nails, and test engineers have adopted the term "bed-of-nails fixture" for the plate. Each nail is positioned so that, when the board is placed on the fixture and pulled down by a vacuum apparatus, the nail contacts its target test point without shorting to neighboring circuit structures.
