E4418B-13

S E R V I C E N O T E

Agilent E4418B EPM Average Power Meter

Replacing A Defective Rivet-Fit Line Module

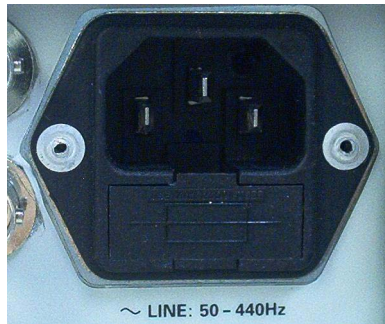
Figure 1 shows the rear panel view of a rivet-fit line module, whilst Figure 2 shows the rear panel view of a push-fit line module.

For these reasons, Agilent recommends that, in the event of line module failure, the chassis assembly be replaced. The chassis assembly comes with a push-fit line module, such that the repair method for any future line module issues becomes much simpler.
