S E R V I C E N O T E

8664A Synthesized Signal Generator

Potential RPP Assembly Failures

DATE: 23 April 1993

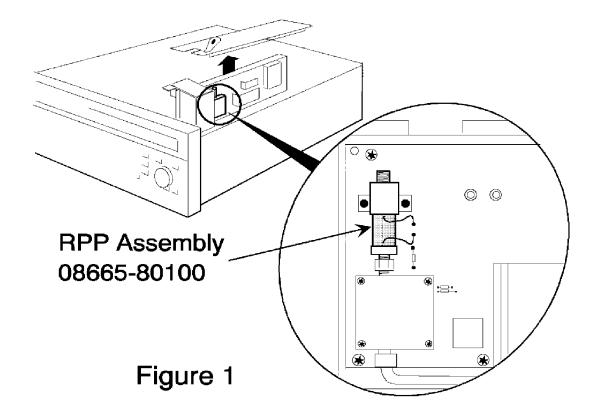
- 1. Remove the original RPP assembly and replace it with the part number listed above. Refer to Figure 1 for assembly and component location.
- 2. Run the internal diagnostics after replacing the RPP assembly.
- 3. Perform RF Level Accuracy Performance Test to insure that the instrument meets specifications.
