E8247C-11

S E R V I C E N O T E

E8247C CW Signal Generator

When replacing an analog power supply (0955-3700), replace the screws on the bottom of the power supply with shorter screws.

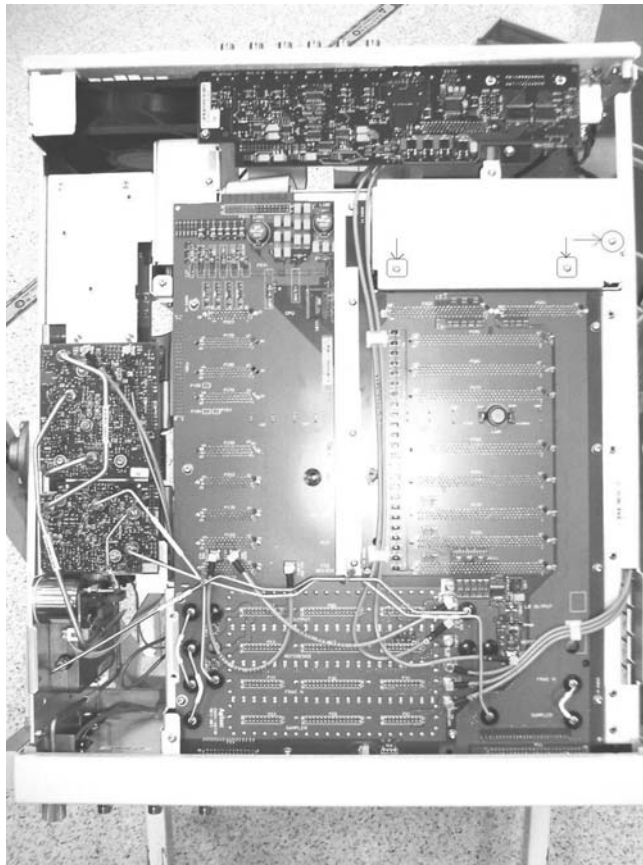
In analog instrument, when a power supply is replaced, replace the 3 mounting screws that hold the power supply with part number 0515-0430. (See picture for parts location).

Due to variations in component locations within the power supply (a purchased part) , if components are tilted the wrong way the current screw (0515-0372) is long enough to cause a high pot failure. Since all instruments are high pot tested before being shipped, there is no problem with instruments already in the field. When a power supply is replaced, the 3 mounting screws on the bottom of the instrument should be changed to a shorter screw (0515-0430) to eliminate any potential problem. With the old screws, even if the part spacing becomes too close to cause a high pot failure, there is NO safety issue.
