S E R V I C E N O T E

8591E Spectrum Analyzer

Modification to A14 Log Amplifier Assy to control overshoot problem

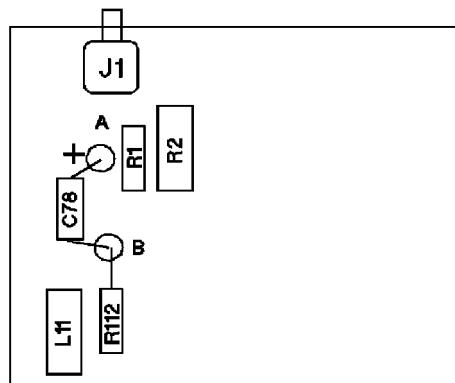
A 10 ufd. capacitor is added to the +11 volt regulated circuit. The capacitor is actually tied to the +11 V2 output to ground. The effect of the capacitor is to suppress the overshoot that has been experienced as described in the Situation description.

1. Lift the top lead of R112 from the circuit board at Point B, see Figure 1.
2. Place the terminal stud (p/n 0360-0124) into Point B and solder in place.
3. Place the (+) end of the capacitor (C78) into the hole at Point A and solder in place.
4. Wrap the (-) lead of C78 and the loose lead of R112 around the terminal stud in Point B and solder.
5. Apply one label with the 08590-60373 imprinted to the assembly over the 5062-8261 part number and place one label on the rear panel for quick identification of the modified Log assembly.
