**37719A-06**

# S E R V I C E N O T E

**OmniBER 37719A**

**Optical power warning label**

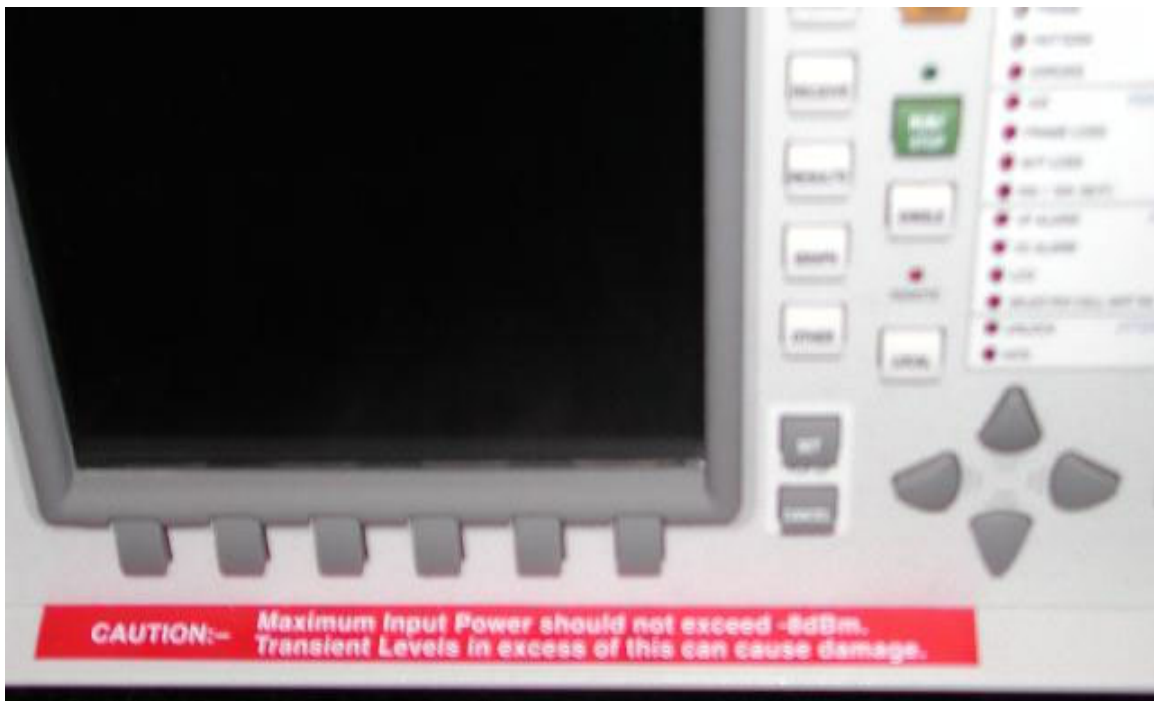
- 2 Change label if information does not match above. Label should be placed along front frame of instrument as shown below

Replace old optical warning label with the new one. Ensure that the letter is sent in the instrument pouch.

- 1 Check that the instrument has the correct information (see below)

**"CAUTION:- Maximum Optical Input Power should not exceed -8dBm. Transient levels in excess of this can cause Damage."**
