Circuit Diagram of BS1 PDA Earphone (0.0 Edit 25) for ver_10

Circuit Diagram of BS1 PDA IRDA (0.0 Edit 27) for ver_10

Circuit Diagram of BS1 Lid Switch (0.0 Edit 26) for ver_10

Parts Placement Diagram of BS1 PDA 2/2 (0.0) _10

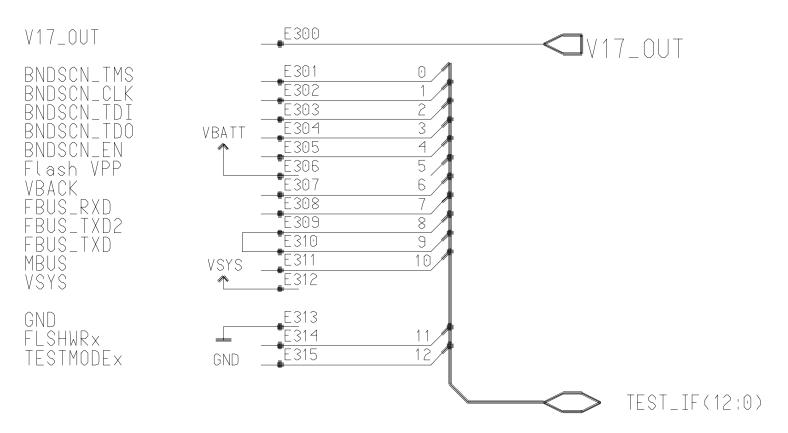
VBATT should connect together with XIP Flash VPP Which is separately routed from frame connector

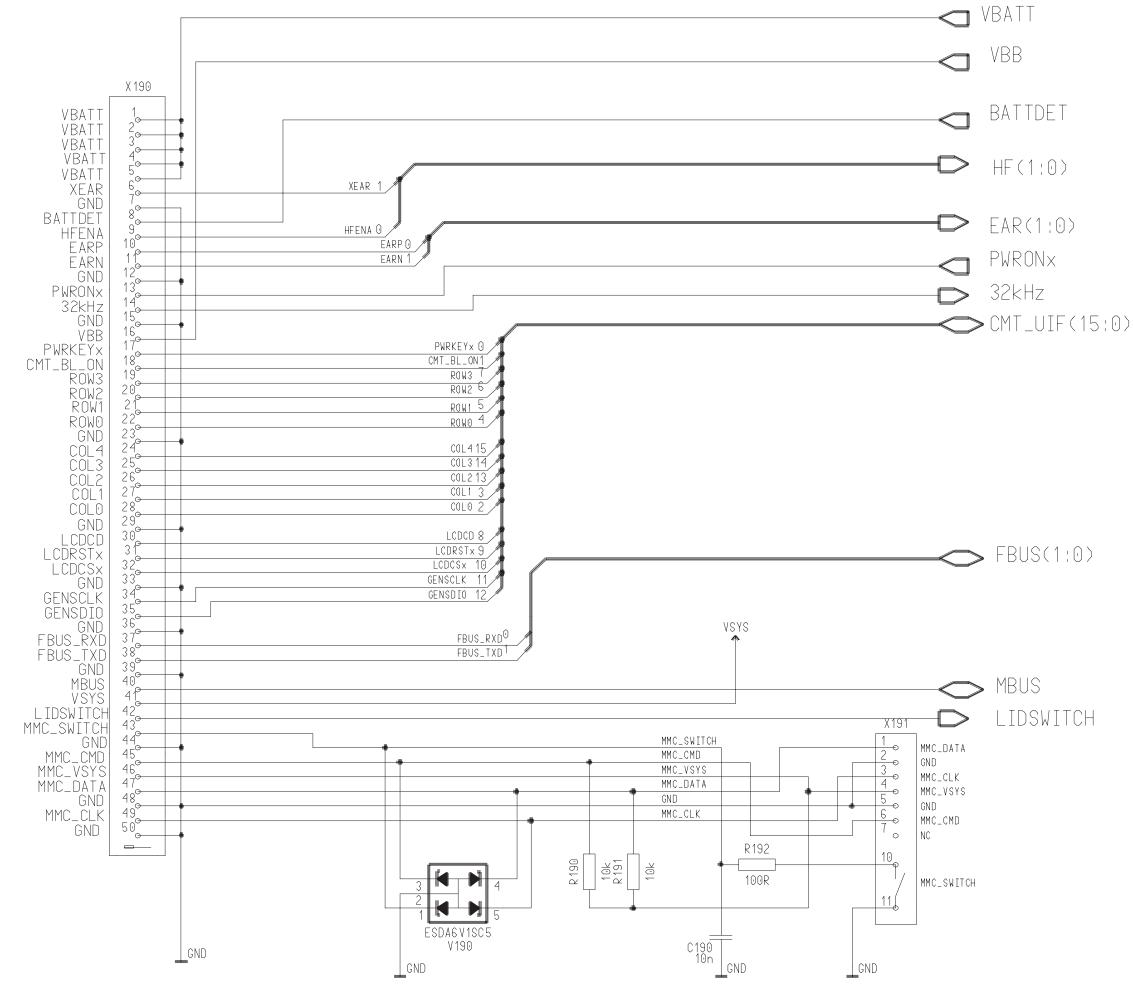
C190 and R192 are not assembled
