## Modification Bulletin

Model: Model K3 Date			e: 1-Nov-02		No.: MH310001	
Modified Article: F	Parts Catalog Corrections		Prepared	by: M.	Mano	
From: Technical Services sec. Service Planning Dept.						
Reason for	□ Parts catalog correction	☐ Vend	lor ch	ange	☐ To n	neet standards
Modification:	☐ To facilitate assembly	☐ To improve reliabilit		e reliability	(	)
	☐ Part standardization	☐ Othe	r

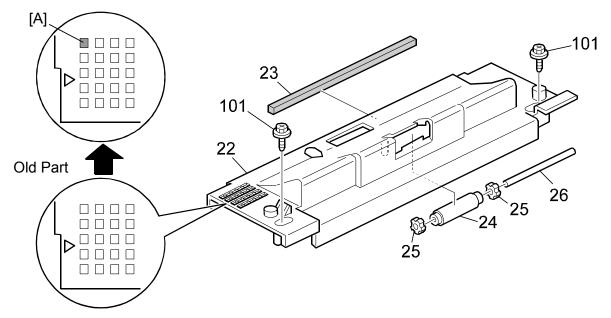
To facilitate assembly, the hole in the Exit Guide shown below has been closed (with no change in function).

### New Part: The shaded hole [A] is closed

Old part	New part	Description	Q'ty	Int	Page	Index	Note
number	number						
H3101196	H3101199	Exit Guide	1	X/O	15	22
