Model: Kaiser1	Date: 16-Mar-00	No.: MH306001a
----------------	-----------------	----------------

MB Correction

Modified Article: Parts Catalog Corrections		Prepared by: M. Mano	
From: Technical Service Dept., GTS Division			
Reason for Modification:	<input checked="" type="checkbox"/> Parts catalog correction	<input type="checkbox"/> Vendor change	<input type="checkbox"/> To meet standards ()
	<input type="checkbox"/> To facilitate assembly	<input type="checkbox"/> To improve reliability	
	<input type="checkbox"/> Part standardization	<input type="checkbox"/> Other

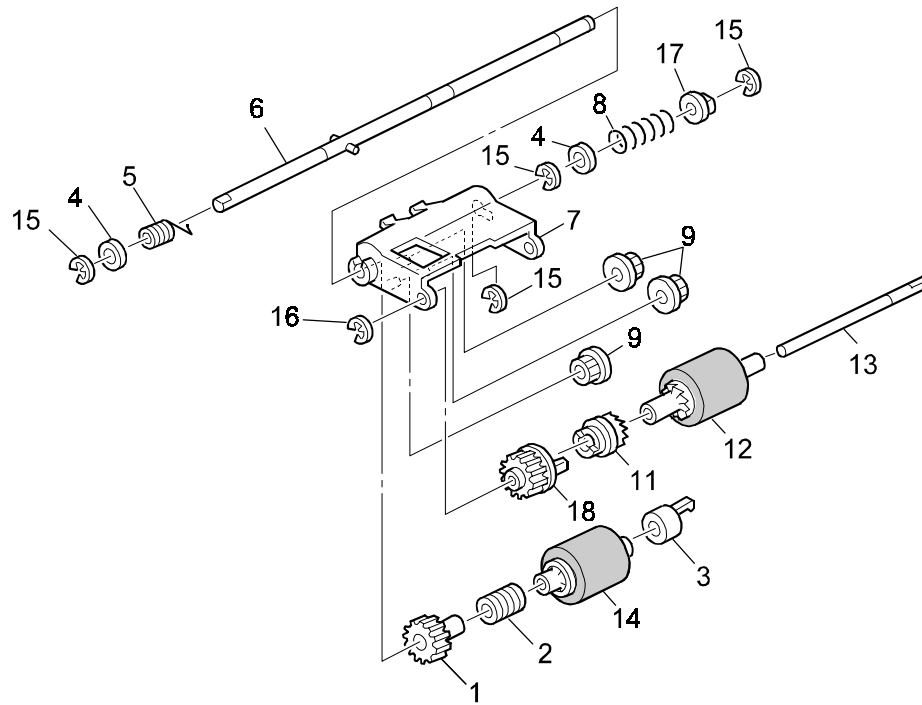
The following are the part numbers for the ADF Pickup Unit Assembly for the Kaiser1:

Old part number	New part number	Description	Q'ty	Int	Page	Index	Note
-	H3061207	ADF Pickup Unit	1				*1

*1: This part contains the following items (see the next page for each part number).

H3061207 contains the following parts.

Index	Part number	Description	Q'ty	Note
1	H5211286	Gear -Feed Roller	1	
2	H5211316	Spring Clutch - M9	1	
3	H3061288	Clutch Roller	1	
4	H0062316	Spacer - Pickup Clutch	2	
5	H5211314	Spring Clutch - M6	1	
6	H3061370	Feed Shaft	1	
7	H3061274	Feed Bracket	1	
8	H3061320	Pressure Spring	1	
9	H3061361	Pickup Idler Gear	3	
10	H5211287	Gear - Pickup Roller	1	
11	H5211288	Collar - Pickup	1	
12	H3061302	Pickup Roller	1	
13	H3061276	Pickup Roller Shaft	1	
14	H3061301	Feed Roller	1	
15	07200040E	Retaining Ring - M4	4	
16	07200030E	Retaining Ring - M3	1	
17	08053480	Bushing - 6mm	1

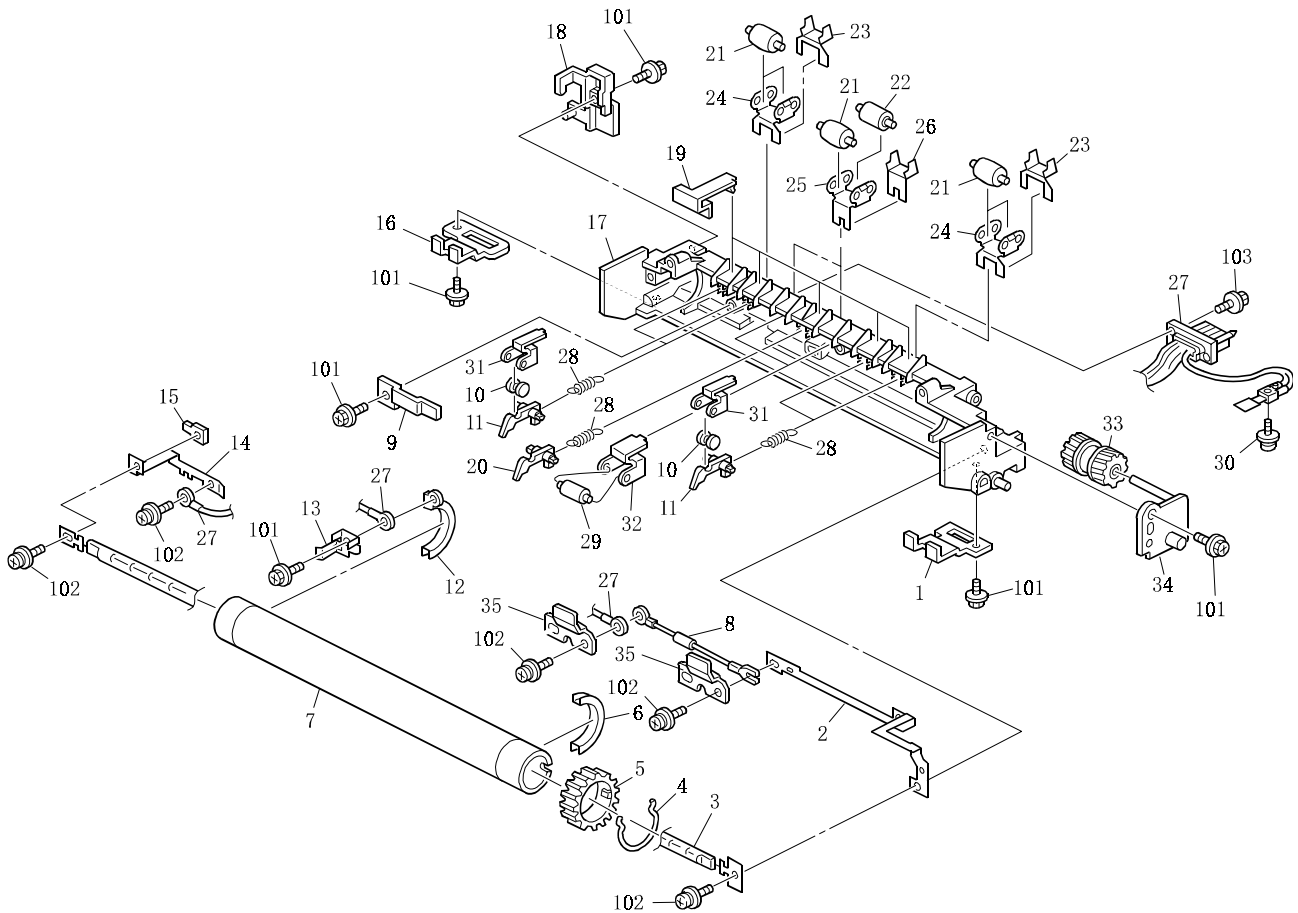
Old part number	New part number	Description	Q'ty	Int	Page	Index	Note
G0294161	H3065068	Thermofuse – 169°C	1	X/O	35	8	
-	G0294133	Cover Screw	2		35	35	*2

*2: This part was not included in the original illustration (not a new part).

Please add the index description and illustration.

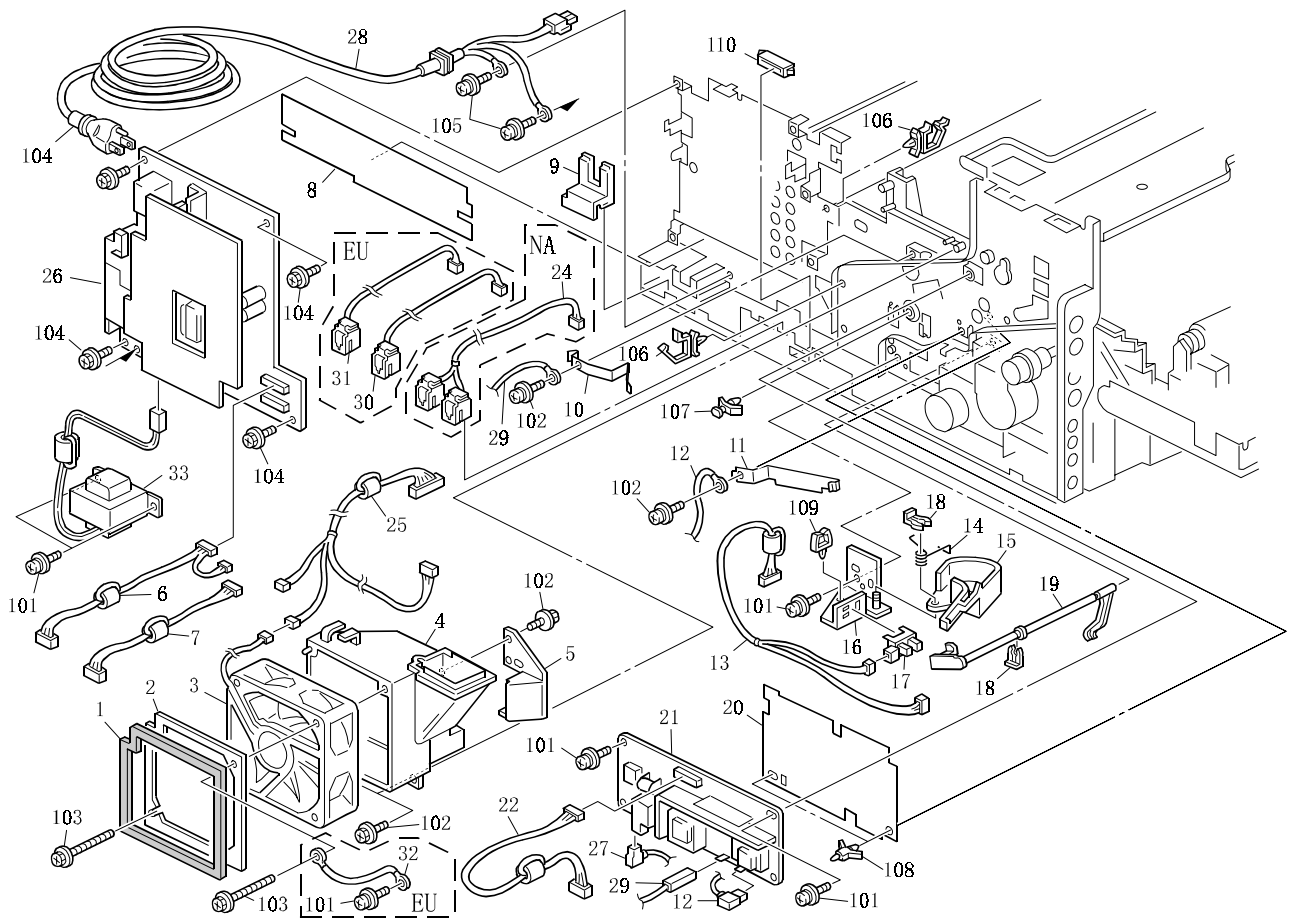
Old part number	New part number	Description	Q'ty	Int	Page	Index	Note
H3065010	H3065011	PSU	1	X/O	41	26	
H3065207	H3065223	Harness NCU-6P	1	X/O	41	30	
H3065212	H3065224	Harness NCU-4P	1	X/O	41	31	
-	N6074525	Choke Coil RITL-9704	1		41	33	*2

*2: This part was not included in the original illustration (not a new part).
Please add the index description and illustration.

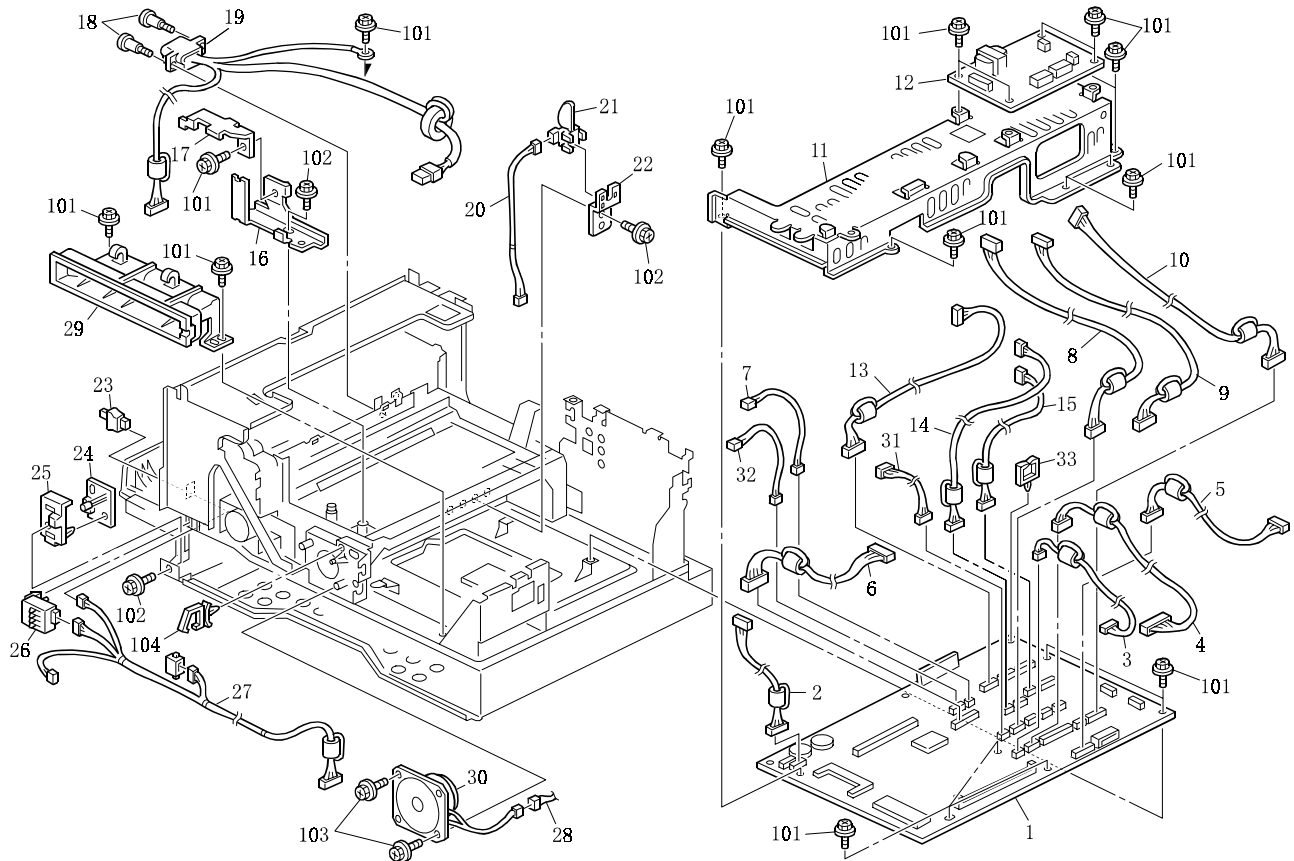
Old part number	New part number	Description	Q'ty	Int	Page	Index	Note
-	H3063198	Clamp	1		43	33	*1

*1: This part was not included in the original illustration (not a new part).
Please add the index description and illustration.

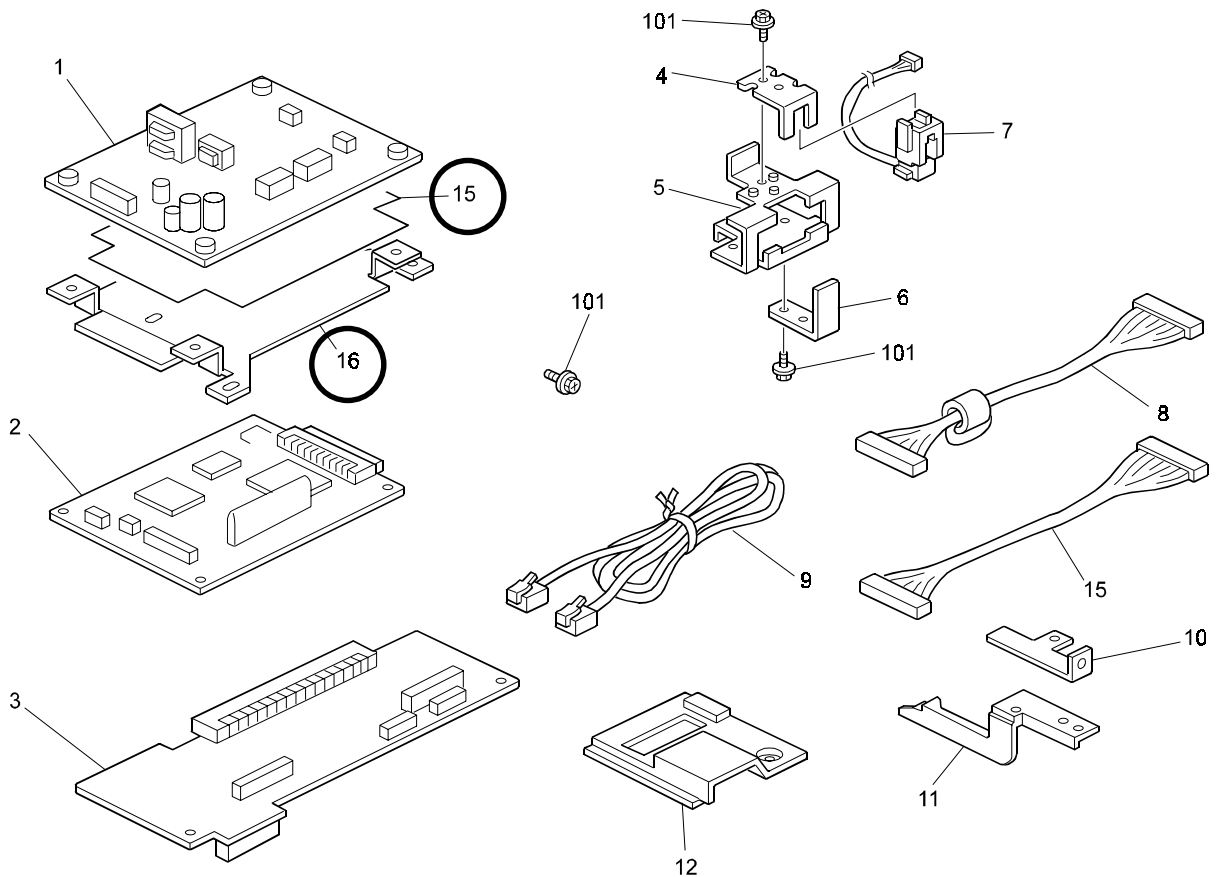
Old part number	New part number	Description	Q'ty	Int	Page	Index	Note
-	54886141	NCU Board – EU/Asia	1		3	1	*1
-	H3064648	Insulation Sheet	1		3	15	*2
	H3064634	Bracket – NCU	1		3	16	*2

*2: These parts were not included in the original illustration (not new parts).

Please add in the three index descriptions above along with the illustration for the Insulation Sheet and the NCU Bracket (#15 and 16, circled below).

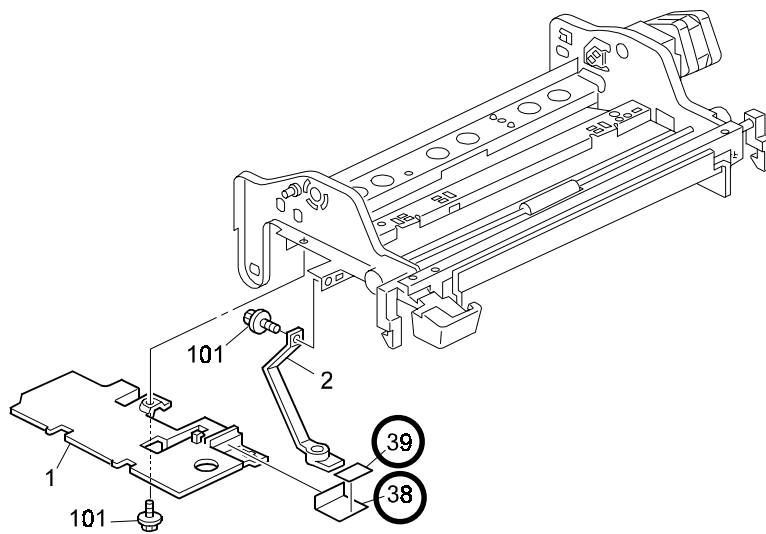
Old part number	New part number	Description	Q'ty	Int	Page	Index	Note
-	H3061334	Sheet ADF Switch 1	1		13	38	*1
-	H3061335	Sheet ADF Switch 2	1		13	39	*1

*1: This part was not included in the original table or illustration (it is not a new part).

Please add in the two index descriptions above along with the illustration for the Sheet ADF Switch 1 and Sheet ADF Switch 2 (#38 and 39, circled below).

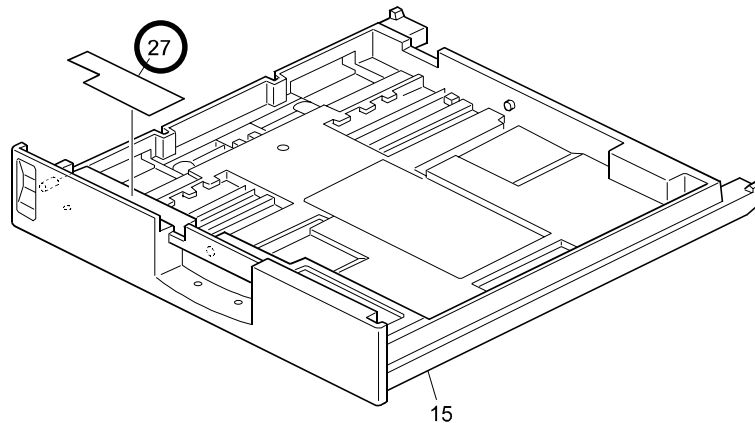
Old part number	New part number	Description	Q'ty	Int	Page	Index	Note
H5235003	AW020075	Photointerrupter	1	X/O	21	5	*1
H3063183	H3062099	Decal – Fusing Cover1	1	O/O	27	7	*2
G0293863	G0293967	Discharge Brush	1	X/O	27	18	*3
H3063129	H3063151	FCU Shield Cover	1	X/O	43	11	*4
G0294175	H3062137	Stripper Pawls	1	O/O	35	20	*2
H3063334	H3063197	Adjusting Screw	1	X/O	45	26	*5
	H3063335	Decal Paper Size	1		29	27	*6

*6: The new part has been added since the June mass production lot.

(see the following illustration)

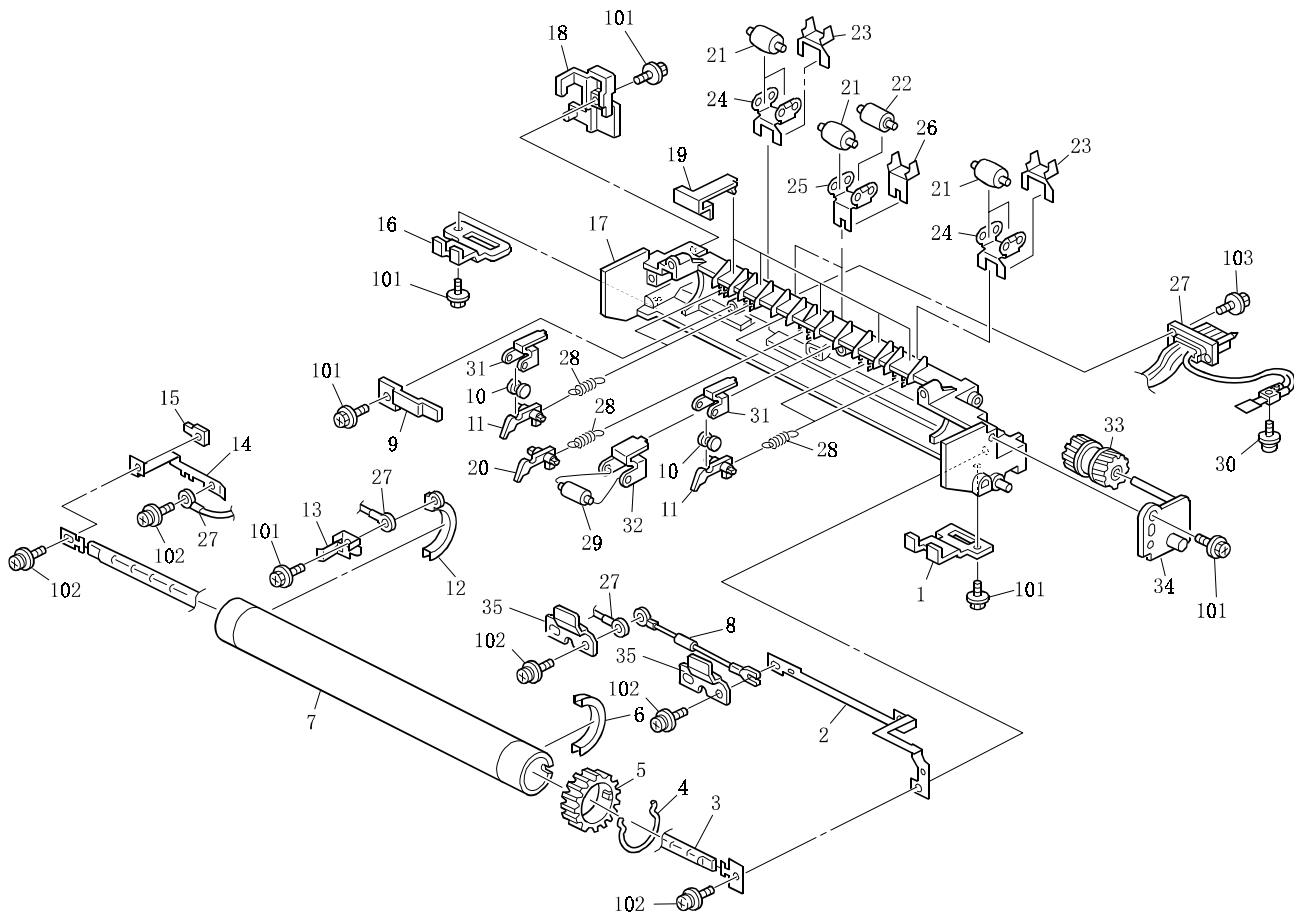
It is possible for the fusing harness cover to become warped due to heat (rare occurrence). To prevent this, its composition has been changed from plastic to metal. Please make the following corrections to your Parts Catalogs.

Old part number	New part number	Description	Q'ty	Int	Page	Index	Note
G0294138	H3062179	Fusing Harness Cover	1	X/O	34	9
