Model: Penguin

Subject: Installation of ST29 for the Penguin (Little: 50 cpm)

Technical Bulletin

Date: 30-Apr-99		99	No.: RA246006
tle: 50 cpm)		Prepared by: F. Noguchi		
☐ Part information		Action required		
Electrical			☐ Service manual revision	
☐ Transmit/receive			☐ Retrofit information

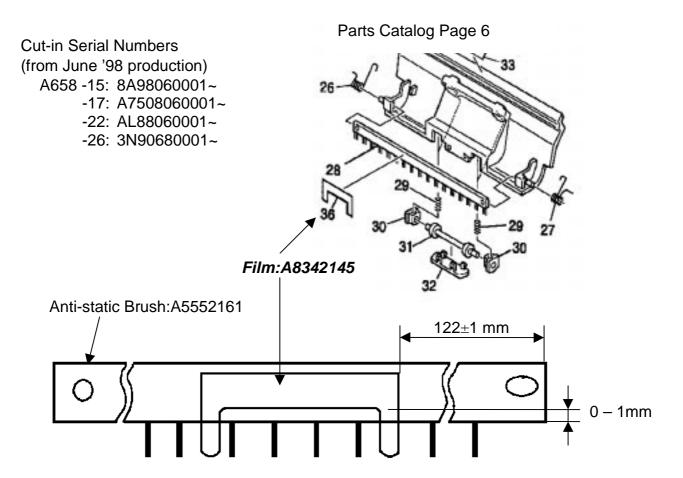
- 1. With some types of recycled paper, jams may occur in the bin's end fence. To prevent this, film (A8342145) has been attached to the anti-static brush as shown.
- 2. When the duplex sorter enable by-pass mode is selected with SP mode, the jogger will be moved even when feeding small size (A5, HLT, B6 Lengthwise) paper and the jogger may crash into the bin. To prevent this, the software has been changed so that the jogger will not be moved for small paper sizes. (ROM A6585103B → C)

Note: For the units manufactured in May 1998 and earlier, please add the film and install the modified ROM.
