**Product:** CRT MONITOR  
**Model:** AQ17LS  
 SyncMaster 750S

**Bulletin No.:** MON02-006 (02-C/M-E0067)  
**Bulletin Date:** July 27, 2002  
**ECN Date:** July 27, 2002

**SUBJECT:** Electronic Shock

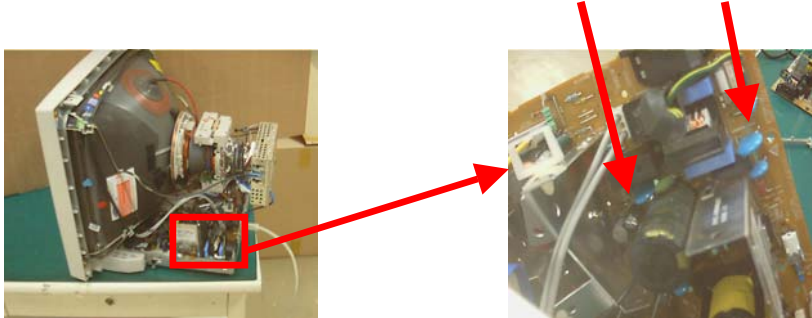
**Background:** There may be a leakage current problem with the AQ17LS model monitor if used in a building that has no grounding system (earth ground). Because of this, the user may feel a slight electronic shock when touching the screen or D-sub connector.

**Cause:** Capacitors C603 and C604.

**Solution:** Change the value of capacitors C603 and C604.

ORIGINAL			NEW	
Location No.	Part No.	Description	Part No.	Description
C603	2201-000024	C-Ceramic Disk, 4.7nf, 20%, 250V	2201-000023	C-Ceramic Disk, 2.2nf, 20%, 125V
C604	2201-000024	C-Ceramic disk, 4.7nf, 20%, 250V	2201-000023	C-Ceramic Disk, 2.2nf, 20%, 125V
