SERVICE BULLETIN

Product : LCD Monitor	Bulletin No. : 01-C/M-E0018
Model : SyncMaster 150MP,170MP	Bulletin Date : 21.March.2001
Buyer :	ECN Date : 03. July. 2001
SUBJECT : Remote controller change for 150MP,170MP(ML15*,ML17*) LCD Monitor

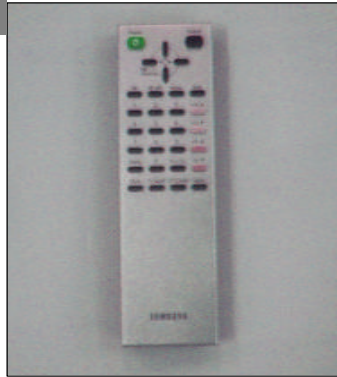
Old type remocon

Background : When using remote controller(Remocon) of 150MP & 170MP model, can affect Samsung air conditioner to abnormal operation.

Cause : Used same custom code with Samsung airconditioner remote controller.

Solution : In case of replacing main board for the units which produced before July.2000, replace remocon with new type.

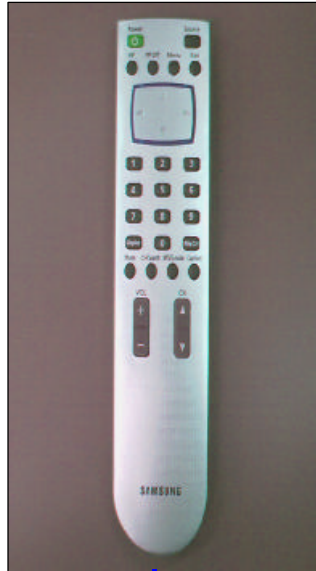
New type remocon

Samsung changed remote controller to prevent interference from 03.July.2000

Old type -> Design change -> Code change to prevent interference

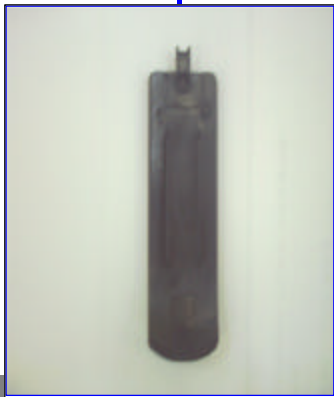
Before code change

Inner side of battery cover

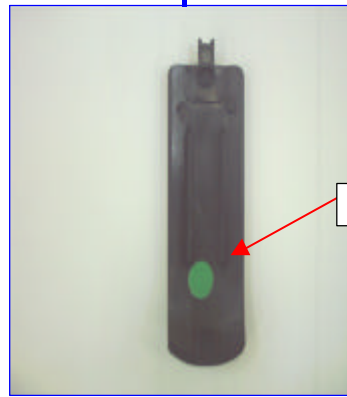
After code change

(Add green sticker on inside battery cover)

Green Sticker

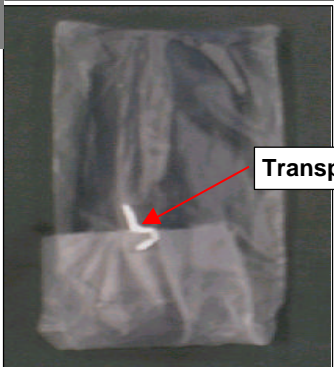
Transparent tape

Remocon Package
